FIELD INSPECTION

Project Name:	Mountain Valley Pipeline	Inspector:	Marshall Willis
Inspection Date:	Thursday, July 11, 2019	Project Contact:	Brian Clauto
Spread I: Franklin County	STA 14042+40 – 14062+17 STA 13840+00 – 13860+00 STA 14209+75 – 14249+19	Weather (Wet/Dry/Rain):	Dry

FIELD INSPECTION PHOTO LOG

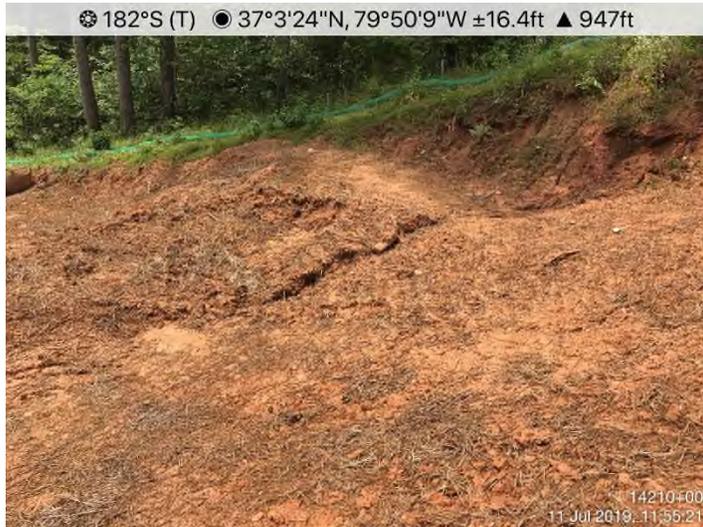
Fig. 1: STA 14210+00 to 14213+75 – Inadequate stabilization. Repair rill erosion and stabilize.

Recommended Corrective Action: Adequately re-stabilize ROW. Maintain and install all controls per the approved plan and specs.

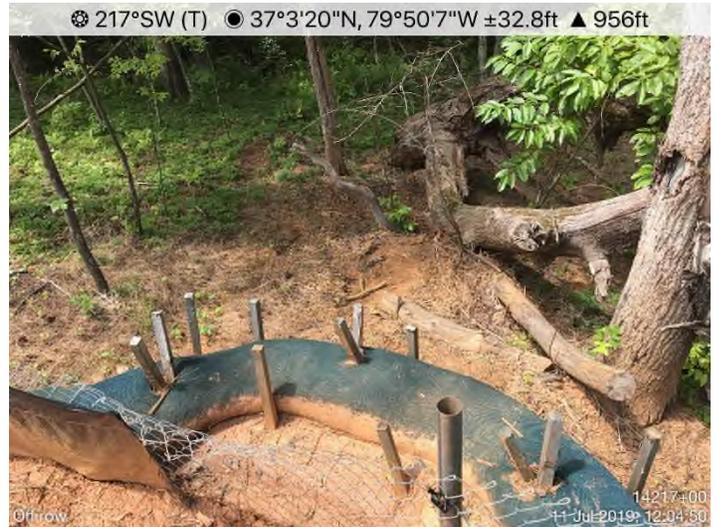
Fig. 2: STA 14217+00 – Sediment off ROW.

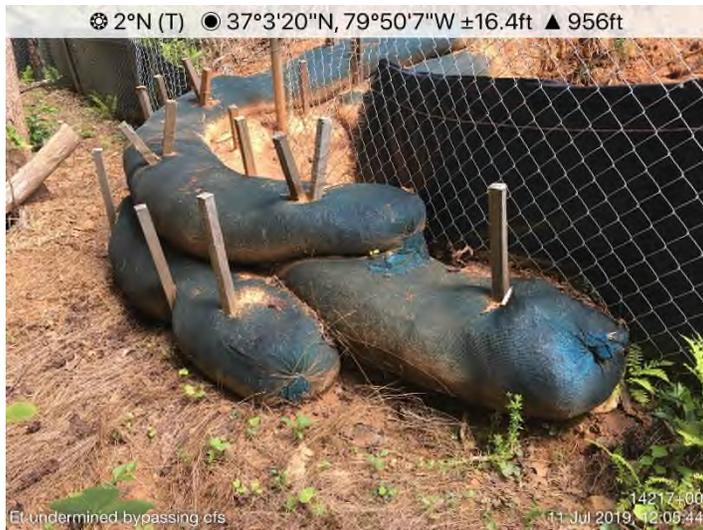
Fig. 3: STA 14217+00 – End treatment undermined.

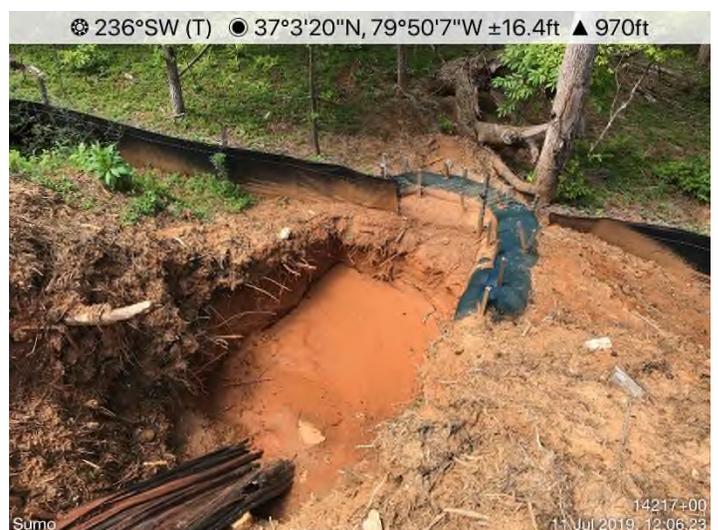
Fig. 4: STA 14217+00 – Sump maintenance needed.

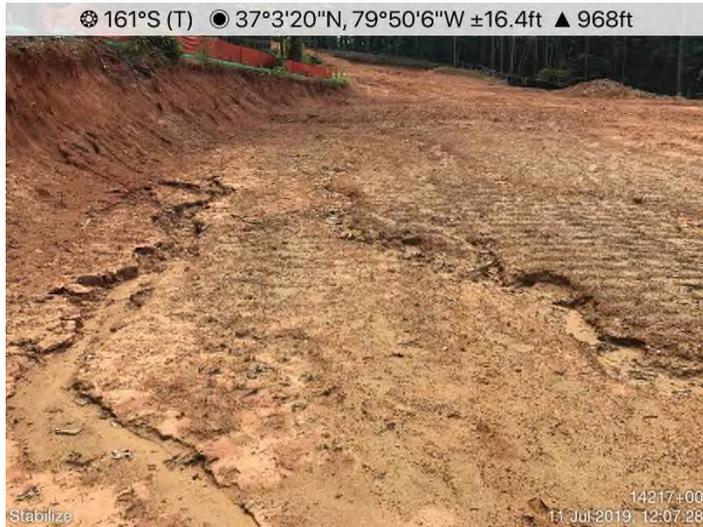
Fig. 5: **STA 14216+00 to 14223+41** – Inadequate stabilization. Repair rill erosion and stabilize.

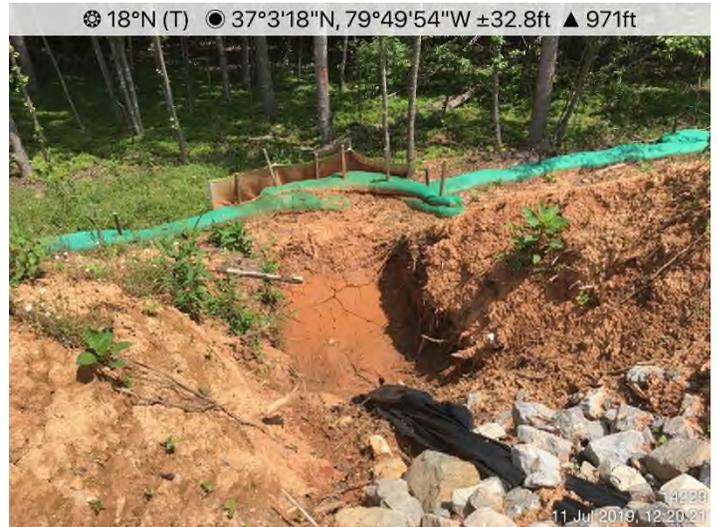
Fig. 6: **STA 14229+00** – Sump maintenance needed.

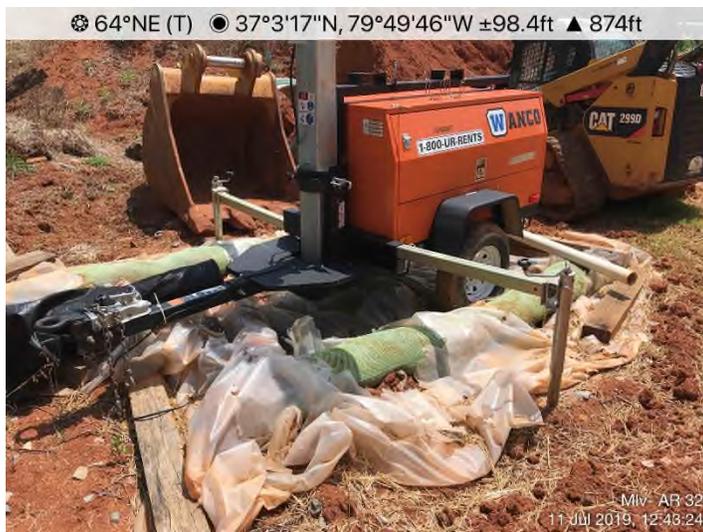
Fig. 7: **MVP-MLV-AR-23** – Repair secondary containment structure.
