FIELD INSPECTION REPORT

| Project Name: | Mountain Valley Pipeline | Inspector: | Marshall Willis |
| Inspection Date: | Friday, July 24, 2020 | Project Contact: | Brian Clauto, Cory Chalmers |
| Spread I: Franklin County | STA 14209+75 – 14249+19 MVP-FR-311 MVP-MLV-AR-32 | Weather: | Dry |

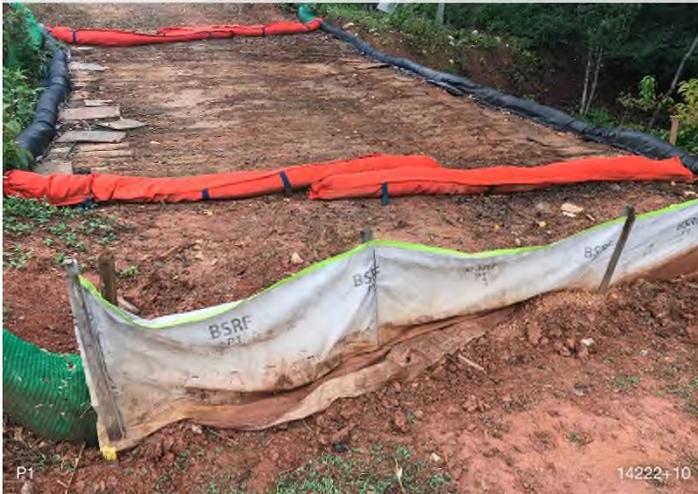
- STA 14222+10: P1 in need of repair.

Figure 1: STA 14222+10 – P1 repair needed.

Recommended Corrective Action: Maintain and install all controls per the approved PSS&S.

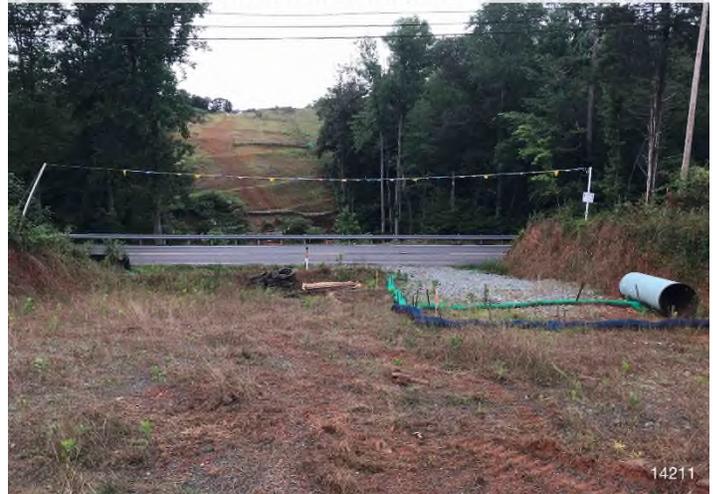
Figure 2: STA 14211+00 – Controls in place and functioning properly.

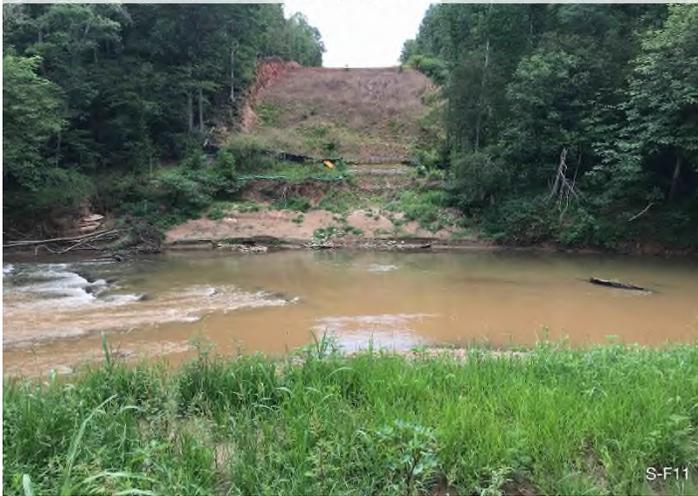
Figure 3: Stream S-F11 – Controls in place and functioning properly around Blackwater River crossing.

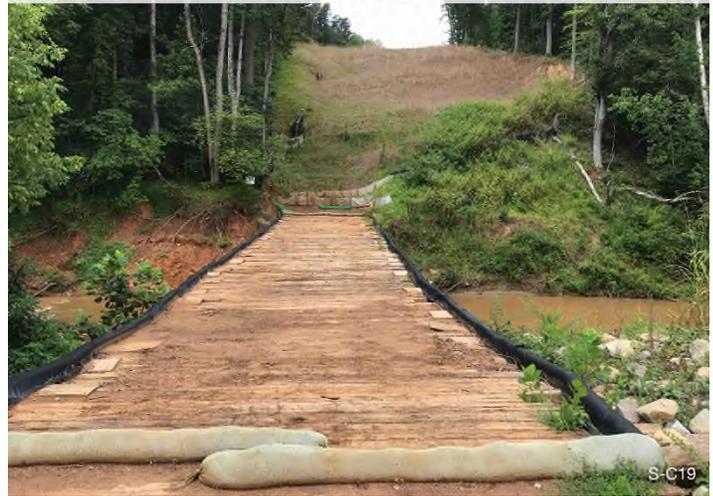
Figure 4: Stream S-C19 – Controls in place and functioning properly around Maggodee Creek crossing.
