FIELD INSPECTION REPORT

Project Name:	Mountain Valley Pipeline	Inspector:	Marshall Willis
Inspection Date:	Monday, July 27, 2020	Project Contact:	Brian Clauto, Cory Chalmers
Spread I: Pittsylvania County	STA 15947+64 – 16000+00 ATWS 401/401A/1325 Transco Station	Weather:	Dry

FIELD INSPECTION PHOTO LOG

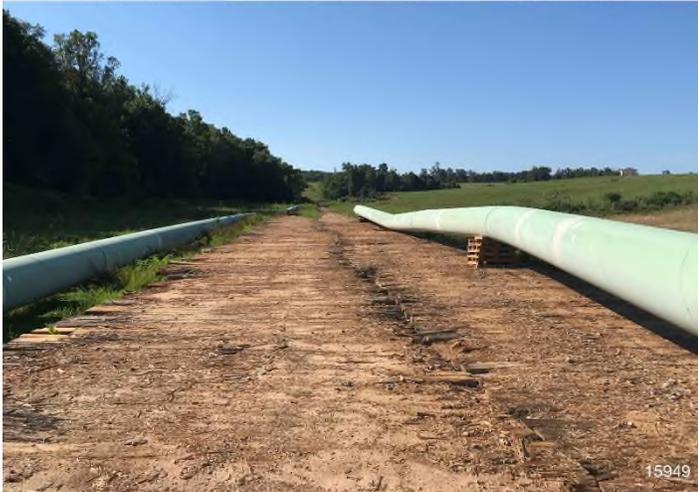
15949

Figure 1: STA 15949+00 – Controls in place and functioning properly.

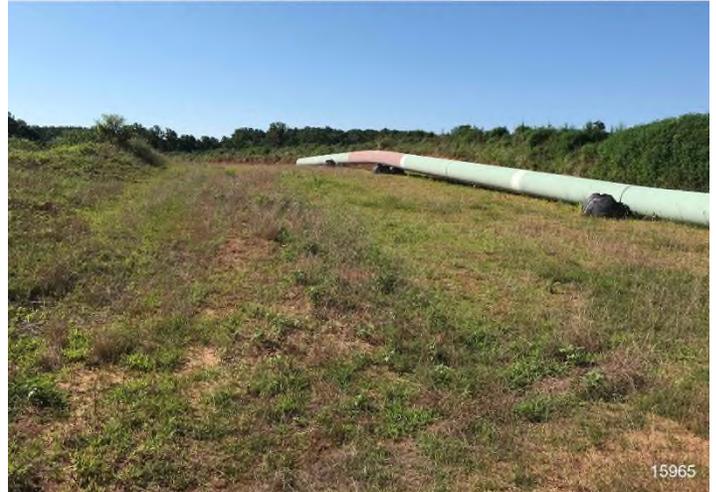
15965

Figure 2: STA 15965+00 – Controls in place and functioning properly.

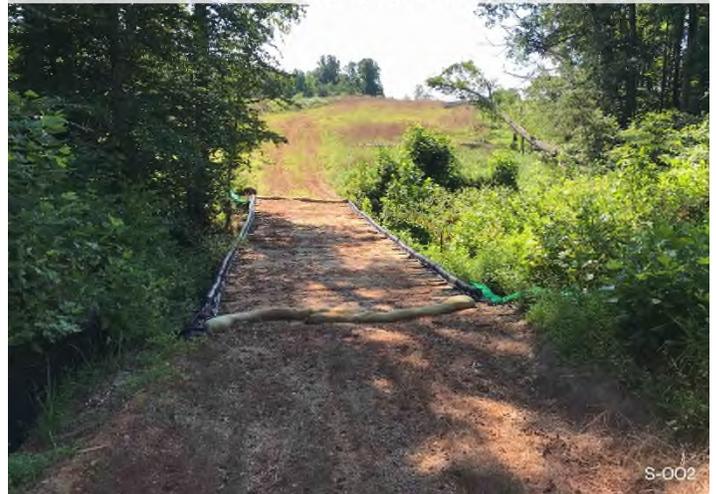
Figure 4: Stream S-002 – Controls in place and functioning properly around stream crossing.
