FIELD INSPECTION

Project Name:	Mountain Valley Pipeline	Inspector:	Marshall Willis
Inspection Date:	Monday, August 12, 2019	Project Contact:	Brian Clauto, Cory Chalmers
Spread I: Franklin County	STA 14230+00 – 14250+00 MVP-MLV-AR-32 ATWS 351 + 351A ATWS 693 + 693A	Weather (Wet/Dry/Rain):	Dry

FIELD INSPECTION PHOTO LOG

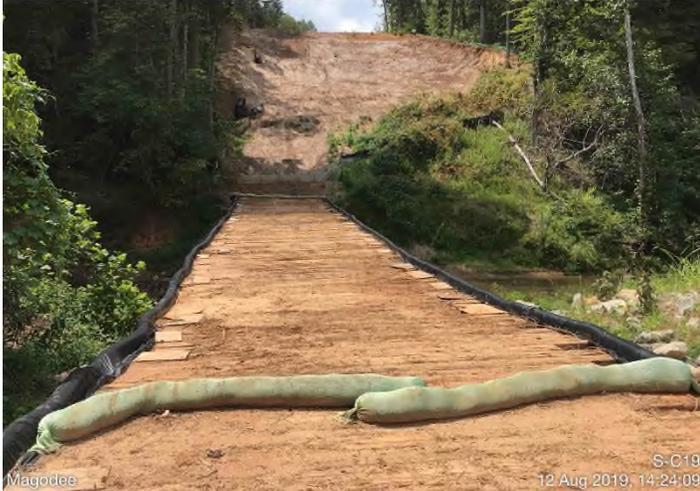
Fig. 1: STA 14233+57 –Maggodee Creek (S-C19) MVP ROW crossing. Controls are in place and functioning. Area stabilized with straw and Earth-Guard.

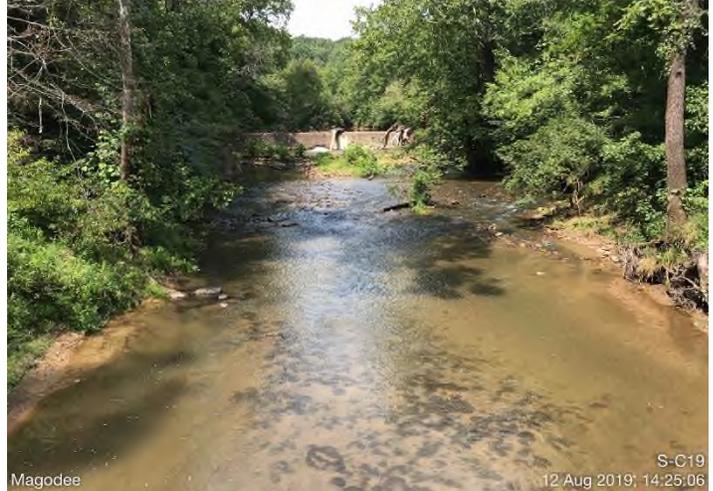
Note: Discharge from Maggodee Creek is no longer going over dam upstream of MVP ROW. Documentation from inspection on 7/26/2019 shows water flowing over dam, however inspection on 8/12 shows low flow orifice active only. Change in discharge from this control device may cause temporary elevated turbidity levels downstream in Maggodee Creek and Blackwater River. USGS MVP "upstream" monitoring station is located just below confluence of Maggodee Creek and Blackwater River.

Fig. 2: STA 14233+57 – Upstream view Maggodee Creek (S-C19) from MVP ROW crossing. Note: Discharge not overtopping dam structure.

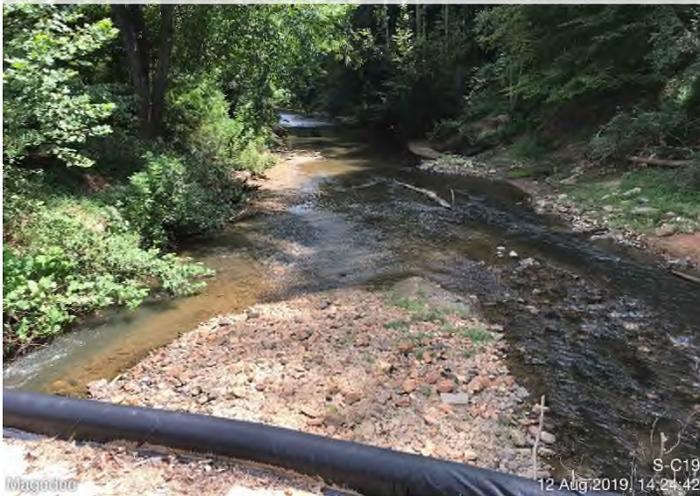
Fig. 3: STA 14233+57 – Downstream view Maggodee Creek (S-C19) from MVP ROW crossing looking towards confluence of Blackwater River.

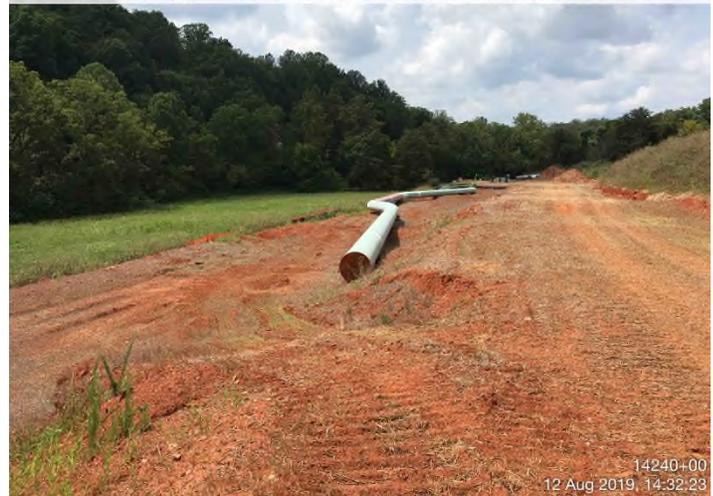
Fig. 4: STA 14240+00 – Area stabilized with Earth-Guard, millet and straw. Controls in place and functioning. No observed sediment off ROW.

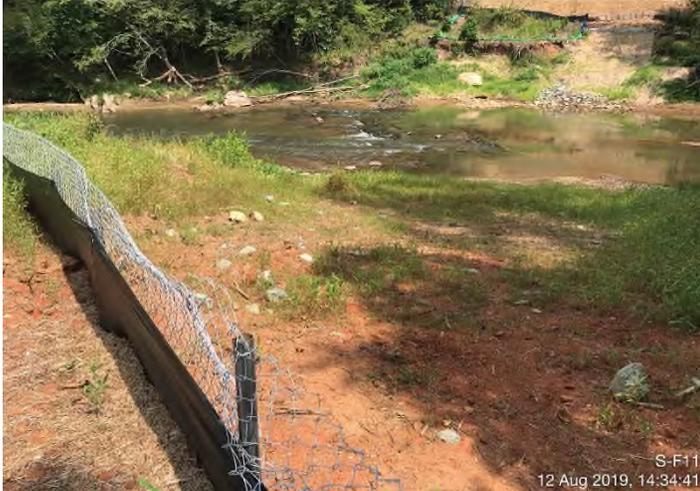
Fig. 5: **STA 14249+19** – Blackwater River (S-F11) from MVP ROW crossing. Area stabilized and controls in place. No observed impacts or sediment off ROW.

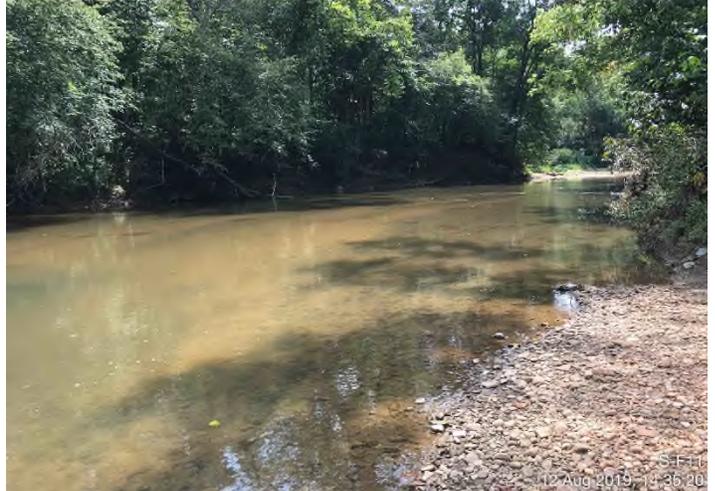
Fig. 6: **STA 14249+19** – Upstream view Blackwater River (S-F11) from MVP ROW.

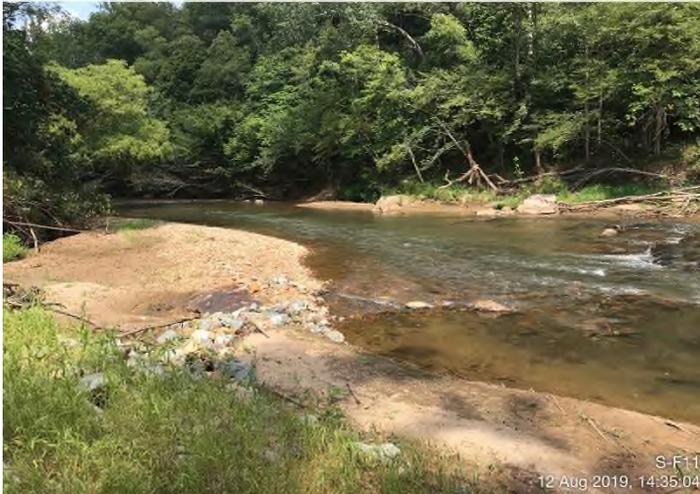
Fig. 7: **STA 14249+19** – Downstream view Blackwater River (S-F11) from MVP ROW.
