## FIELD INSPECTION REPORT

<b>Project Name:</b>	Mountain Valley Pipeline	<b>Inspector:</b>	Marshall Willis
<b>Inspection Date:</b>	Friday, August 14, 2020	<b>Project Contact:</b>	Brian Clauto, Cory Chalmers
<b>Spread I: Franklin County Pittsylvania County</b>	STA 14981+55 – 15063+85 MVP-FR-324 ATWS 380/1283/1284/486/487/382	<b>Weather:</b>	Wet

## FIELD INSPECTION PHOTO LOG

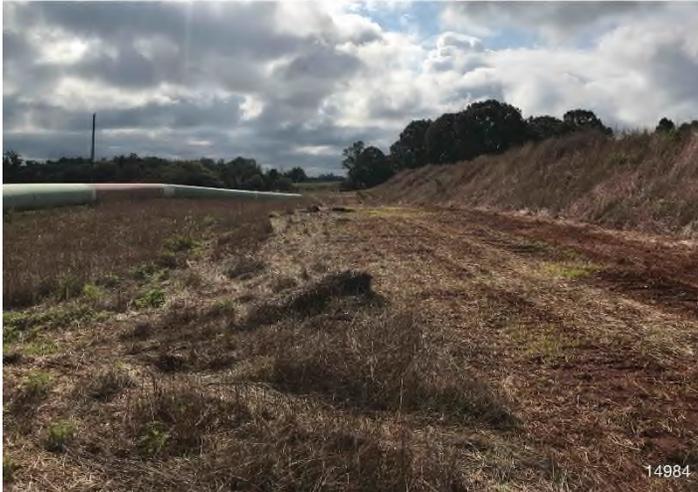
**Figure 1: STA 14984+00** – Controls in place and functioning properly.

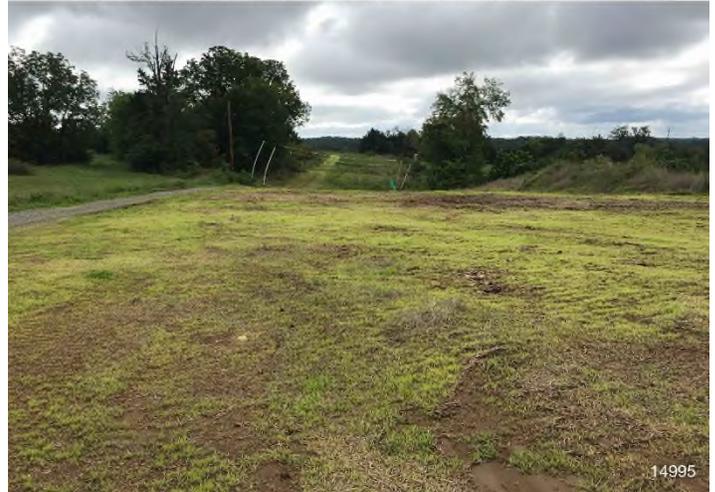
**Figure 2: STA 14995+00** – Controls in place and functioning properly.

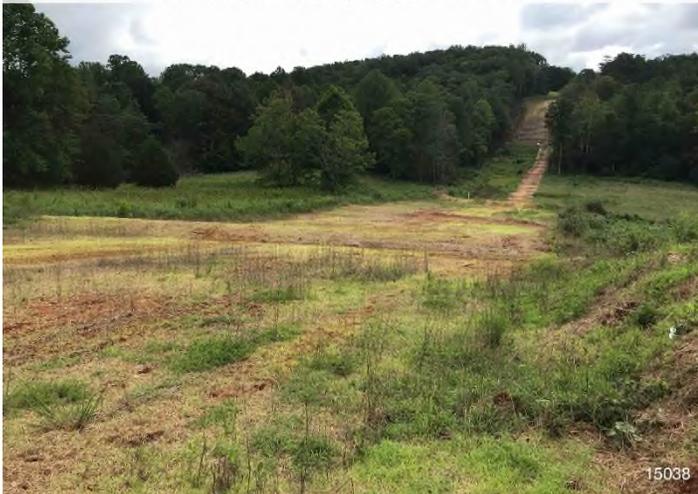
**Figure 3: STA 15038+00** – Controls in place and functioning properly.

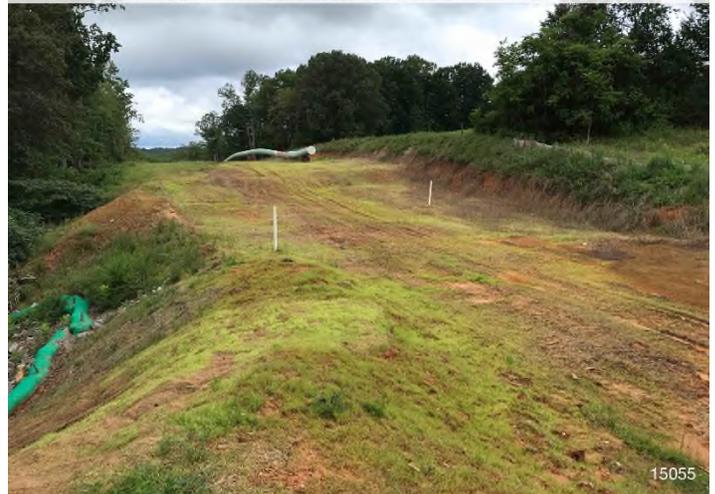
**Figure 4: STA 15055+00** – Controls in place and functioning properly.
