FIELD INSPECTION

Project Name:	Mountain Valley Pipeline	Inspector:	Matthew Grant
Inspection Date:	Thursday, August 16, 2018	Project Contact:	Brian Clauto
Spread: Locations inspect near: MP 263 ST#13888-13893 MP 254 ST#13421-13424, ST #13439	Spread I	Weather (Wet/Dry/Rain):	Dry

FIELD INSPECTION PHOTO LOG

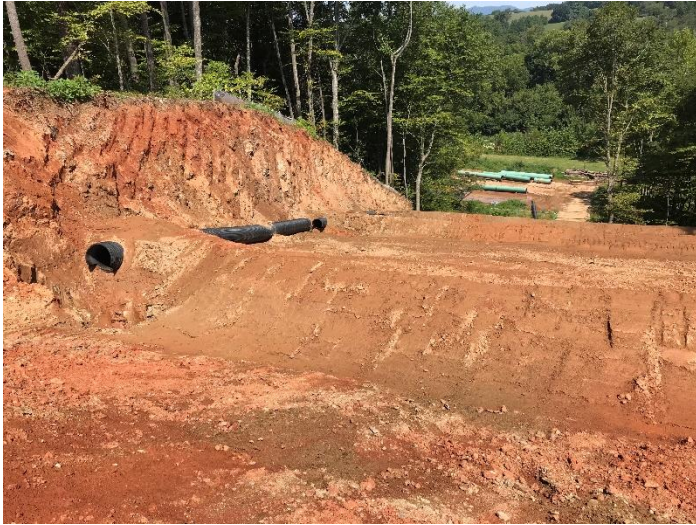
Comments:
 Area 1 - Spread I, near MP 263 ST#13888 slope drain system observed not built per DEQ site specific approval.
Recommended Corrective Action: Install slope drain per DEQ site-specific approval.

Fig. 1
Near station 13888+00 observed slope drain system not built per approval

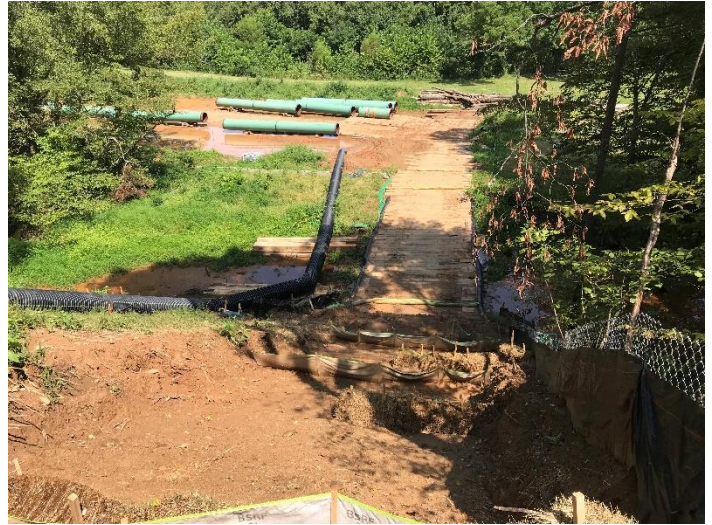
Fig. 2
Near station 13888+00 observed slope drain system not built per approval

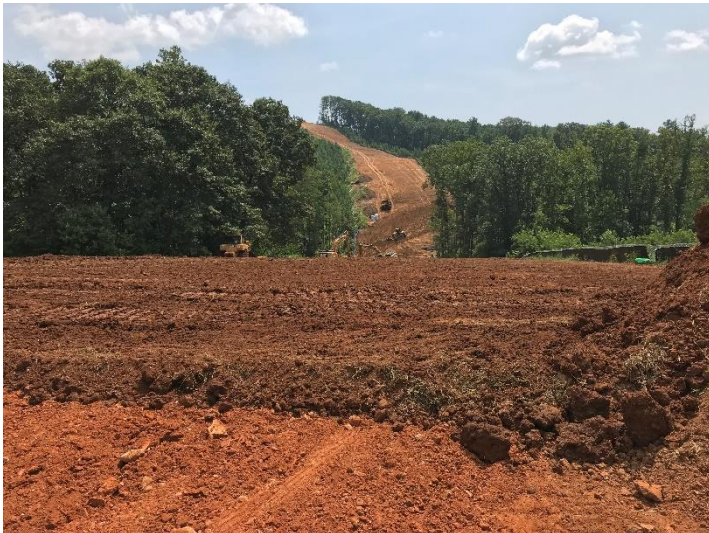
Fig. 3
Near station 13421+99, restoration in progress

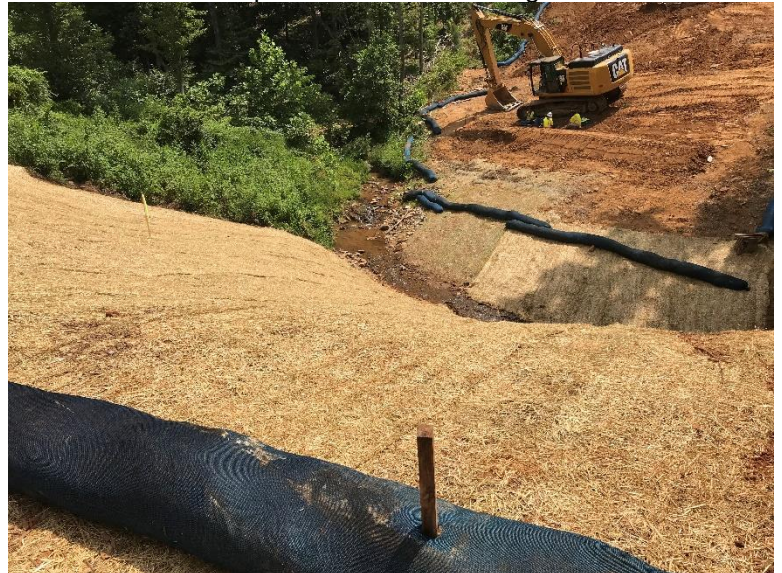
Fig. 4
Observed matted slope installed above designated stream S-IJ 4
