FIELD INSPECTION REPORT

Project Name:	Mountain Valley Pipeline	Inspector:	Marshall Willis
Inspection Date:	Monday, August 17, 2020	Project Contact:	Brian Clauto, Cory Chalmers
Spread I: Pittsylvania County	STA 15063+85 – 15142+66 ATWS 382/383/384	Weather:	Wet

FIELD INSPECTION PHOTO LOG

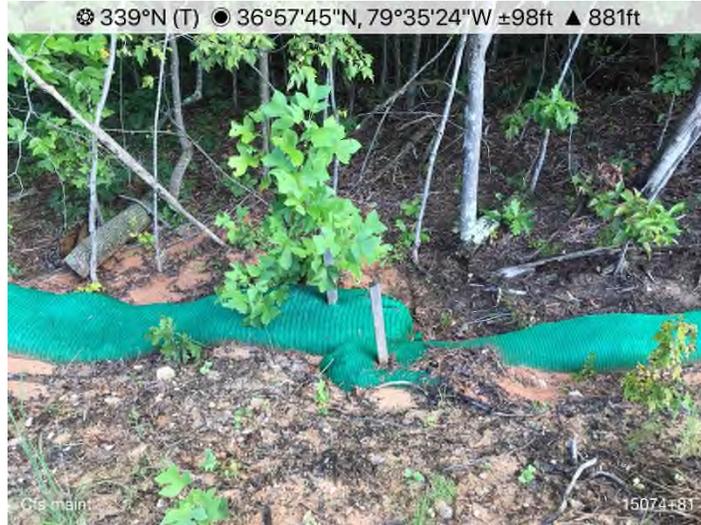
- STA 15074+81: CFS maintenance needed.
- STA 15074+81: Sediment off ROW.
- STA 15105+82: WB does not discharge off ROW.
- STA 15126+75: CFS maintenance needed.
- STA 15127+30: Repair and stabilize erosion.
- STA 15127+50: Waterbar maintenance needed. Discharge overtopping.
- STA 12128+00: Waterbar maintenance needed. Discharge overtopping.

Figure 1: STA 15074+81 – CFS maintenance needed.

Recommended Corrective Action: Maintain and install all controls per the approved PSS&S.

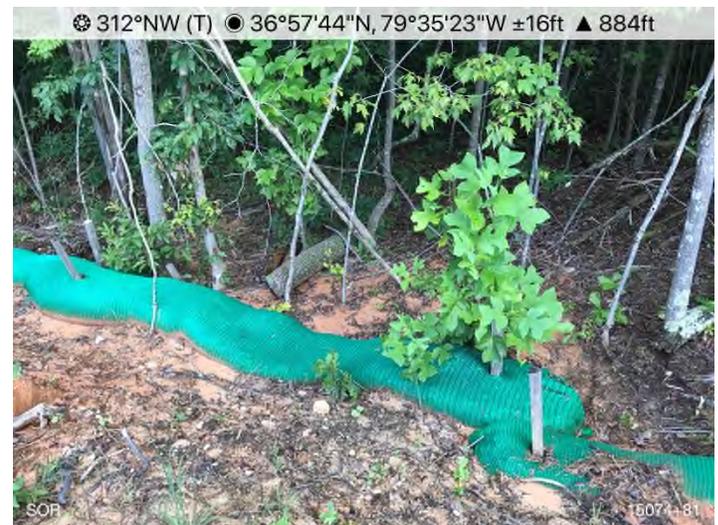
Figure 2: STA 15074+81 – Sediment off ROW.

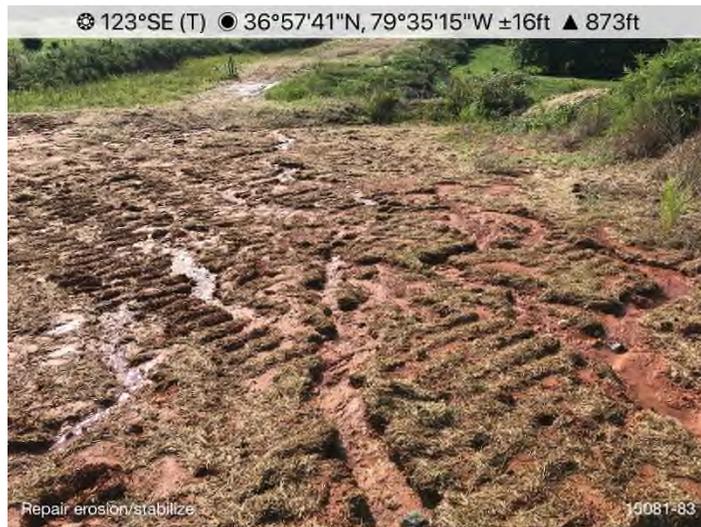
- STA 15081+00 to 15083+00: Repair and stabilize erosion.
- STA 15105+25 to 15105+50: Repair and stabilize erosion.
- STA 15109+00: Repair and stabilize erosion.

Figure 3: STA 15081+00 – Repair and stabilize erosion.

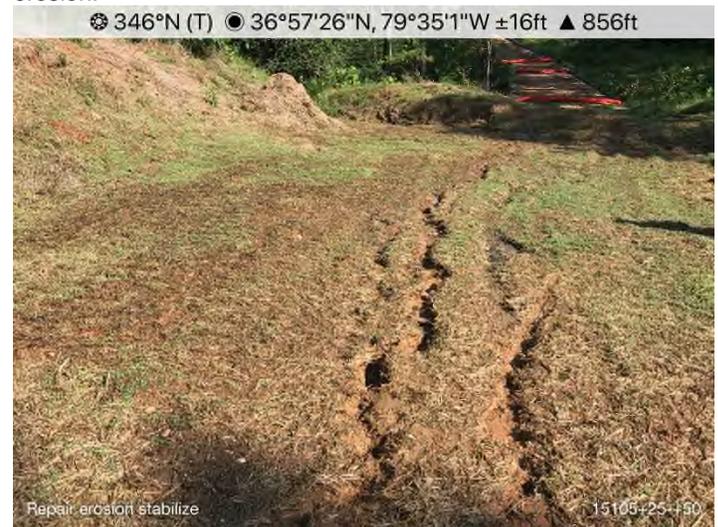
Figure 4: STA 15105+25 to 15105+50 – Repair and stabilize erosion.

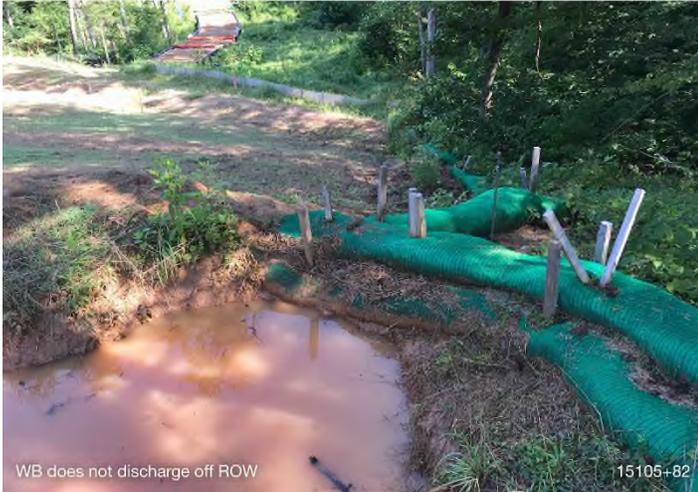
Figure 5: STA 15105+82 – Waterbar unable to discharge off ROW. Outlet higher than WB/CFS interface.

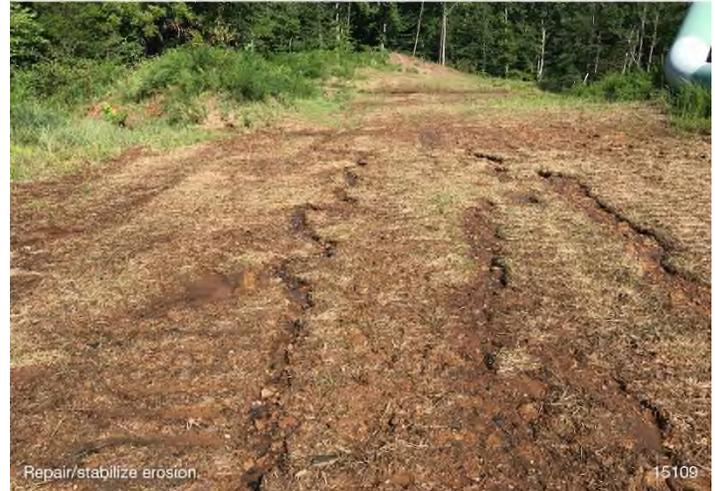
Figure 6: STA 15109+00 – Repair and stabilize erosion.

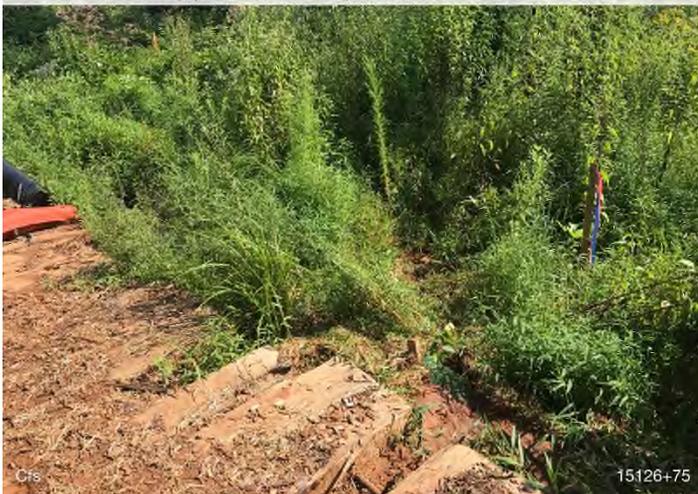
Figure 7: STA 15126+75 – CFS maintenance needed.

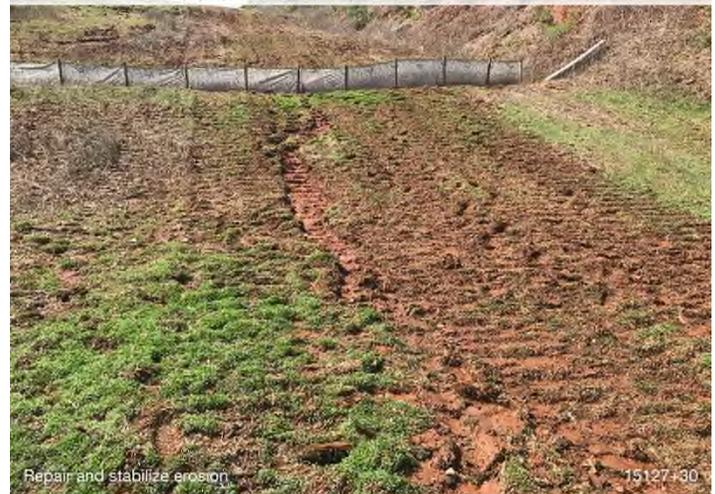
Figure 8: STA 15127+30 – Repair and stabilize erosion from overtopped waterbar.

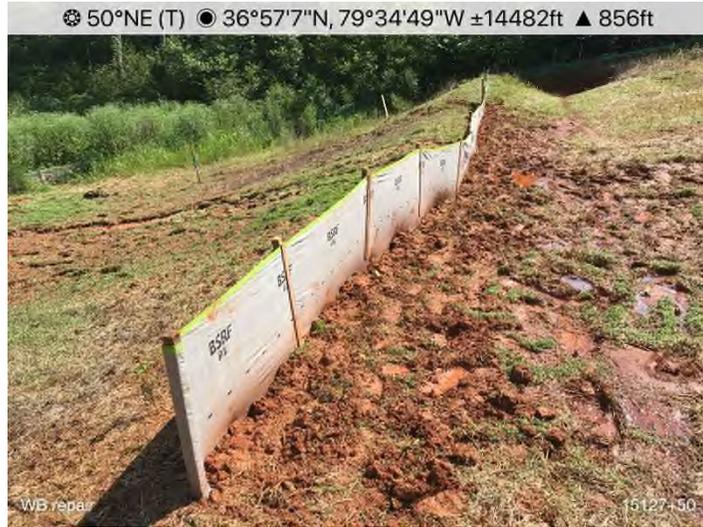
Figure 9: STA 15127+50 – Waterbar maintenance needed.
Sediment accumulation in throat.

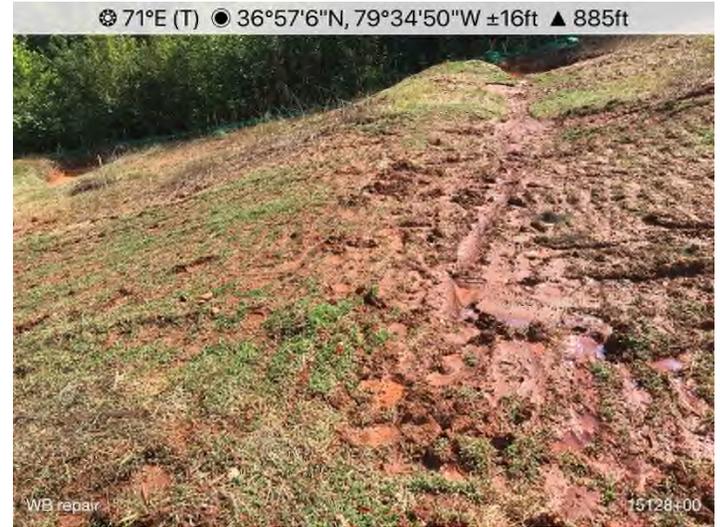
Figure 10: STA 15128+00 – Waterbar maintenance needed.
Sediment accumulation in throat.
