FIELD INSPECTION REPORT

Project Name:	Mountain Valley Pipeline	Inspector:	Marshall Willis
Inspection Date:	Thursday, August 20, 2020	Project Contact:	Brian Clauto, Cory Chalmers
Spread I: Pittsylvania County	STA 15496+70 – 15584+23 ATWS 819/820	Weather:	Dry

FIELD INSPECTION PHOTO LOG

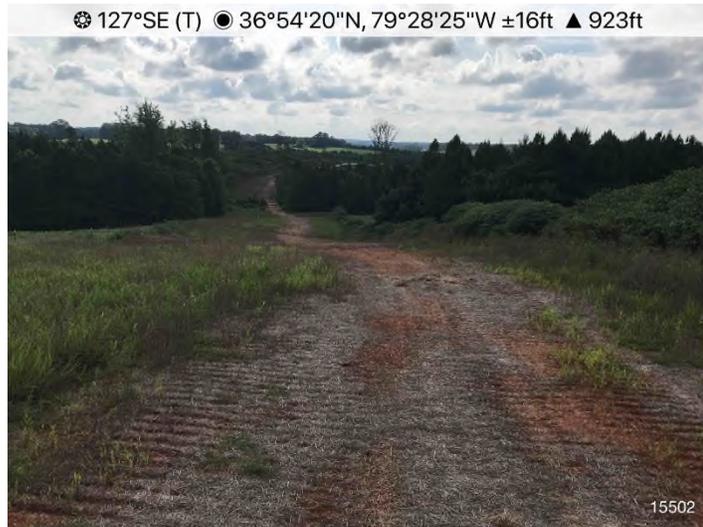
Figure 1: STA 15502+00 – Controls in place and functioning properly. Area stabilized with straw.

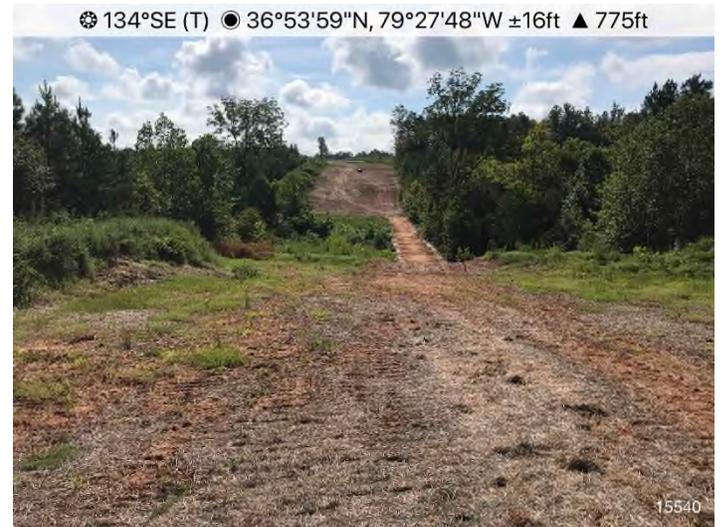
Figure 2: STA 15540+00 – Controls in place and functioning properly. Area stabilized with straw.

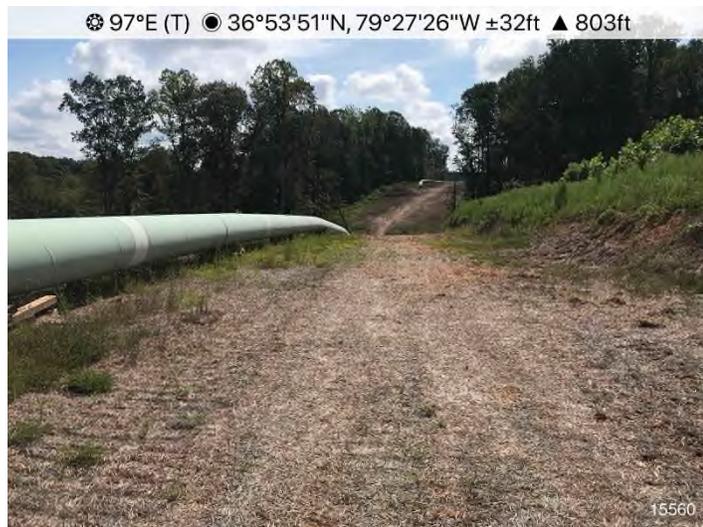
Figure 3: STA 15560+00 – Controls in place and functioning properly. Area stabilized with straw.

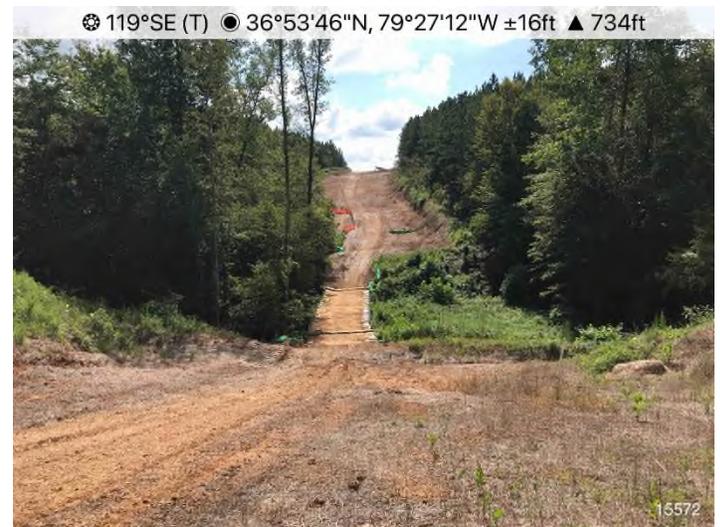
Figure 4: STA 15572+00 – Controls in place and functioning properly. Area stabilized with straw.
