## FIELD INSPECTION

<b>Project Name:</b>	Mountain Valley Pipeline	<b>Inspector:</b>	Marshall Willis
<b>Inspection Date:</b>	Thursday, August 22, 2019	<b>Project Contact:</b>	Brian Clauto, Cory Chalmers
<b>Spread I: Franklin County</b>	STA 14018+47 – 14042+25 MVP-MLV-31 STA 13996+56 – 14001+97	<b>Weather (Wet/Dry/Rain):</b>	Wet

# FIELD INSPECTION PHOTO LOG

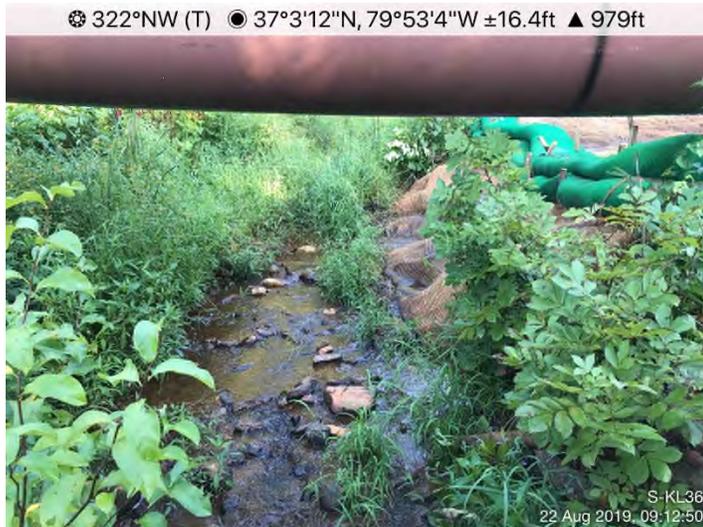
Fig. 1: **Stream S-KL36** – Controls in place and functioning.

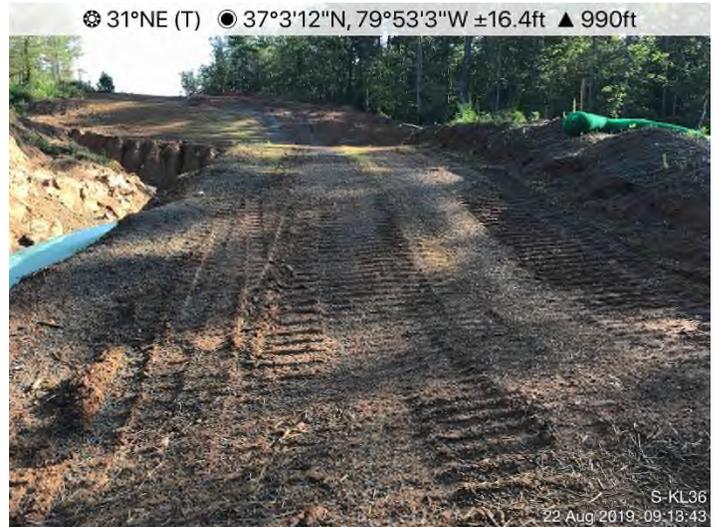
Fig. 2: **STA 13999+00** – Area stabilized with Earth-Guard and seed.

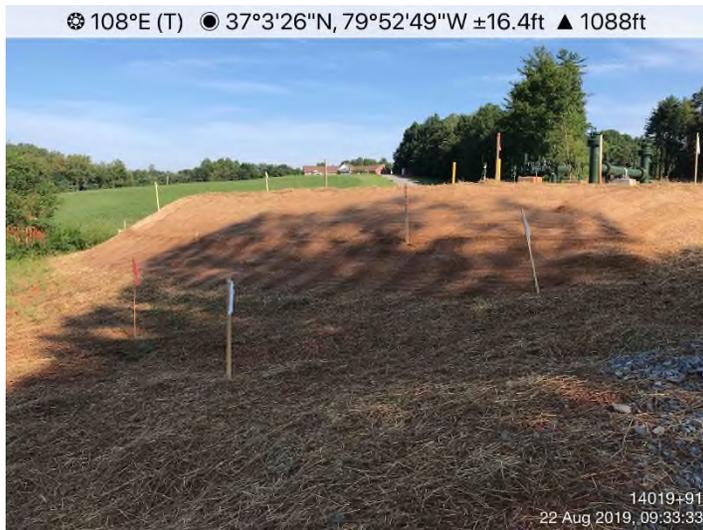
Fig. 3: **STA 14019+91** – Area stabilized with erosion fabric, seed and straw.

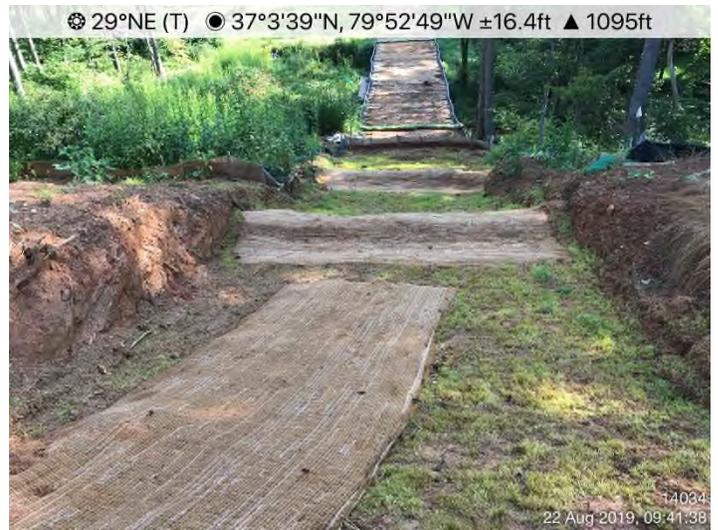
Fig. 4: **STA 14034+00** – Waterbars repaired and stabilized with erosion fabric and seed.
