FIELD INSPECTION REPORT

| Project Name: | Mountain Valley Pipeline | Inspector: | Marshall Willis |
| Inspection Date: | Tuesday, August 25, 2020 | Project Contact: | Brian Clauto, Cory Chalmers |
| Spread I: Franklin County | STA 13627+40 – 13644+82 STA 13763+00 – 13786+55 MVP-FR-300/302 | Weather: | Dry |

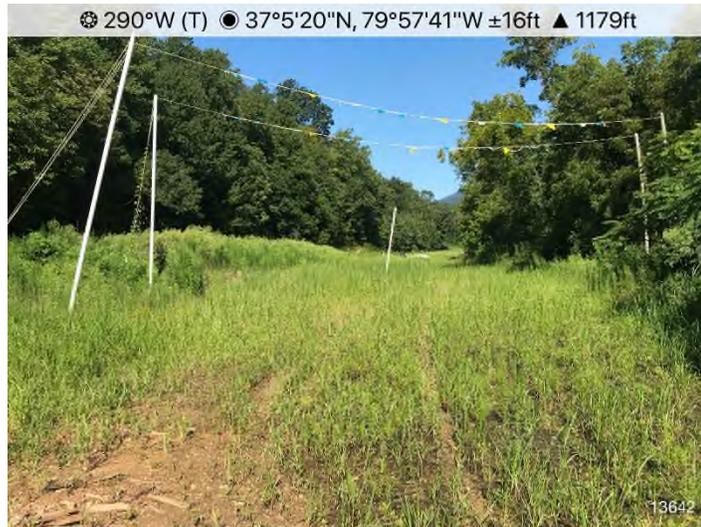
Figure 1: STA 13642+00 – Controls in place and functioning properly.

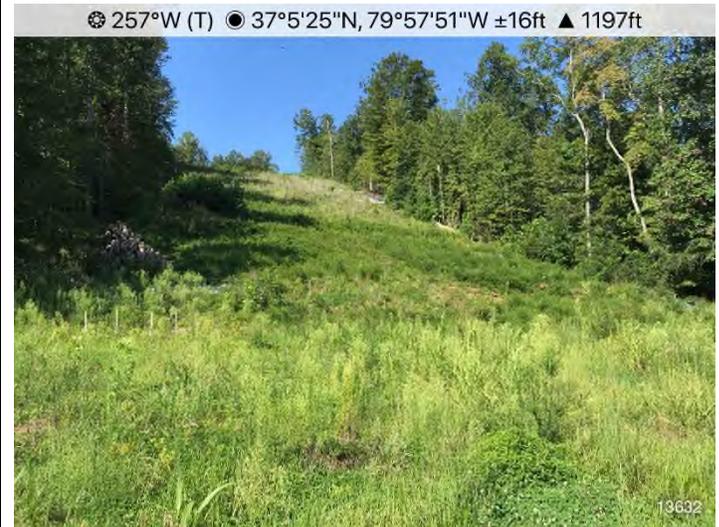
Figure 2: STA 13632+00 – Controls in place and functioning properly.

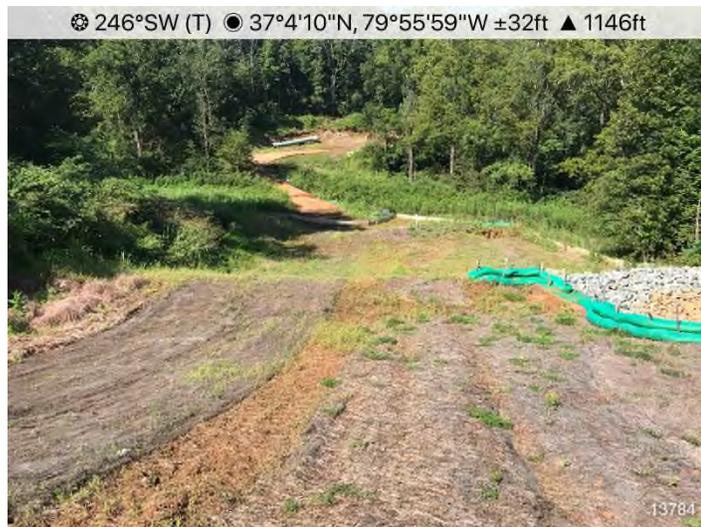
Figure 3: STA 13784+00 – Controls in place and functioning properly. Area stabilized with erosion matting and straw.

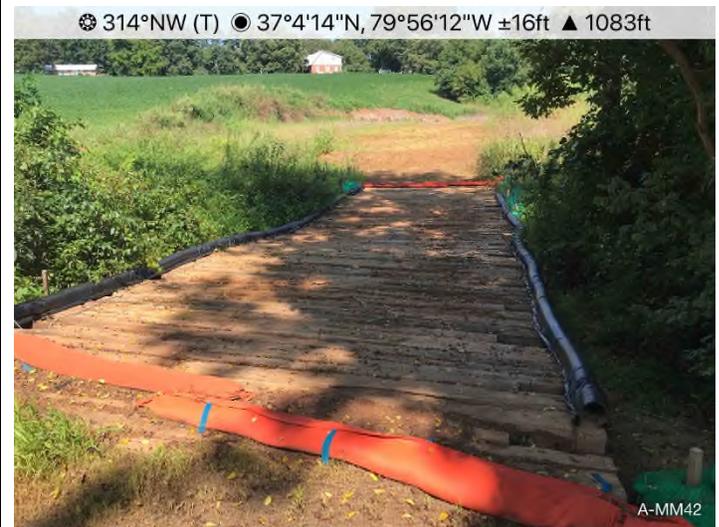
Figure 4: S-MM42 – Controls in place and functioning properly around S-MM42 crossing.
