FIELD INSPECTION REPORT

Project Name:	Mountain Valley Pipeline	Inspector:	Marshall Willis
Inspection Date:	Monday, August 31, 2020	Project Contact:	Brian Clauto, Cory Chalmers
Spread I: Franklin County	STA 13846+78 – 13862+60 STA 13949+24 – 13970+00 STA 13995+00 – 14000+00 MVP-FR-303.01/306.02	Weather:	Rainy

FIELD INSPECTION PHOTO LOG

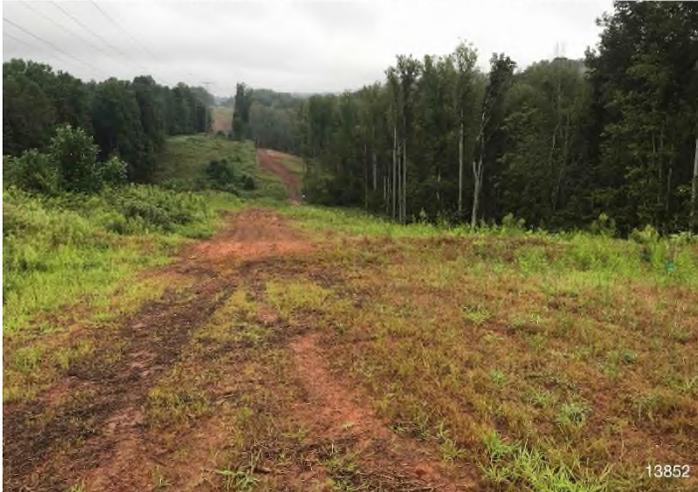
Figure 1: STA 13852+00 – Controls in place and functioning properly.

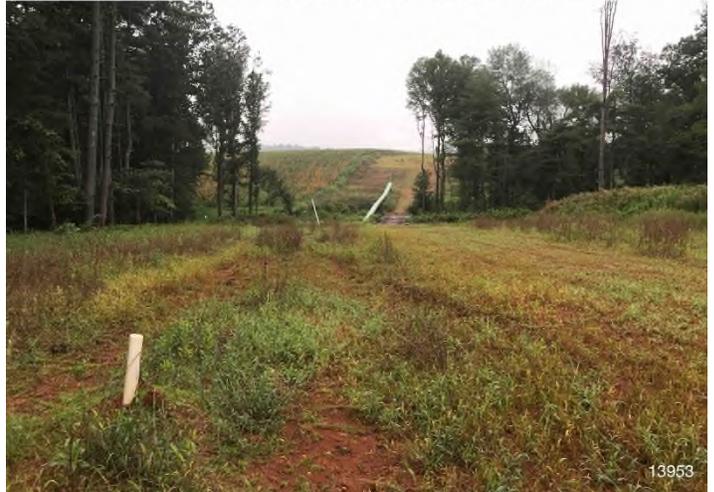
Figure 2: STA 13953+00 – Controls in place and functioning properly.

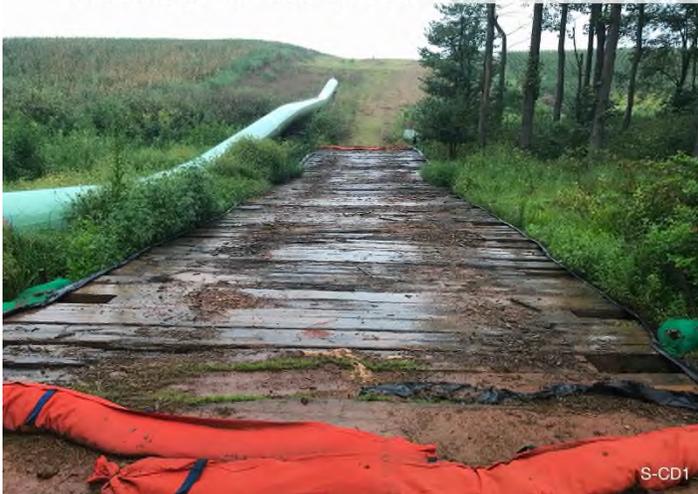
Figure 3: Stream S-CD1 – Controls in place and functioning properly around S-CD1 crossing.

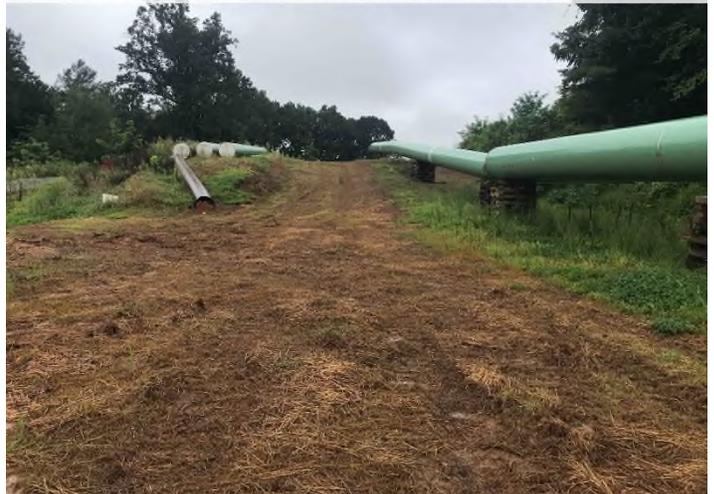
Figure 4: STA 13996+00 – Controls in place and functioning properly. Area stabilized with straw.
