FIELD INSPECTION REPORT

Project Name:	Mountain Valley Pipeline	Inspector:	Matthew Grant
Inspection Date:	Wednesday, August 5, 2020	Project Contact:	Brian Clauto
Spread I: Franklin	MP271.9-273.6 AR-FR314, 315, 622 623 ATWS1272, 526, 526b, 526a, 356, 356a, 358, 358a	Weather:	Dry

FIELD INSPECTION PHOTO LOG

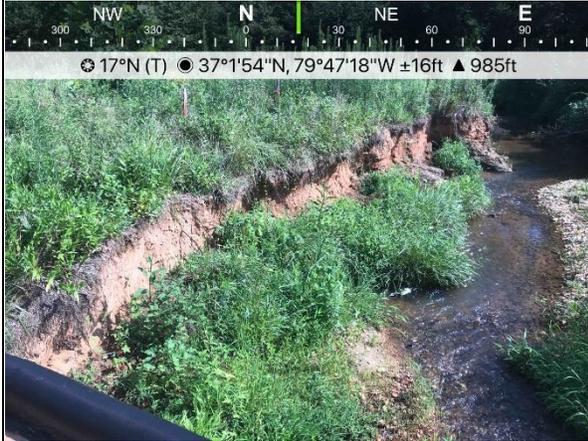
Figure 1: Designated stream S-A41 noted for repair on 5/4/2020.

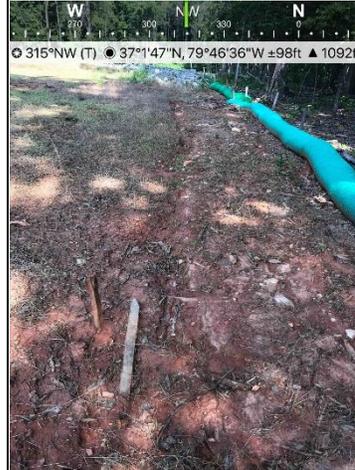
- St14414+00 rill erosion requires repair and stabilization

Figure 2: Near St14414+00 rill erosion requires repair and stabilization.

Recommended Corrective Action: Maintain and install all controls per the approved PSS&S.

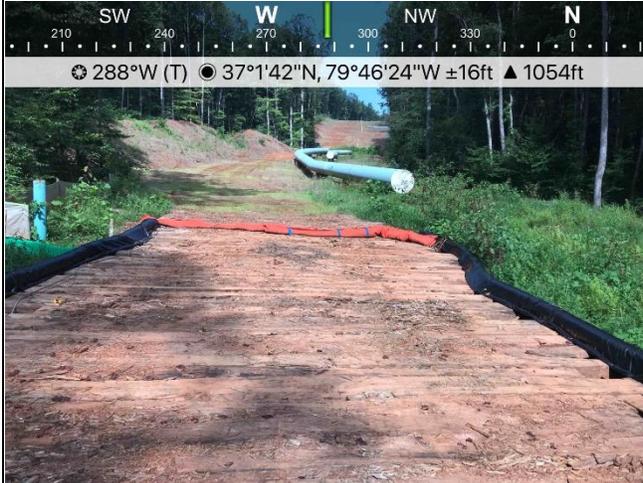
- Comments: Inspected the following resources: W-DD1, S-A41, S-GH36, S-KL17, S-GH37, S-GH38, S-GH39, S-GH40, W-GH16, S-GH44, S-IJ46.
- ECD's were in place and functioning at crossing.

Figure 3: ECD's are in place at designated crossing S-IJ46.

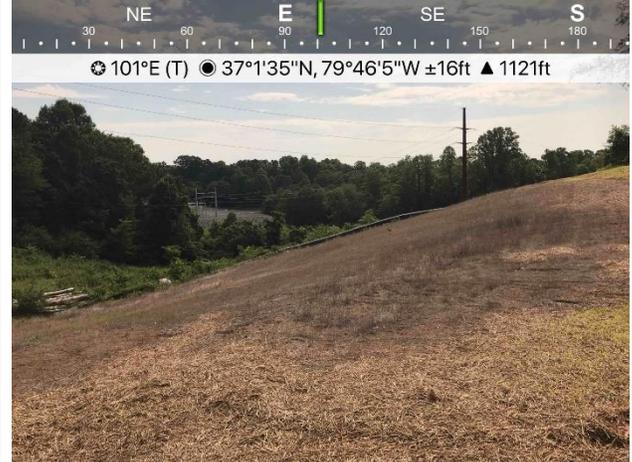
Figure 4: Slope drain installed and functioning near MP 273.6
