FIELD INSPECTION REPORT

Project Name:	Mountain Valley Pipeline	Inspector:	Marshall Willis
Inspection Date:	Thursday, August 6, 2020	Project Contact:	Brian Clauto, Cory Chalmers
Spread I: Franklin County	STA 14272+62 – 14411+00 MVP-FR-313/315 ATWS 525/352/353/354/526/622	Weather:	Dry

FIELD INSPECTION PHOTO LOG

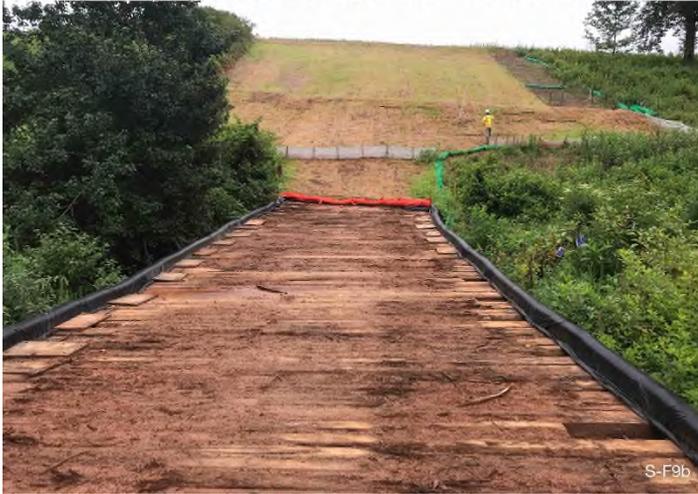
Figure 1: Stream S-F9b – Controls in place and functioning properly. Banks stabilized with erosion matting and straw.

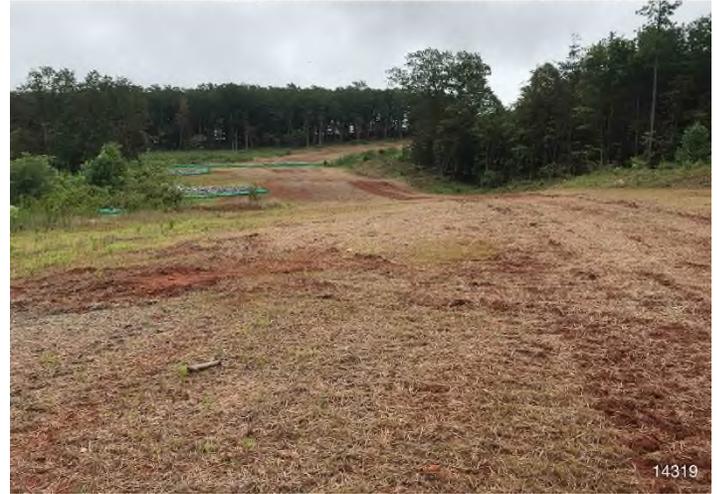
14319

Figure 2: STA 14319+00 – Controls in place and functioning properly. Area stabilized with straw.

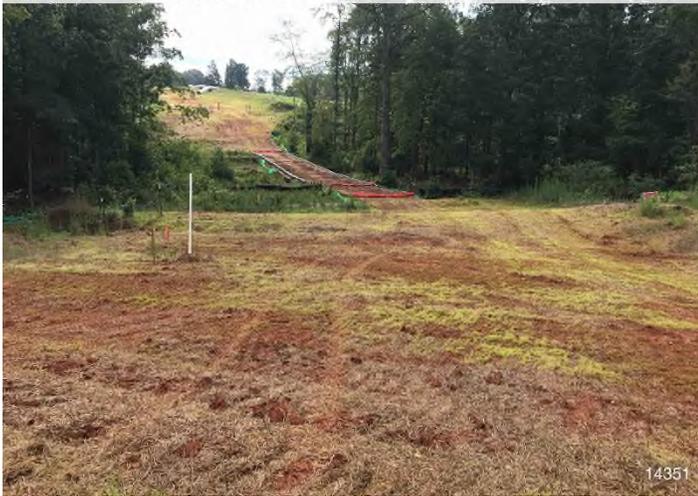
14351

Figure 3: STA 14351+00 – Controls in place and functioning properly. Area stabilized with straw.

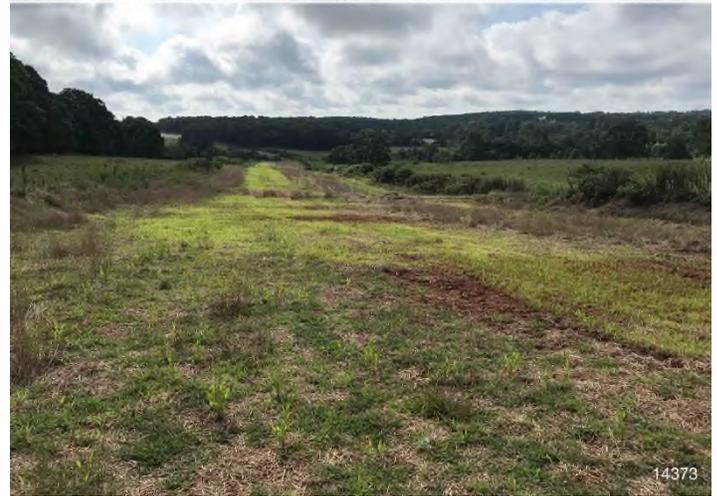
14373

Figure 4: STA 14373+00 – Controls in place and functioning properly. Area stabilized.
