FIELD INSPECTION

Project Name:	Mountain Valley Pipeline	Inspector:	Marshall Willis
Inspection Date:	Thursday, August 8, 2019	Project Contact:	Brian Clauto, Cory Chalmers
Spread I: Franklin County	STA 13958+31 – 14009+85 STA 14694+77 – 14802+19	Weather (Wet/Dry/Rain):	Dry

FIELD INSPECTION PHOTO LOG

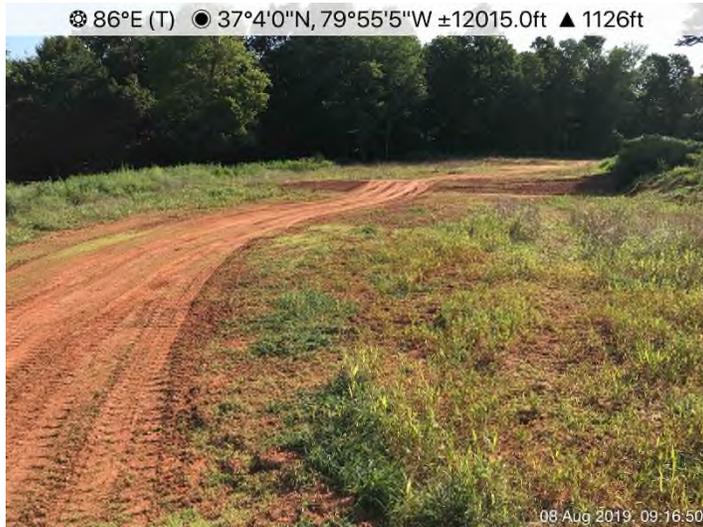
Fig. 1: **STA 13978+00** – Controls in place. Area stabilized with Earth-Guard and millet.

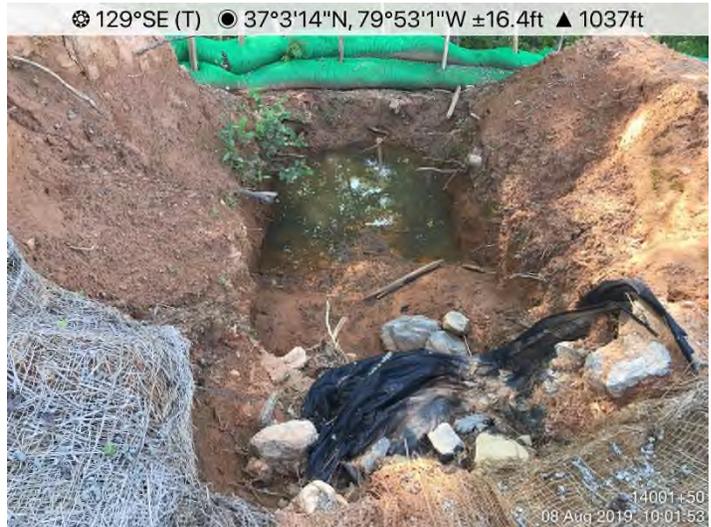
STA 14001+50: Sump maintenance needed.

Fig. 2: **STA 14001+50** – Sump maintenance needed.

Recommended Corrective Action: Maintain and install all controls per the approved plans and PSS&S.

Deadline: Within 24-hr notification

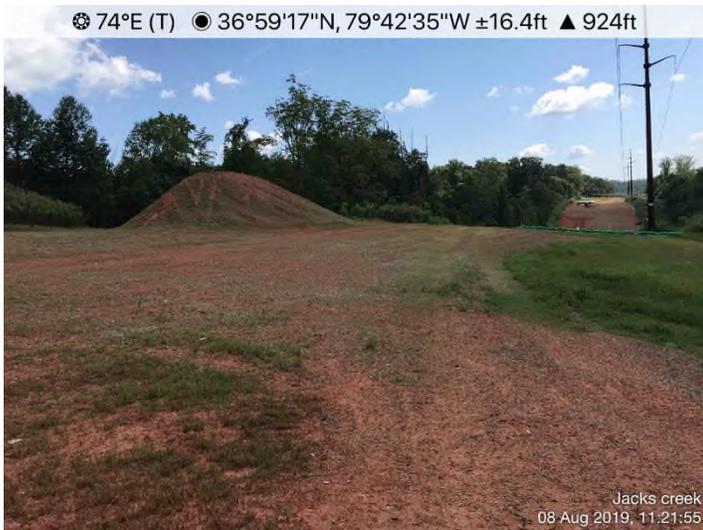
Fig. 3: **STA 14695+00** – Controls in place. Area stabilized with Earth-Guard and millet.

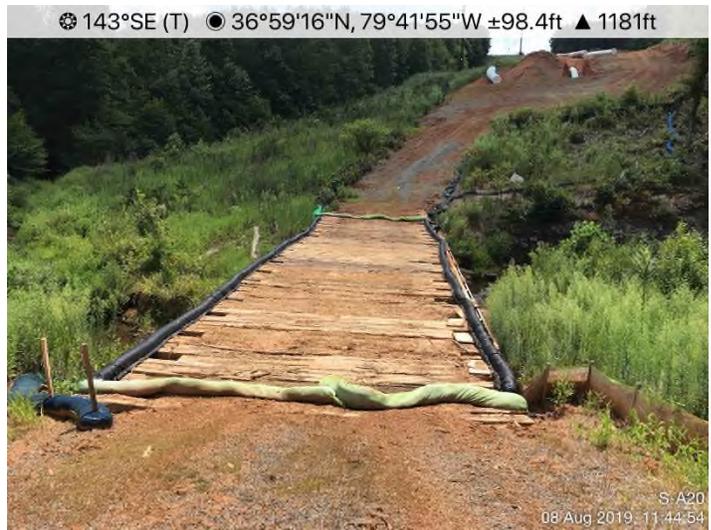
Fig. 4: **Stream S-A20** – Controls in place. Sideboards and perimeter controls appear to be functioning. Area stabilized with Earth-Guard and millet.
