## FIELD INSPECTION

Project Name:	Mountain Valley Pipeline	Inspector:	Matthew Grant
Inspection Date:	Wednesday, September 12, 2018	Project Contact:	Brian Clauto
Spread: Franklin County	Spread I	Weather (Wet/Dry/Rain):	Wet

## FIELD INSPECTION PHOTO LOG

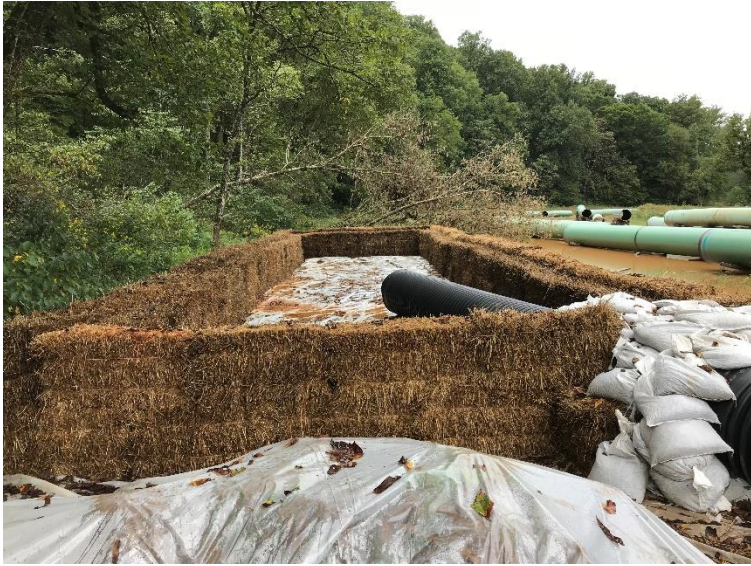
- **Area 1** – MP 263 slope drain dewatering sump installed at St# 13887+00
- **Area 2** - MP 261 St# 13816+00 sump is full. **Recommended Corrective Action** clean out sump, install adequate sump for drainage area ASAP per site conditions. Sediment below this area has been previously identified.
- **Area 3** - MP 255.40 Cahas Mtn Rd, additional controls have been installed at CE.

Fig. 1  
MP 263 slope drain dewatering sump installed at St#  
13887+00

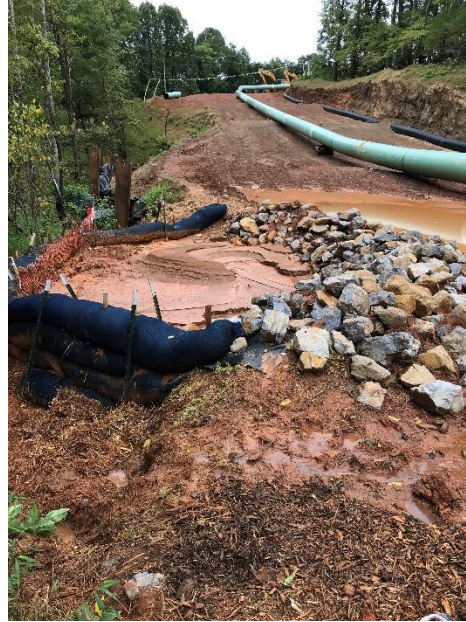
Fig. 2  
MP 261 St# 13816+00 sump is full

**Deadline:** Within 24hr notification

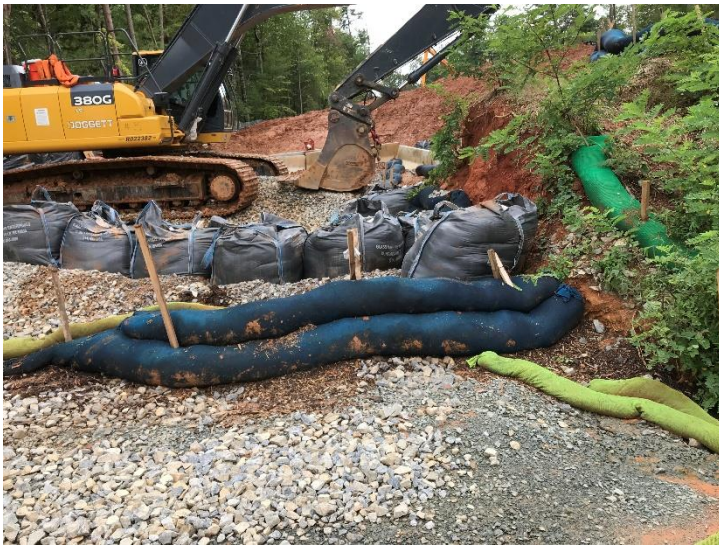
Fig. 3  
MP255.40 Cahas Mtn Rd, additional controls have been  
installed at CE.
