FIELD INSPECTION

Project Name:	Mountain Valley Pipeline	Inspector:	Matthew Grant
Inspection Date:	Thursday, September 19, 2019	Project Contact:	Brian Clauto
Spread: Franklin Co. MP267.9-265.9	Spread I	Weather (Wet/Dry/Rain):	Dry

FIELD INSPECTION PHOTO LOG

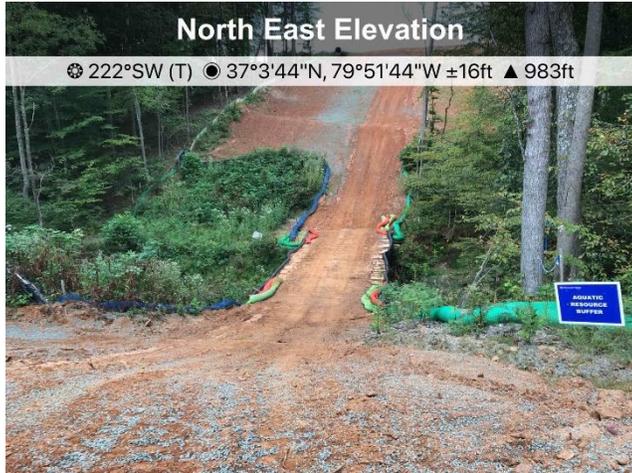
- Fig. 1 At designated stream S-KL48, contractors were in the area working on stabilization,

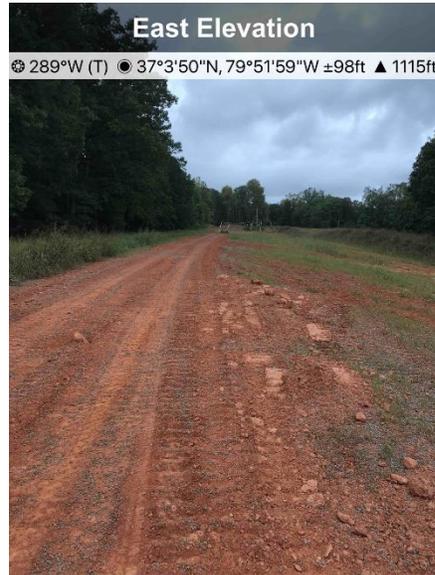
- Fig. 2 Near St14091+00 area has been stabilized with earthguard.

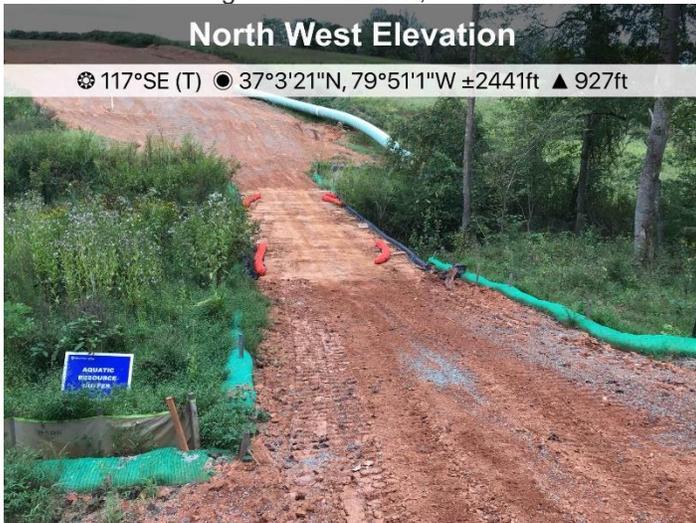
- Fig. 3 At designated stream S-KL51 contractors were in the area working on stabilization,

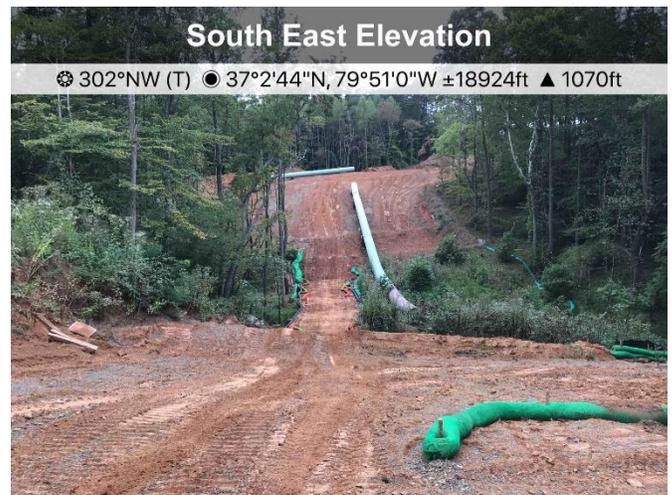
- Fig. 4 At designated stream S-C8 contractors were in the area working on stabilization,
