## FIELD INSPECTION

<b>Project Name:</b>	Mountain Valley Pipeline	<b>Inspector:</b>	Marshall Willis
<b>Inspection Date:</b>	Thursday, September 19, 2019	<b>Project Contact:</b>	Brian Clauto, Cory Chalmers
<b>Spread I: Franklin County</b>	STA 14062+17 – 14171+36 STA 13575+00 – 13562+63	<b>Weather (Wet/Dry/Rain):</b>	Dry

# FIELD INSPECTION PHOTO LOG

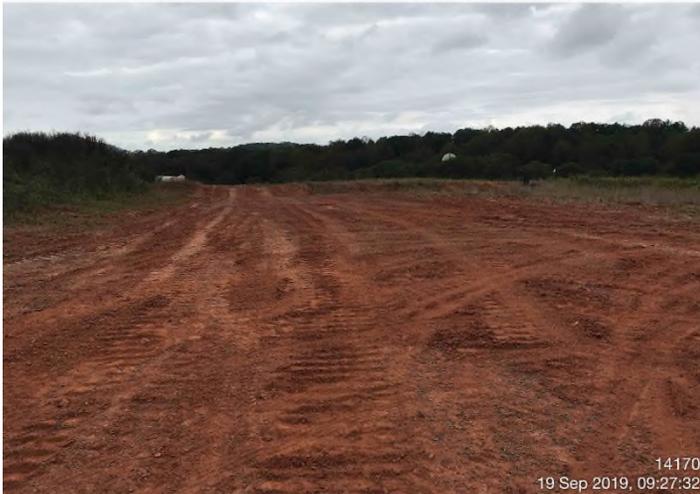
Fig. 1: **STA 14170+00** – Controls in place. Area stabilized with seed and Earth Guard Edge.

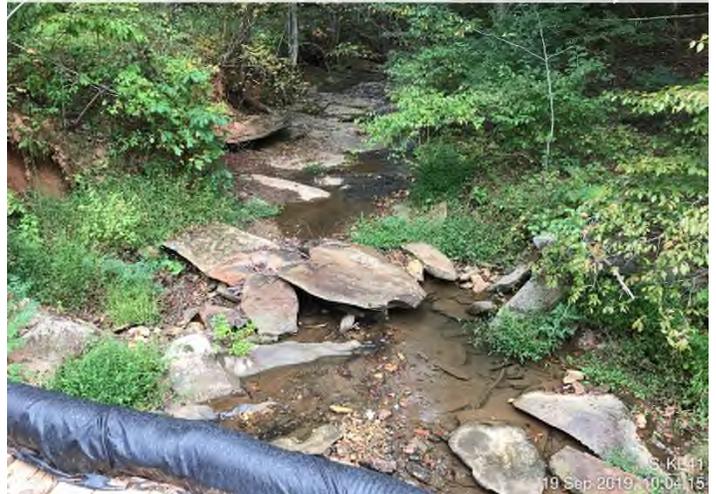
Fig. 2: **Stream S-KL41** – Controls in place.

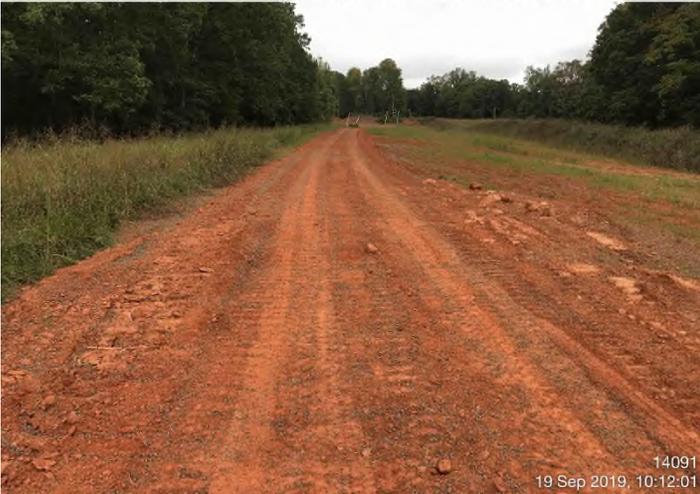
Fig. 3: **STA 14091+00** – Controls in place. Area stabilized with seed and Earth Guard Edge.

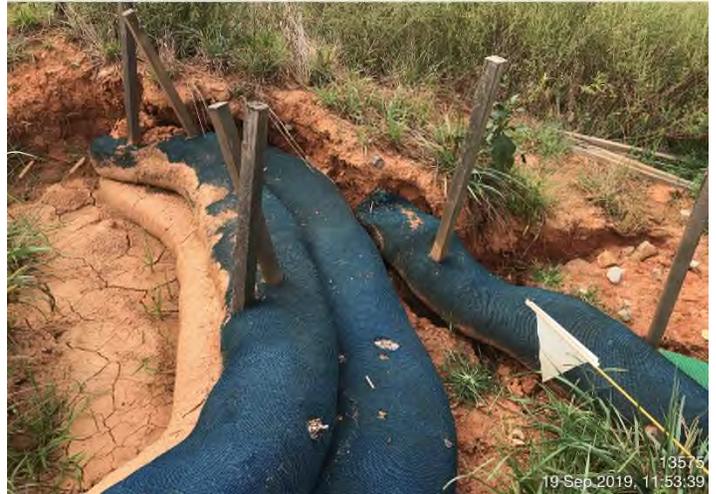
STA 13575+00: Maintain CFS.

Fig. 4: **STA 13575+00** – CFS undermined.

**Recommended Corrective Action:** Install and maintain all controls per the approved plans and PSS&S.
