FIELD INSPECTION REPORT

Project Name:	Mountain Valley Pipeline	Inspector:	Marshall Willis
Inspection Date:	Wednesday, September 2, 2020	Project Contact:	Brian Clauto, Cory Chalmers
Spread I: Franklin County	STA 14050+00 – 14064+71 STA 14157+55 – 14175+00 STA 14233+12 – 14249+19 MVP-MLV-AR-32	Weather:	Wet

FIELD INSPECTION PHOTO LOG

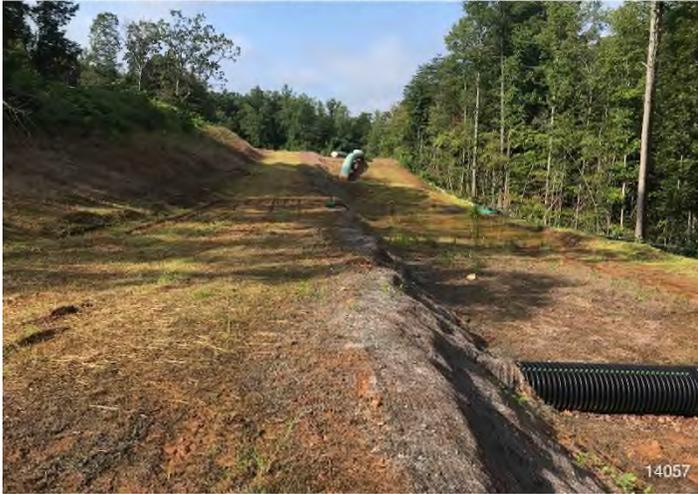
14057

Figure 1: STA 14057+00 – Controls in place and functioning properly. Area stabilized with straw and erosion matting.

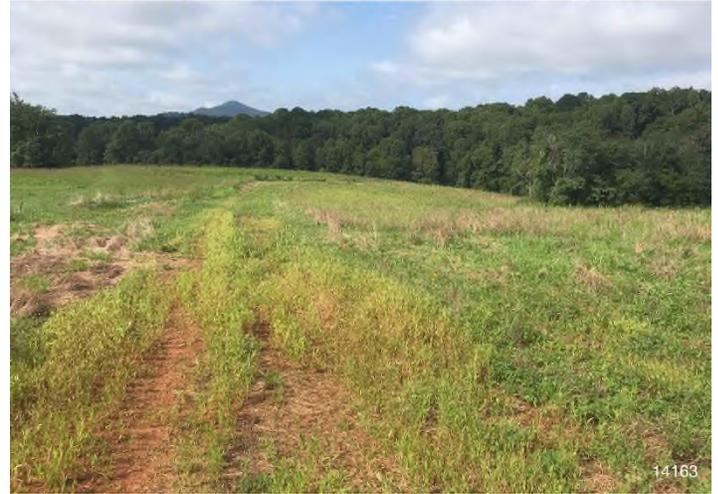
14163

Figure 2: STA 14163+00 – Controls in place and functioning properly.

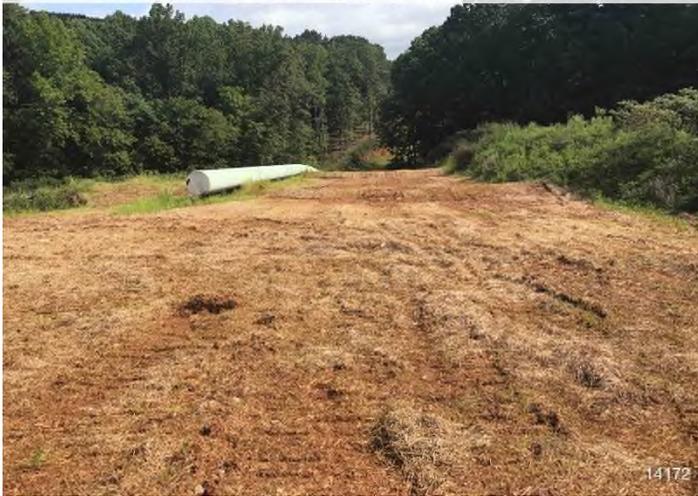
14172

Figure 3: STA 14172+00 – Controls in place and functioning properly. Area stabilized with straw.

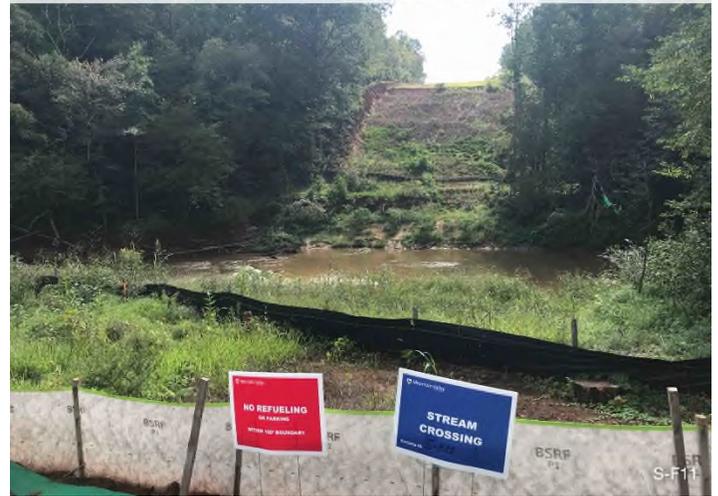
Figure 4: Stream S-F11 – Controls in place and functioning properly around S-F11 crossing.
