FIELD INSPECTION

Project Name:	Mountain Valley Pipeline	Inspector:	Marshall Willis
Inspection Date:	Tuesday, September 24, 2019	Project Contact:	Brian Clauto, Cory Chalmers
Spread I: Franklin County	STA 13892+55 – 13940+00 MVP-FR-305	Weather (Wet/Dry/Rain):	Dry

FIELD INSPECTION PHOTO LOG

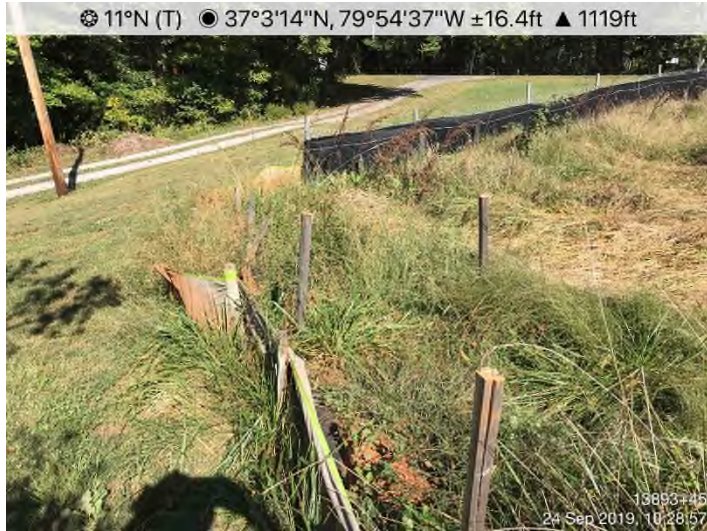
1. At the time of inspection, ECDs within the MVP LOD were installed per the approved plans and appeared to be functioning as designed.
2. Perimeter controls at STA 13894+12 were upgraded from 12" CFS (ESCP Sheet 14.55) to include an additional row of P1 after the CFS (Figure 1).

Fig. 1: **STA 13894+12** – Controls in place. Controls have been upgraded to include row of P1 after 12" CFS.

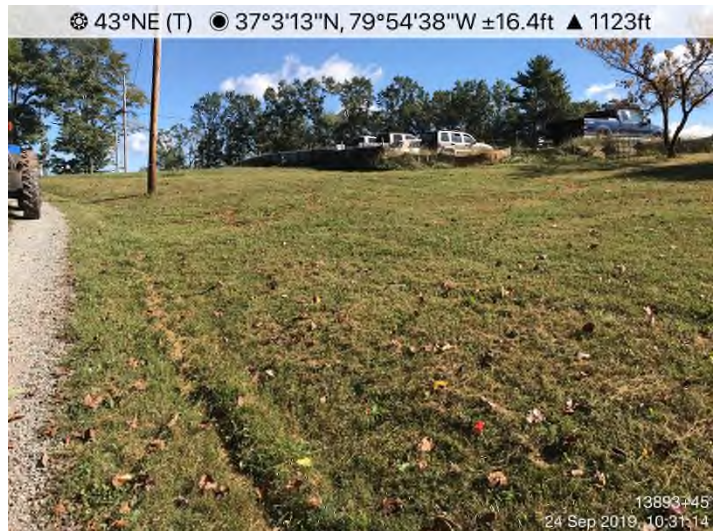
1. Stormwater discharge from MVP controls along ROW causing driveway erosion at approx. STA 13894+12 (Figures 1, 2 and 3).
2. Stormwater discharge from MVP controls may have caused a "sinkhole" depression off ROW adjacent to the Blackwater River (Figure 4)

Fig. 2: **OFF ROW** – Angle driveway looking NE towards discharge point at STA 13894+12.

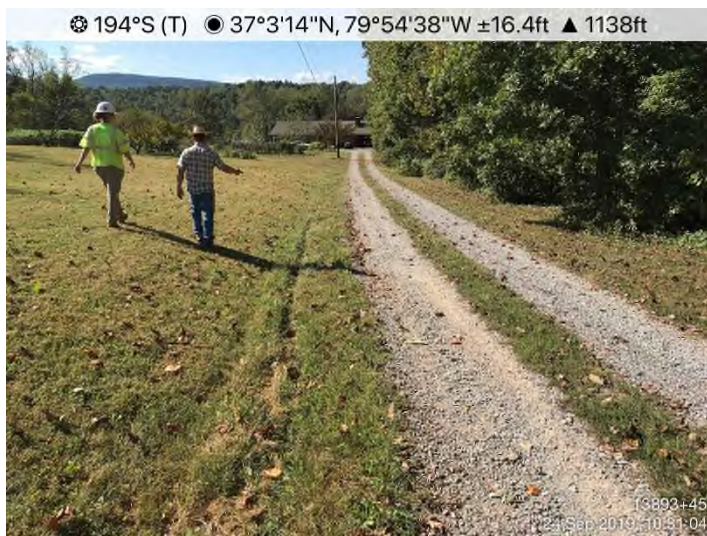
Fig. 3: **OFF ROW** – Angle driveway down gradient from stormwater discharge at STA 13894+12.

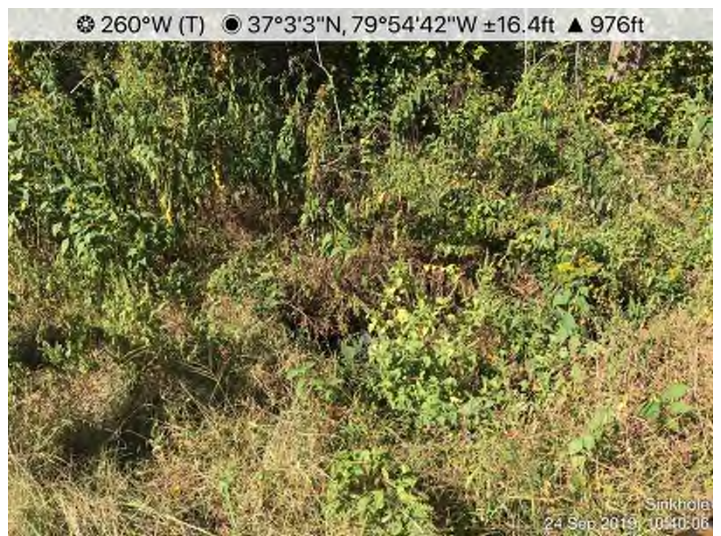
- STA 13904+50 to 13905+00: SSF maintenance needed.
 - STA 13906+55: SSF maintenance needed.
6. Causation of the "sinkhole" off ROW adjacent to the Blackwater River (Figure 4) was unable to be determined during the investigation. There was no evidence of sedimentation or scour in this area.

Fig. 4: **OFF ROW** – “Sinkhole” depression adjacent to Blackwater River off MVP ROW.

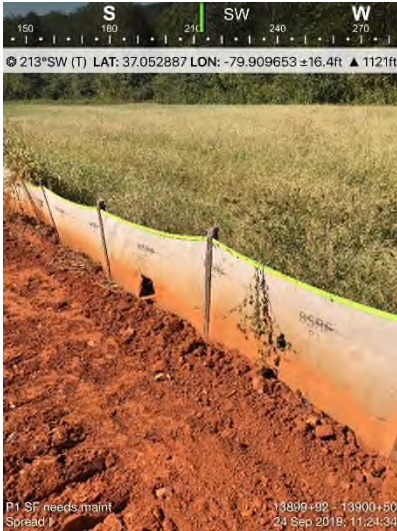
5. Following meeting with Angle, three routine maintenance items were noted during the inspection for repair (Figures 5, 6 and 7):
 - STA 13899+92 to 13890+50: P1 maintenance needed.

Fig. 5: **STA 13899+92 to 13890+50** – P1 maintenance needed.

Recommended Corrective Action: Install and maintain all controls per the approved plans and PSS&S.

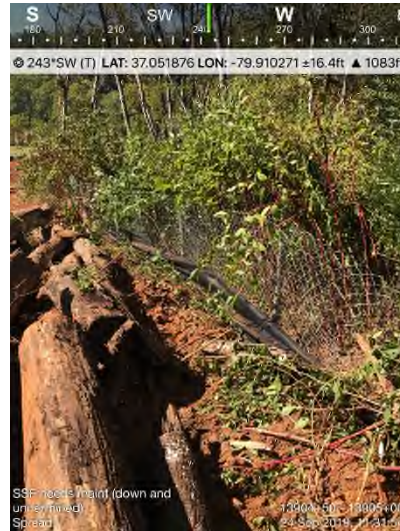
Fig. 6: **STA 13904+50 to 13905+00** – SSF maintenance needed.

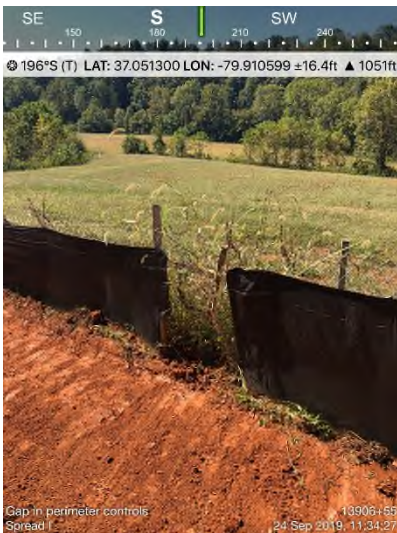
Fig. 7: **STA 13906+55** – SSF maintenance need.

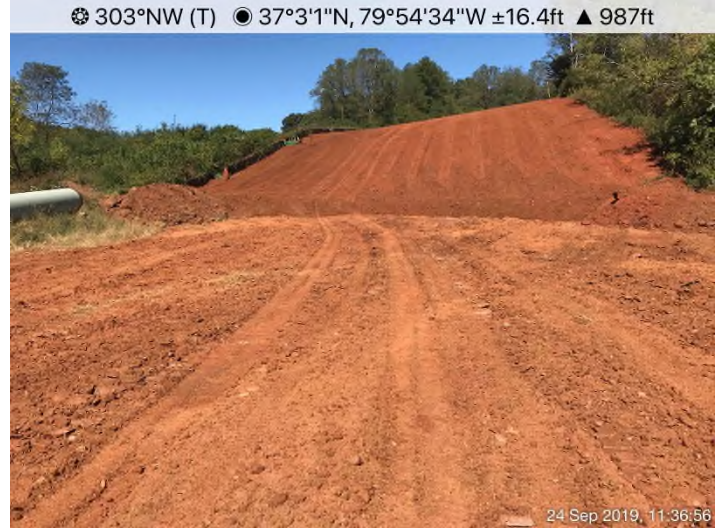
Fig. 8: **STA 13908+00** – Final grading in progress. Spreading topsoil and re-establishing grade to existing contours.
