## FIELD INSPECTION

<b>Project Name:</b>	Mountain Valley Pipeline	<b>Inspector:</b>	Matthew Stafford
<b>Inspection Date:</b>	Tuesday, July 3, 2018	<b>Project Contact:</b>	Brian Clauto
<b>Spread:</b>	Spread G	<b>Weather (Wet/Dry/Rain):</b>	Dry

# FIELD INSPECTION PHOTO LOG

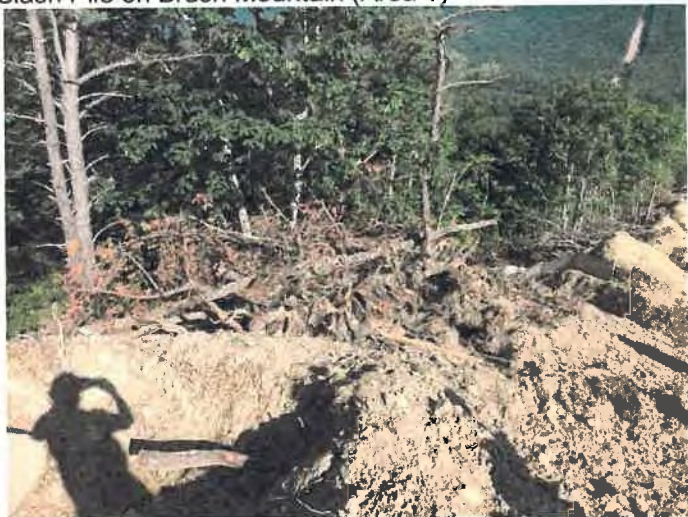
Area 1 - Jefferson National Forest station 11621+50 to 11661+25. (Approximate Mile Post (MP) 219.9 to 220.6) Work authorized in this area is limited to recovering woody debris (slash) placed outside the LOD and reestablishment of ESC measures. Re-inspection of established ESC measures is required prior to resumption of land disturbing activity. Contact DEQ for re-inspection.

Fig. 1  
Slash Pile on Brush Mountain (Area 1)

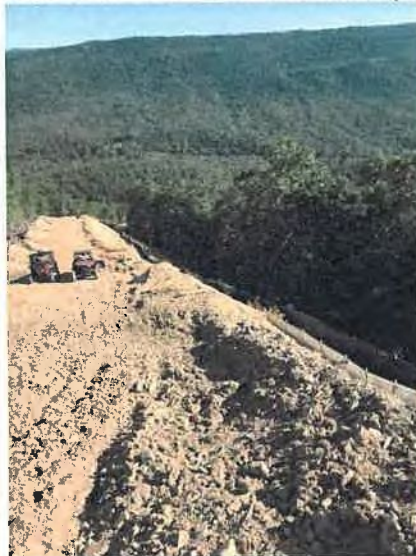
Fig. 2  
Area of work on Brush Mountain (Area 1)

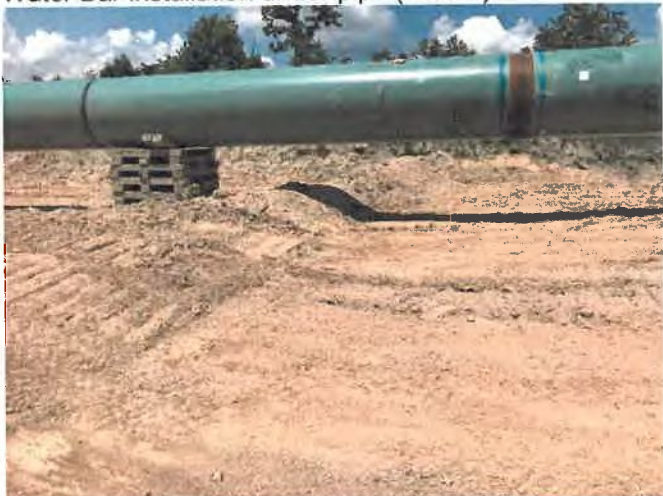
Area 2 - Mt. Tabor Rd to Catawba Rd station 11789+02 To 12005+00 (Approximate MP 223.12 to 227.15) The ROW and two access roads (266.03 and 266) were inspected for compliance with required ESC measures and no deficiencies were observed.

Fig. 3  
Water Bar installation under pipe (Area 2)

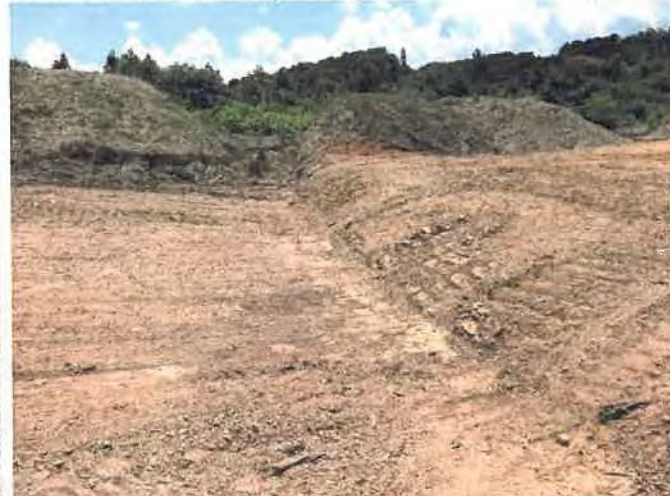
Fig. 4  
Water Bar installation (Area 2)

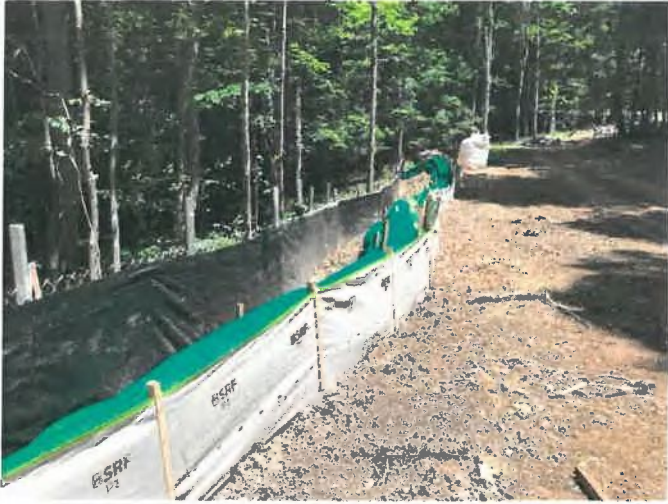
Fig. 5  
Additional Karst Measures (Area 2)
