FIELD INSPECTION

Project Name:	Mountain Valley Pipeline	Inspector:	Matthew Stafford
Inspection Date:	Tuesday, July 10, 2018	Project Contact:	Brian Clauto
Spread:	Spread I	Weather (Wet/Dry/Rain):	Dry

FIELD INSPECTION PHOTO LOG

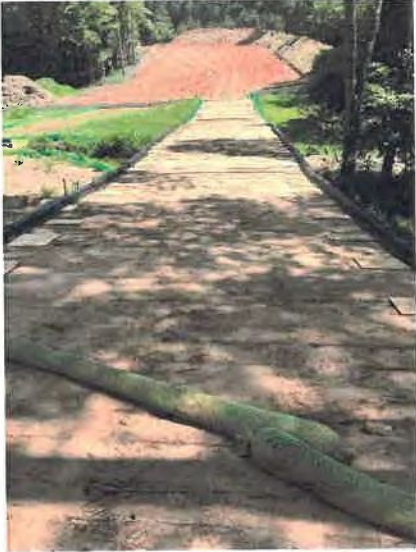
Area 1 - Bonbrook Road to Angle Plantation Road, station 14019+00 (MP 265.4) to 14171+36 (MP 268.2). The ROW and one access road (MVP-FR-309) was inspected for compliance with required ESC measures and deficiencies were observed. Deficiencies included extension of bumpers at stream crossing, additional water bars and correction of one water bar cross-slope grade. All items were repaired prior to end of day inspection.

Fig. 1
Extended bumpers and install additional waterbar (Area 1)

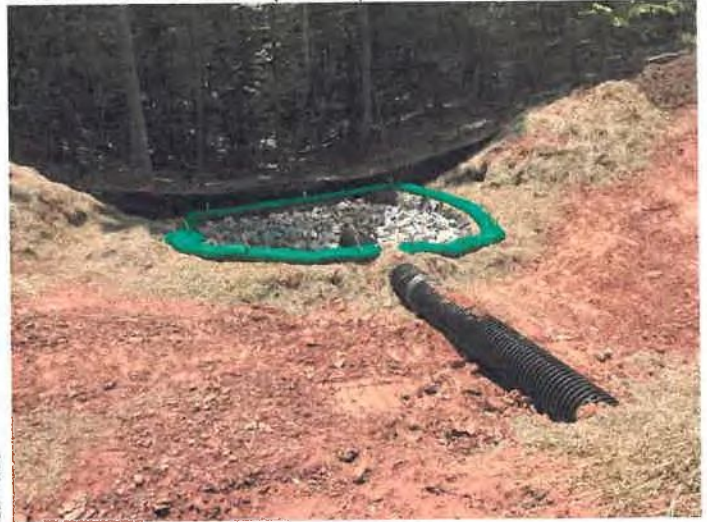
Fig. 2
Clean water diversion (Area 1)

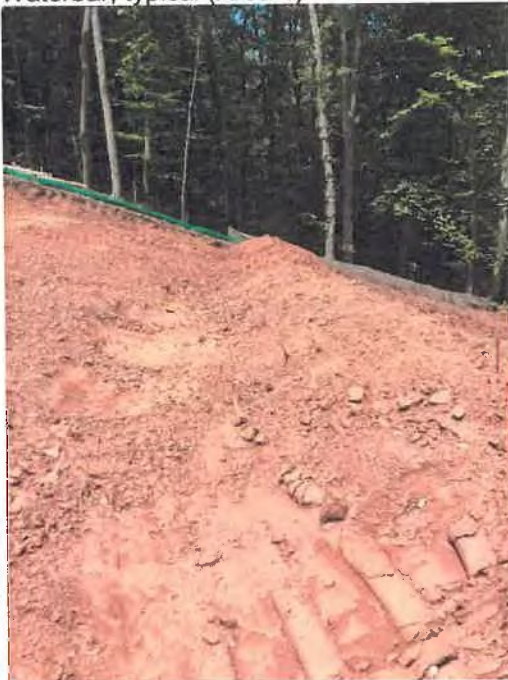
Fig. 3
Waterbar, typical (Area 1)

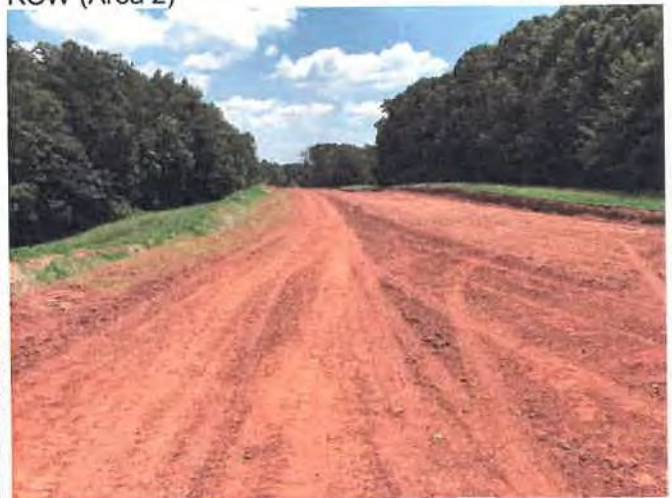
Area 2 – Angle Plantation Rd to Magoddee Creek, station 14171+36 (MP 268.2) to 14243+16 (MP 269.4). The ROW and one access road (FR-311) was inspected for compliance with required ESC measures and no deficiencies were observed.

Fig. 4
ROW (Area 2)

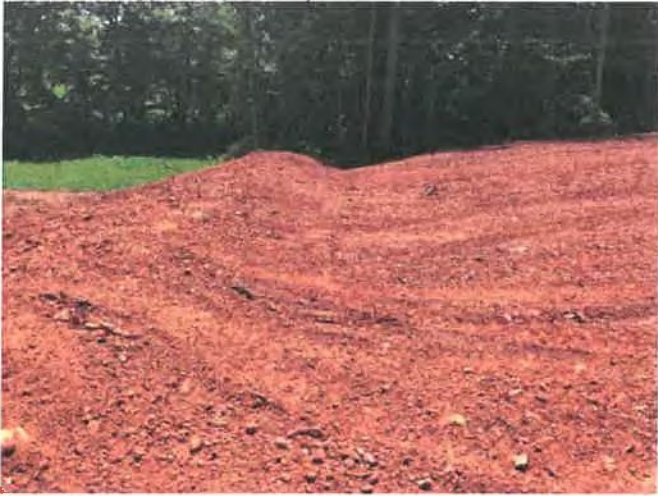
Fig. 5
Waterbar, typical (Area 2)
