FIELD INSPECTION

Project Name:	Mountain Valley Pipeline	Inspector:	Matthew Grant
Inspection Date:	Tuesday, October 9, 2018	Project Contact:	Brian Clauto
Spread: Franklin County MP 261 St#13819-13807	Spread I	Weather (Wet/Dry/Rain):	Wet

FIELD INSPECTION PHOTO LOG

Project Name: Mountain Valley Pipeline

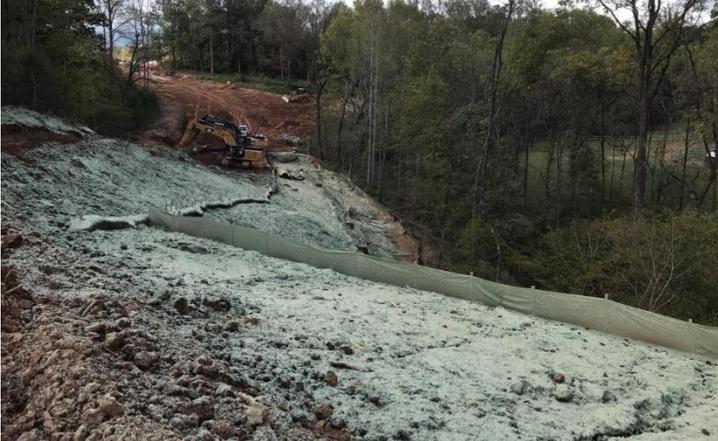
<p>Fig. 1 At St#13819 stabilization has been applied.</p> <div style="text-align: center; background-color: #cccccc; padding: 5px;"> <p>South East Elevation</p> <p>📍 327°NW (T) ● 37°4'5"N, 79°55'20"W ±16.4ft ▲ 1101ft</p> </div>

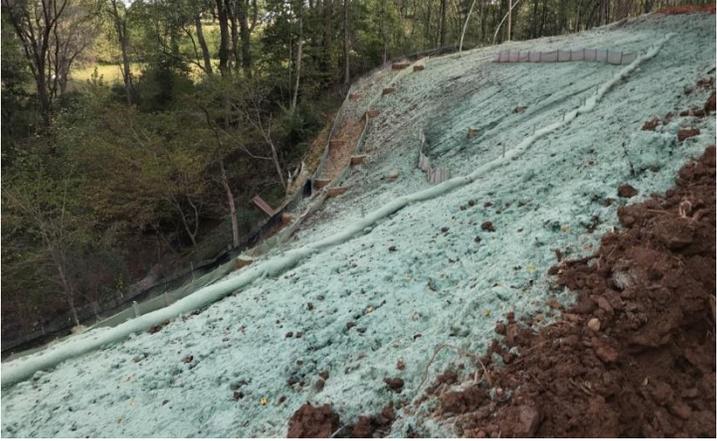
<p>Fig. 2 At St#13819 stabilization has been applied.</p> <div style="text-align: center; background-color: #cccccc; padding: 5px;"> <p>West Elevation</p> <p>📍 96°E (T) ● 37°4'5"N, 79°55'22"W ±16.4ft ▲ 1087ft</p> </div>

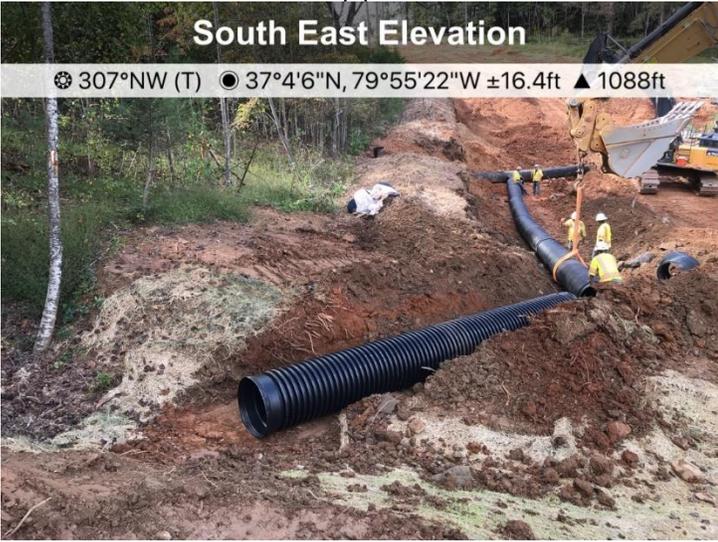
<p>Fig. 3 At St#13817+10 clean water pipe install.</p> <div style="text-align: center; background-color: #cccccc; padding: 5px;"> <p>South East Elevation</p> <p>📍 307°NW (T) ● 37°4'6"N, 79°55'22"W ±16.4ft ▲ 1088ft</p> </div>
