# INSPECTION

<b>Project Name:</b>	Mountain Valley Pipeline	<b>Inspector:</b>	John McCutcheon
<b>Inspection Date:</b>	Thursday, July 19, 2018	<b>Project Contact:</b>	Brian Clauto
<b>Spread:</b>	Spread H	<b>Weather (Wet/Dry/Rain):</b>	Dry

## FIELD INSPECTION PHOTO LOG

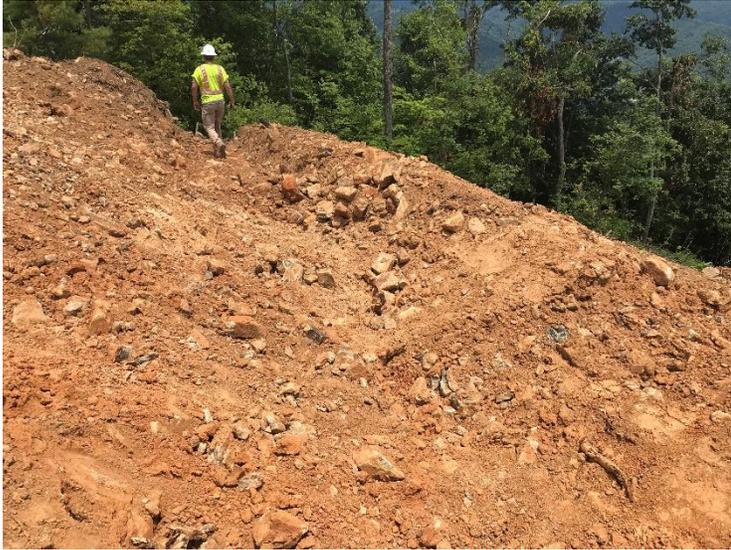
Comment 2.

1. Silt fence along ROW and at bottom of graded area OK.
2. Water bar at top of slope is poorly shaped with debris in flow line.
3. Water bar missing at STA 13119+00 between first and 2<sup>nd</sup> waterbars from top of slope
4. Water bars below 2<sup>nd</sup> waterbar unfinished/

Poorly shaped waterbar with debris in flowline.

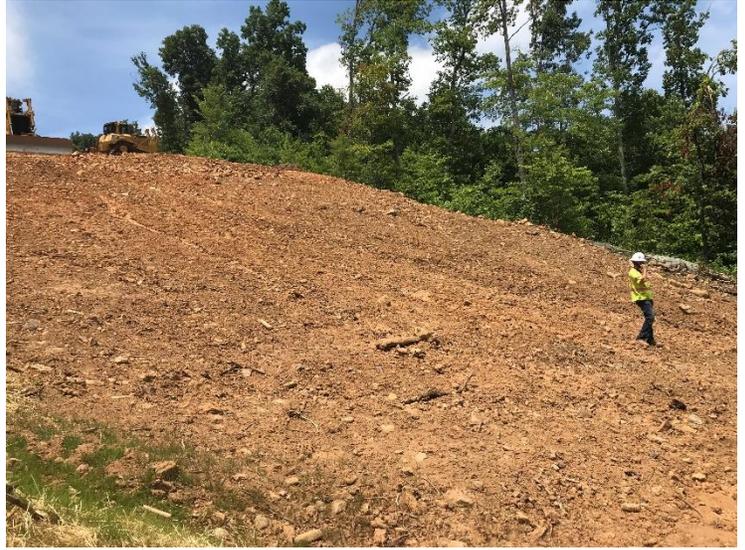
Comment 3.

Waterbar missing on steep slope.

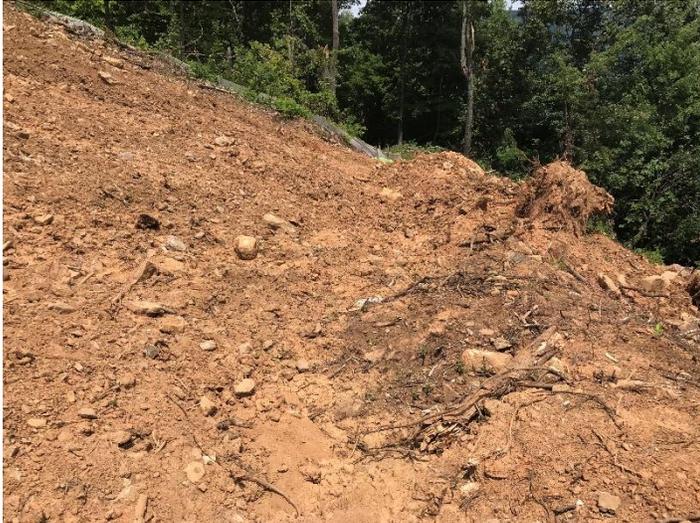
Comment 4.

Waterbar unfinished.

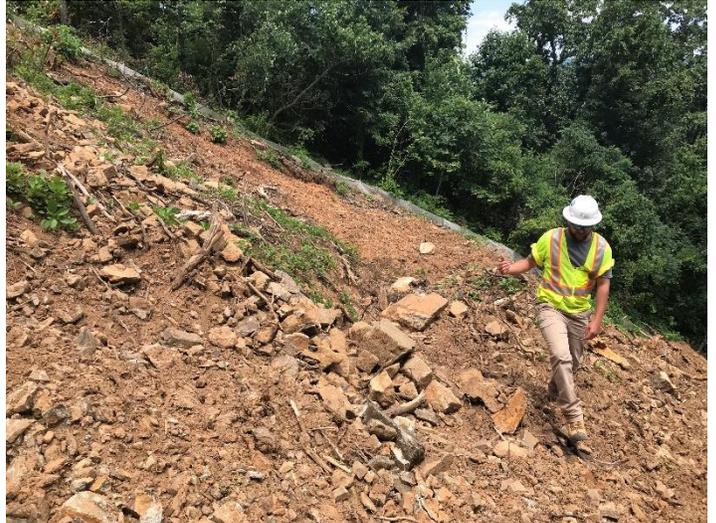
Comment 4.

Waterbar unfinished.
