FIELD INSPECTION

Project Name:	Mountain Valley Pipeline	Inspector:	Matthew Stafford
Inspection Date:	Thursday, July 12, 2018	Project Contact:	Brian Clauto
Spread:	Spread H	Weather (Wet/Dry/Rain):	Dry

FIELD INSPECTION PHOTO LOG

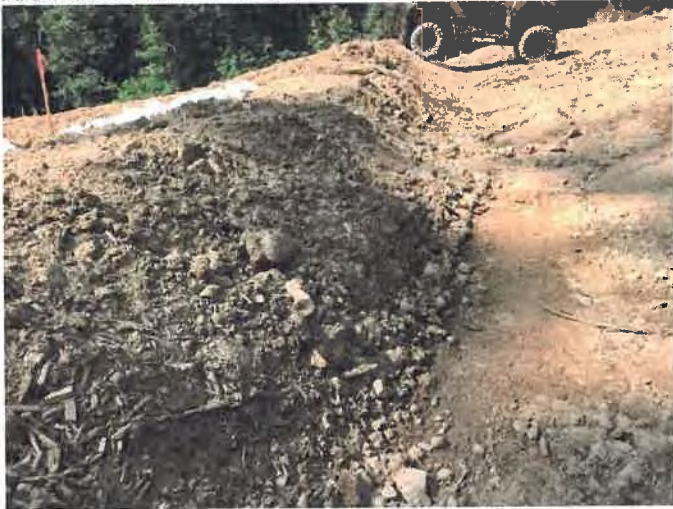
Fig. 1
Area above MVP-FR-291

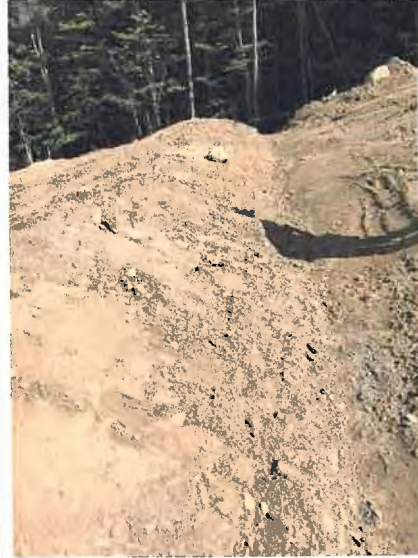
Fig. 2
Water bar, good shape and compaction

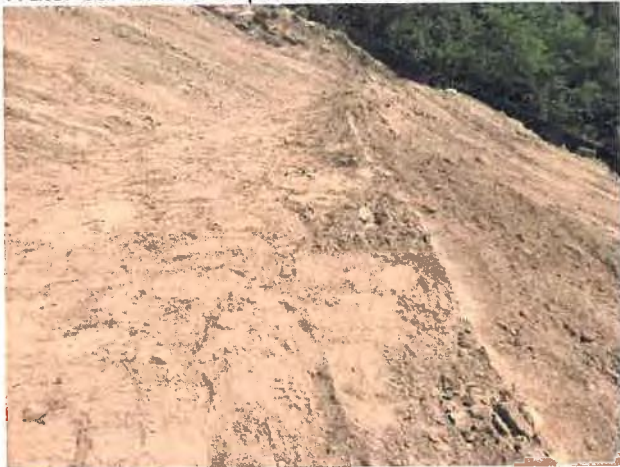
-Outstanding punch list items, additional stabilization necessary, water bars with height less than 18", and water bars needing additional compaction.

Fig. 3
Water bar with no depth to hold water

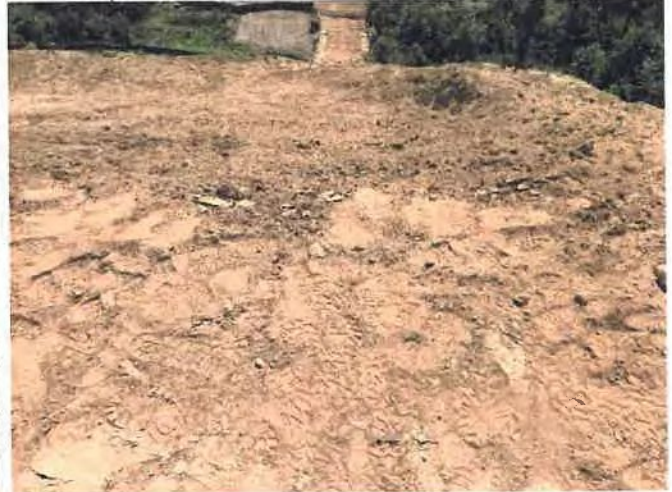
Fig. 4
Downslope from water bars with no storage depth
