VWP FIELD INSPECTION CHECKLIST

Project Name	Mountain Valley Pipeline Spread G, Giles County	VWP Permit #	N/A	Inspection Date	8/29/2018
Inspector Name	Nathan Hughes; Matt Grant	Phone # & Email Address	(804) 698-4026; Nathan.Hughes@deq.virginia.gov (804) 418-9874; Matthew.Grant@deq.virginia.gov		
Address or lat/long (if no permit no.)	Stream Crossing NN-12	Others Present During Inspection	N/A		
Project Phase	Land Clearing; Grading	Reason for Inspection	Construction		
PERMIT / REGULATORY REQUIREMENT		Yes/ No/ NA	Location, Description and Other Notes		
Unauthorized impacts to surface waters, including wetlands, or upland preservation areas have occurred . <i>(This includes sedimentation impacts due to inadequate or failed erosion controls.)</i>		Yes	Approximately 600 linear feet of stream channel has been impacted by sedimentation		
Non-impacted wetlands, streams and preservation areas within 50 feet of construction are clearly marked to prevent unpermitted impacts.		Yes

Site Name: Mountain Valley Pipeline_Spread G; Stream NN-12

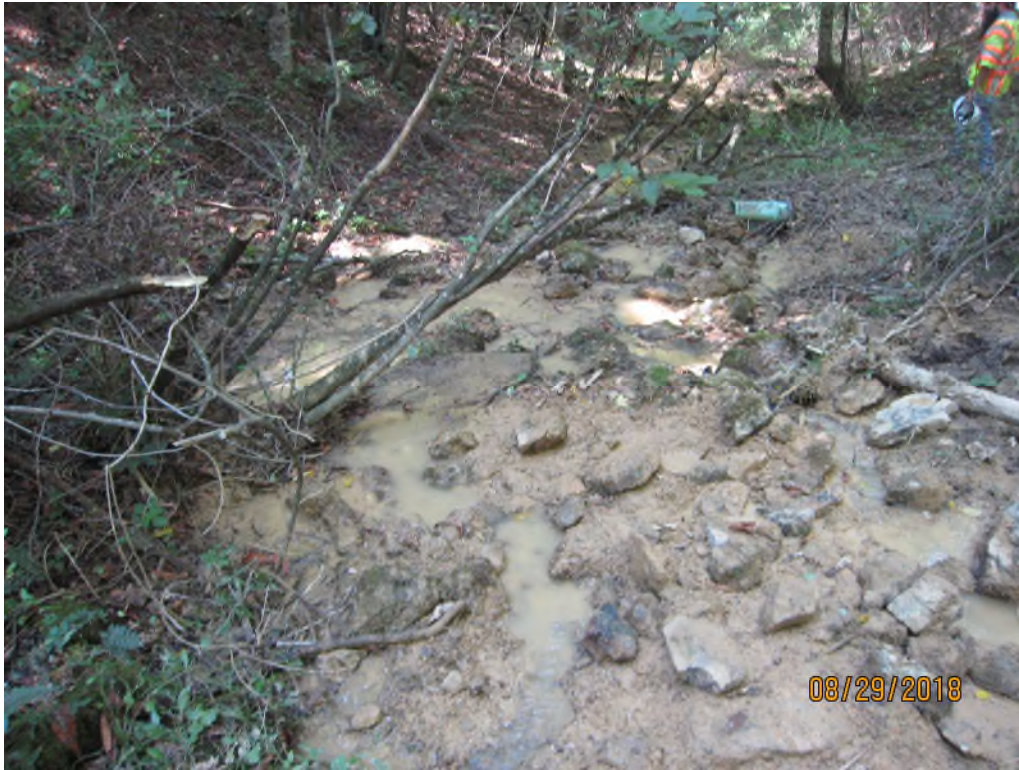
Approximately 600 linear feet of stream channel contained sediment ranging from <0.5-inch to a maximum depth of 3-inches was observed. Sediment within the stream's thalweg was generally <1-inch in depth; sediment bars and pool deposition was generally 1-3 inches in depth. Cleanup activity ESC repair were underway at time of field inspection.

Photo 3: Sediment in stream approximately 300' downstream of ROW; Depth = 1-3"
Orientation: Downstream

1. Repair erosion and sediment controls in areas where needed;
2. Stabilize all slopes above and below perimeter controls;
3. Remove sediment from impacted stream channel using hand removal methods (buckets and shovels) and stabilize with appropriate seed mix where applicable.

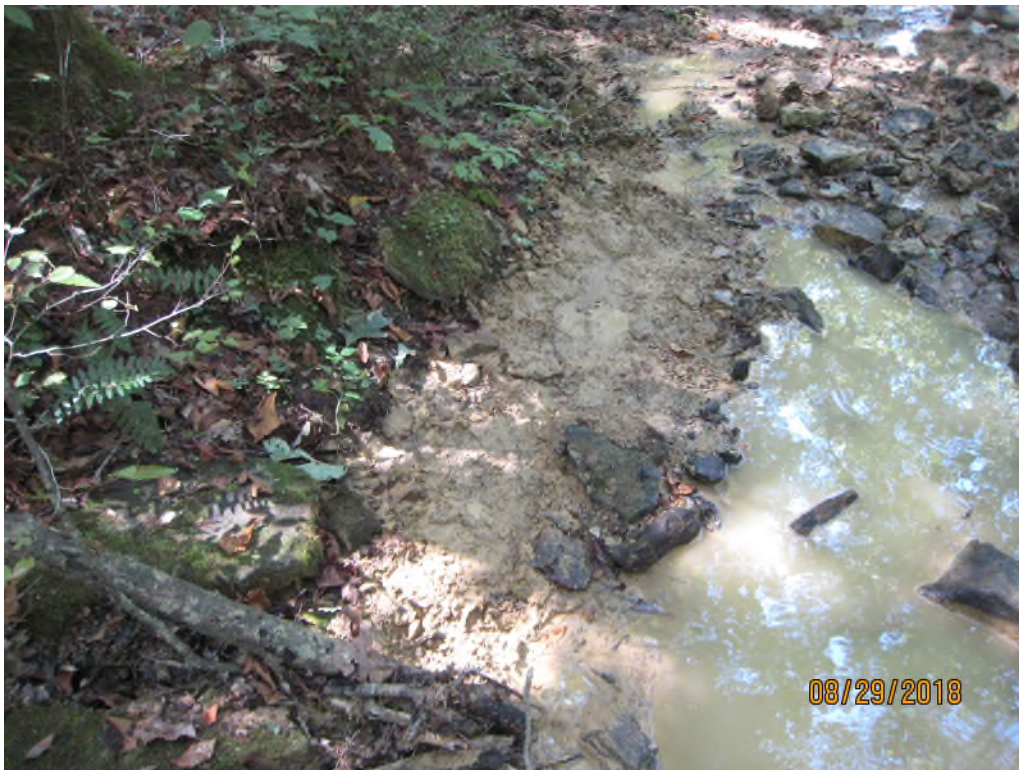
Photo 4: Sediment along bank of stream approximately 500' downstream of ROW; Depth = 2"
Orientation: Upstream
