## VWP FIELD INSPECTION CHECKLIST

<b>Project Name</b>	Mountain Valley Pipeline Spread G, Giles County	<b>VWP Permit #</b>	N/A	<b>Inspection Date</b>	9/5/2018
<b>Inspector Name</b>	Nathan Hughes; Matt Grant	<b>Phone # &amp; Email Address</b>	(804) 698-4026; <a href="mailto:Nathan.Hughes@deq.virginia.gov">Nathan.Hughes@deq.virginia.gov</a> (804) 418-9874; <a href="mailto:Matthew.Grant@deq.virginia.gov">Matthew.Grant@deq.virginia.gov</a>		
<b>Address or lat/long (if no permit no.)</b>	Stream Crossing Q-14	<b>Others Present During Inspection</b>	N/A		
<b>Project Phase</b>	Land Clearing; Grading	<b>Reason for Inspection</b>	Construction		
<b>PERMIT / REGULATORY REQUIREMENT</b>		<b>Yes/ No/ NA</b>	<b>Location, Description and Other Notes</b>		
Unauthorized impacts to surface waters, including wetlands, or upland preservation areas <b>have occurred</b> .* <i>(This includes sedimentation impacts due to inadequate or failed erosion controls.)</i>		Yes	Approximately 630 linear feet of stream channel has been impacted by sedimentation

Site Name: Mountain Valley Pipeline\_Spread G; Stream Q-14

Date: 9/5/2018

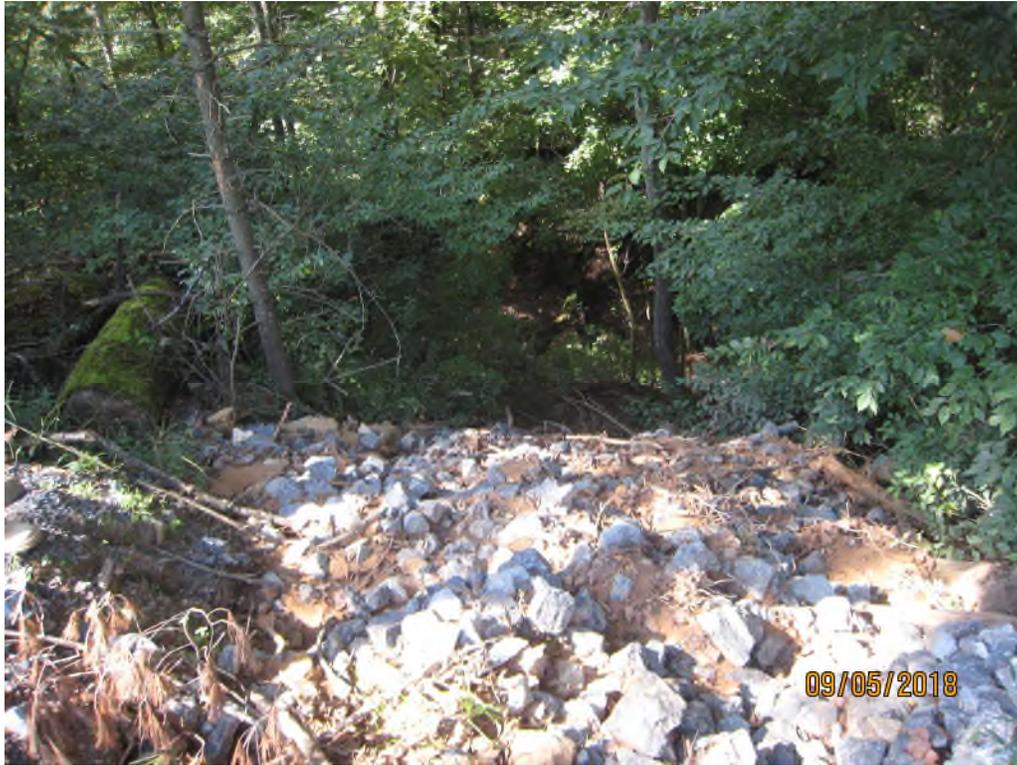
**Photo 1:** View from Access Road G/I 234 toward Kimballton Branch downslope of ESC failure  
**Orientation:** N/A

1. Repair erosion and sediment controls in areas where needed;
2. Stabilize all slopes above and below perimeter controls;
3. Remove sediment from impacted stream channel using hand removal methods (buckets and shovels) and stabilize with appropriate seed mix where applicable.

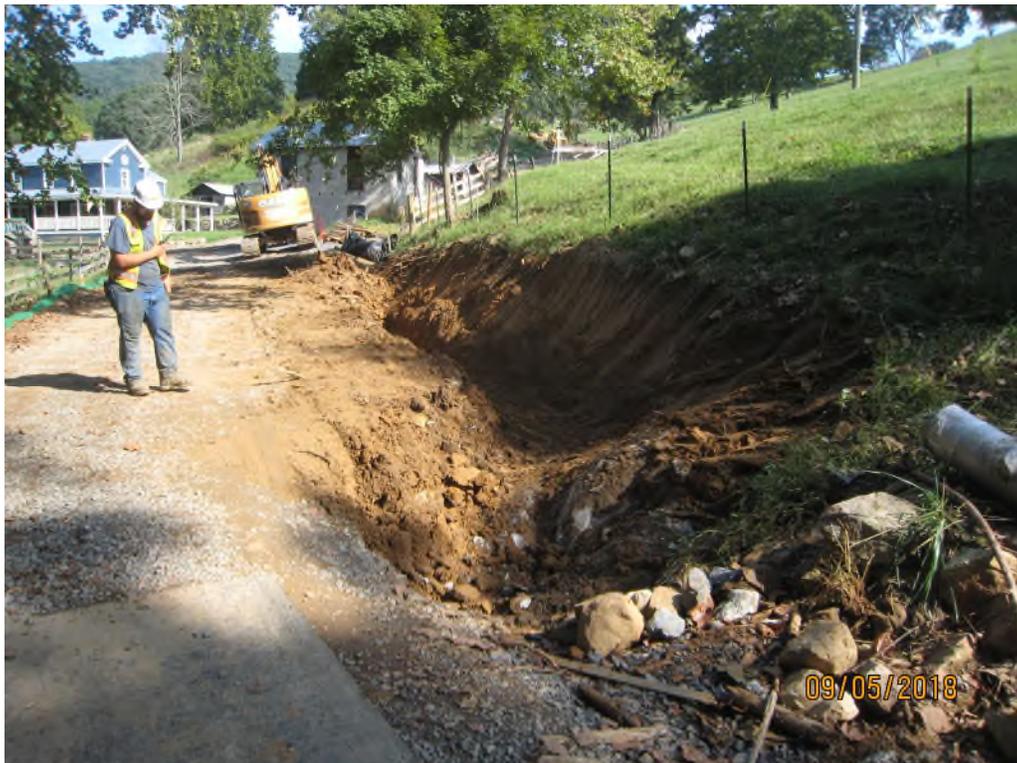
**Photo 2:** Access Road construction/maintenance near Photo 1  
**Orientation:** Upslope

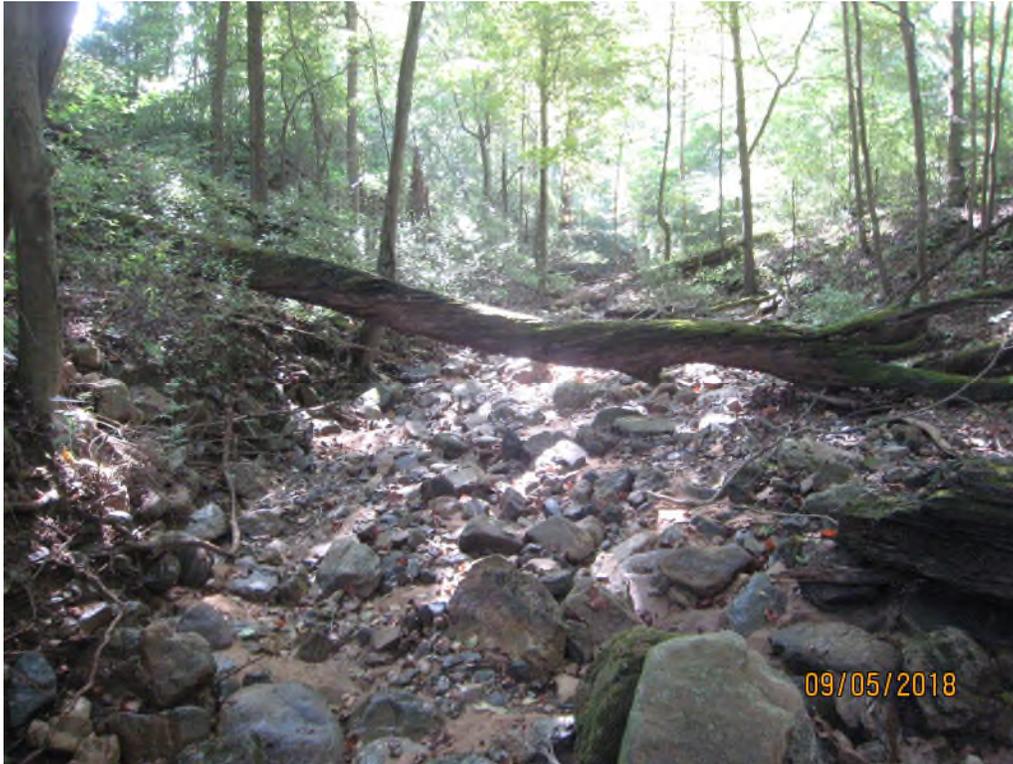
Approximately 630 linear feet of stream channel contained sediment ranging from <0.5-inch to a maximum depth of 9-inches was observed. No flow was present in the 10-12' wide channel at time of inspection. Sediment within the stream's thalweg was generally 3-inches in depth; sediment bars and pool deposition was generally >6-inches in depth. Landowner permission was not granted for Kimballton Branch downstream of Rogers Road culverts.

**Photo 3:** Sediment in stream approximately 50' downslope of Access Road G/I 234 Depth = 3"  
**Orientation:** Downstream

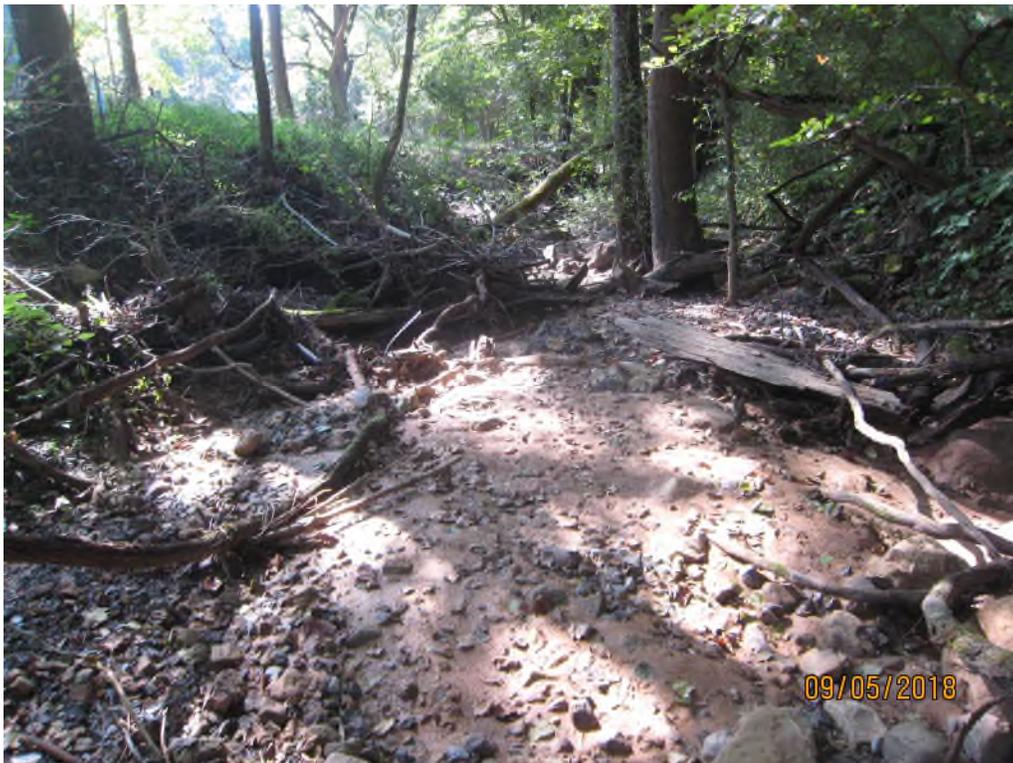
**Photo 4:** Sediment at debris dam approximately 400' downstream of Photo 1; Depth = 4"  
**Orientation:** Downstream

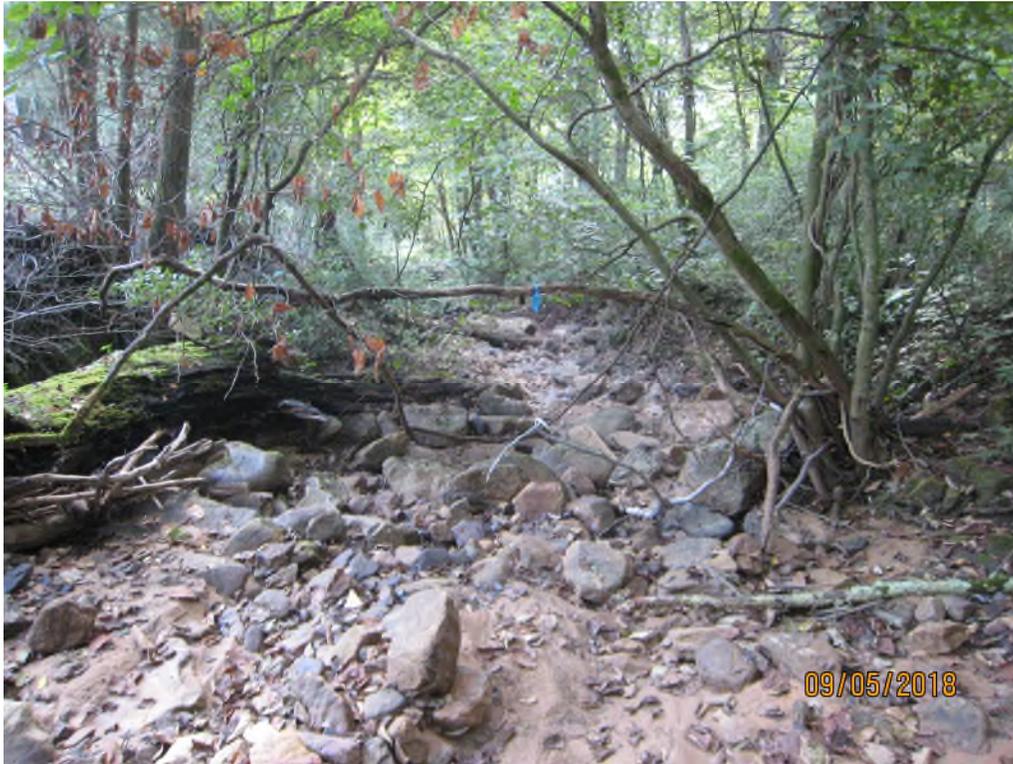
**Photo 5:** Sedimentation in channel 100' upstream of Rogers Road culverts; Depth = 8'  
**Orientation:** Upstream

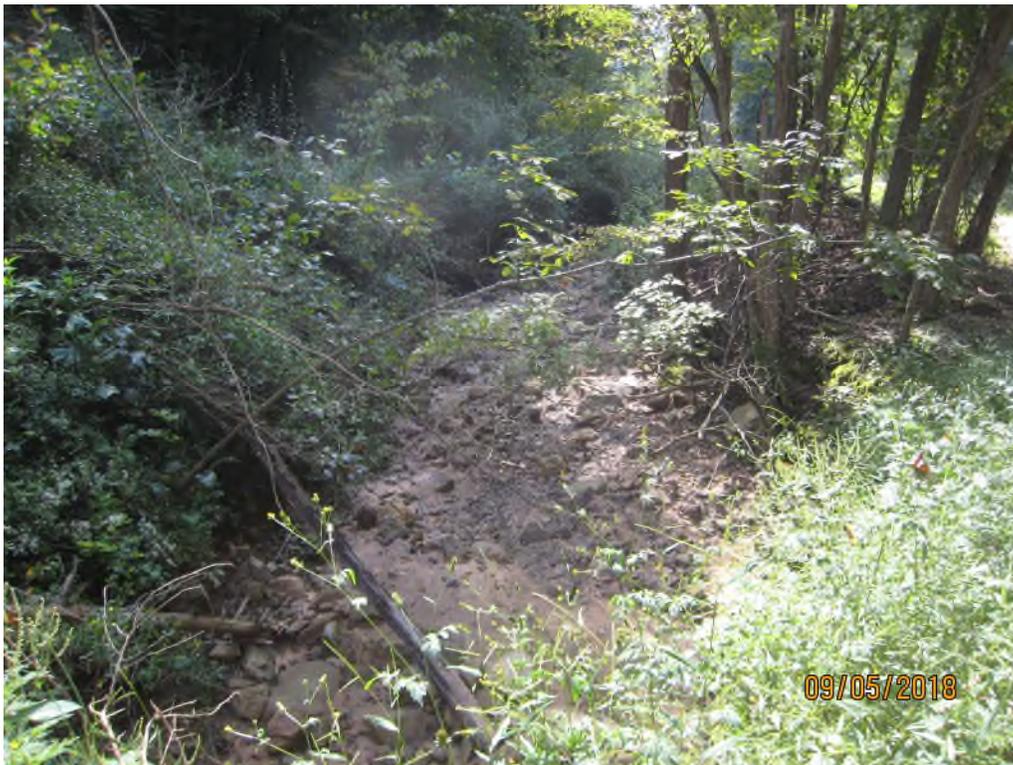
**Photo 6:** Sedimentation in channel downstream of Rogers Road culverts; no landowner permission  
**Orientation:** Downstream
