VWP FIELD INSPECTION CHECKLIST

Project Name	Mountain Valley Pipeline Spread H, Montgomery County	VWP Permit #	N/A	Inspection Date	6/27/2018
Inspector Name	Nathan Hughes; Matt Grant	Phone # & Email Address	(804) 698-4026; Nathan.Hughes@deq.virginia.gov (804) 418-9874; Matthew.Grant@deq.virginia.gov		
Address or lat/long (if no permit no.)	Half Acre Rock Road; Stream Crossing MN-513	Others Present During Inspection	N/A		
Project Phase	Land Clearing; Grading	Reason for Inspection	Construction		
PERMIT / REGULATORY REQUIREMENT		Yes/ No/ NA	Location, Description and Other Notes		
Unauthorized impacts to surface waters, including wetlands, or upland preservation areas have occurred . <i>(This includes sedimentation impacts due to inadequate or failed erosion controls.)</i>		Yes	Approximately 209 linear feet has been impacted by sedimentation		
Non-impacted wetlands, streams and preservation areas within 50 feet of construction are clearly marked to prevent unpermitted impacts.		N/A	Impacted stream is located greater than within and downstream of LOD

Site Name: Mountain Valley Pipeline_Spread H; Stream MN-513

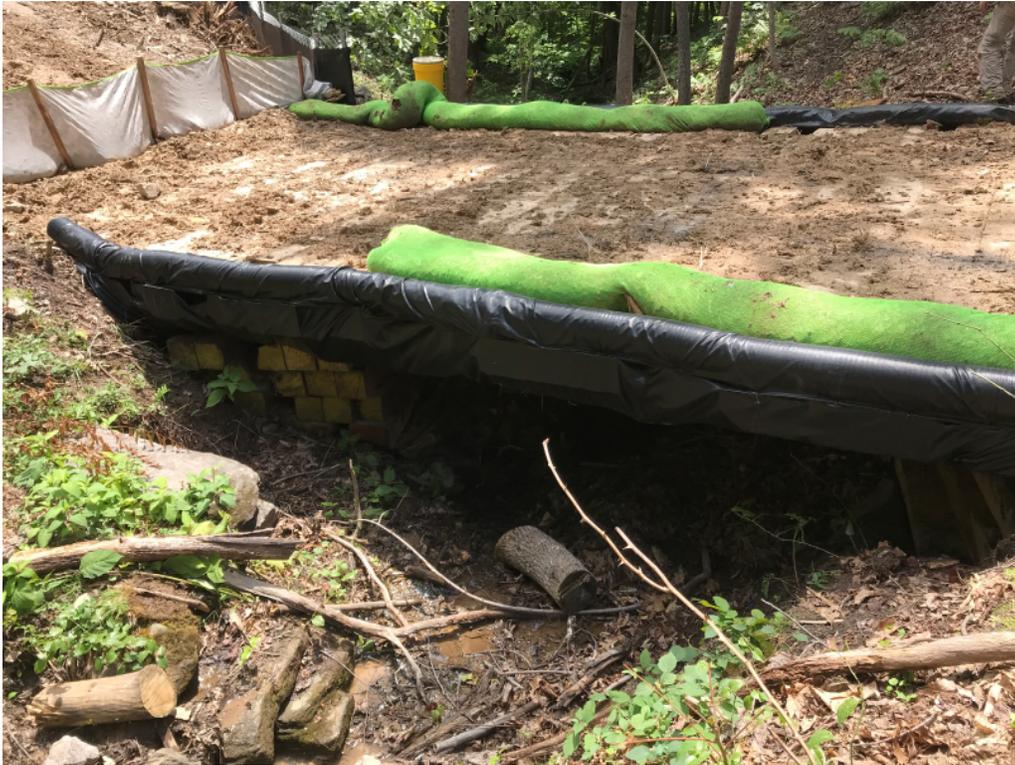
Approximately 209 linear feet of stream channel contained sediment ranging from <0.5-inch to a maximum depth of 3-inches was observed. Sediment within the stream's thalweg was generally <1-inch in depth; sediment bars and pool deposition was generally 1-3 inches in depth.

Photo 1: Sedimentation and woody debris within Stream MN-513 at bridge crossing
Orientation: Downstream

1. Repair erosion and sediment controls in areas where needed;
2. Stabilize all slopes above and below perimeter controls;
3. Remove sediment from impacted stream channel using hand removal methods (buckets and shovels) and stabilize with appropriate seed mix where applicable.

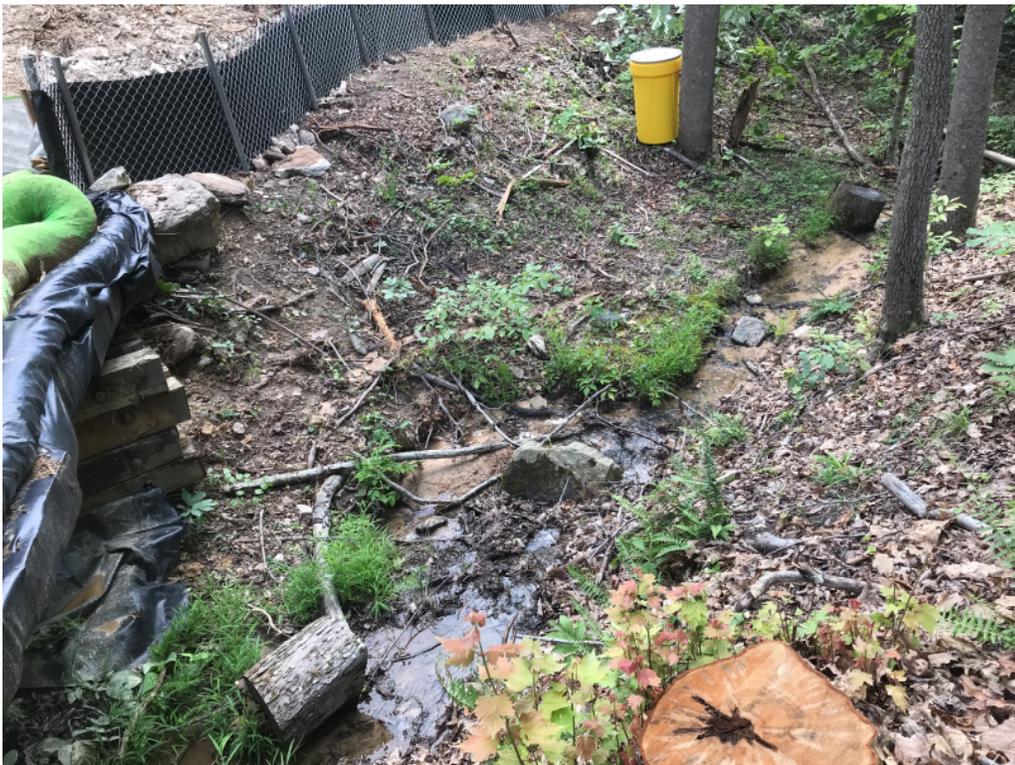
Photo 2: Sedimentation and woody debris downstream of bridge crossing
Orientation: Downstream
