VWP FIELD INSPECTION CHECKLIST

Project Name	Mountain Valley Pipeline Spread H, Montgomery County	VWP Permit #	N/A	Inspection Date	6/26/2018
Inspector Name	Nathan Hughes; Matt Grant	Phone # & Email Address	(804) 698-4026; Nathan.Hughes@deq.virginia.gov (804) 418-9874; Matthew.Grant@deq.virginia.gov		
Address or lat/long (if no permit no.)	Bacchus Road; 37°15'30.5"N, 80°17'46.8"W Stream Crossing SMM-15	Others Present During Inspection	N/A		
Project Phase	Land Clearing; Grading	Reason for Inspection	Complaint		
PERMIT / REGULATORY REQUIREMENT		Yes/ No/ NA	Location, Description and Other Notes		
Unauthorized impacts to surface waters, including wetlands, or upland preservation areas have occurred .* <i>(This includes sedimentation impacts due to inadequate or failed erosion controls.)</i>		Yes	Approximately 3,600 linear feet of stream channel have been impacted by sedimentation		
Non-impacted wetlands, streams and preservation areas within 50 feet of construction are clearly marked to prevent unpermitted impacts.		N/A	Impacted streams are located greater than 50 feet from project's LOD

Site Name: Mountain Valley Pipeline_Spread H south of Catawba Road

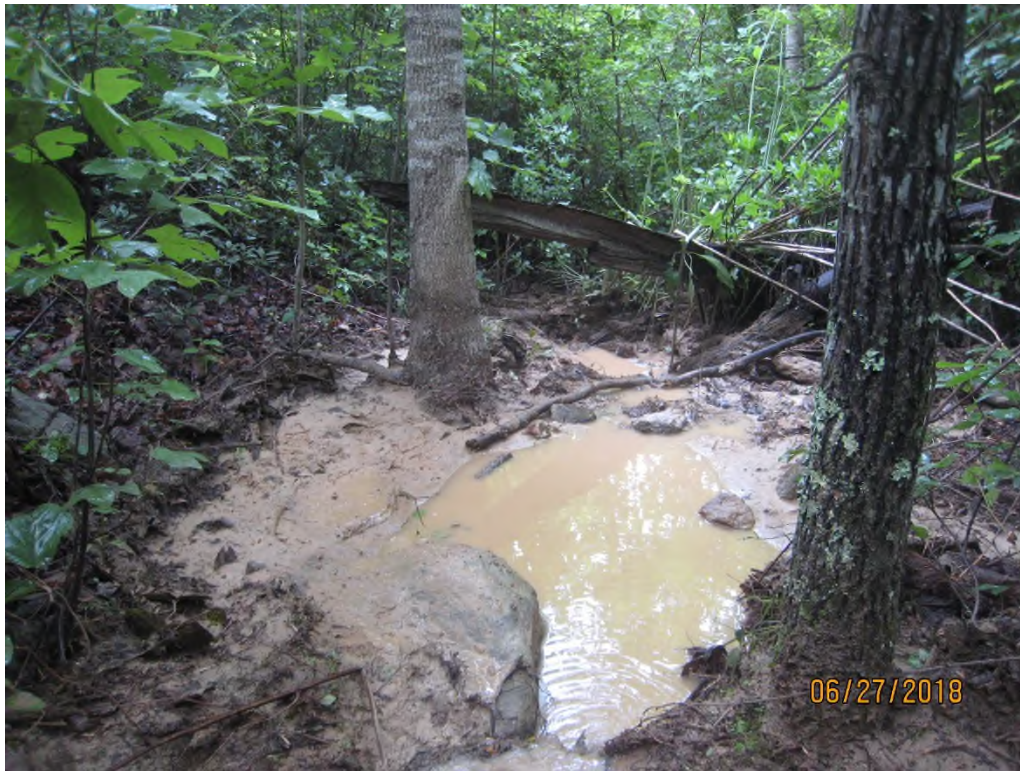
Photo 1: Sedimentation within “SMM-15” ~160’ downstream of LOD; Depth = 3”

Orientation: Downstream

1. Repair erosion and sediment controls in areas where needed;
2. Stabilize all slopes above and below perimeter controls;
3. Remove sediment from impacted stream channels using hand removal methods (buckets and shovels) and stabilize with appropriate seed mix where applicable.

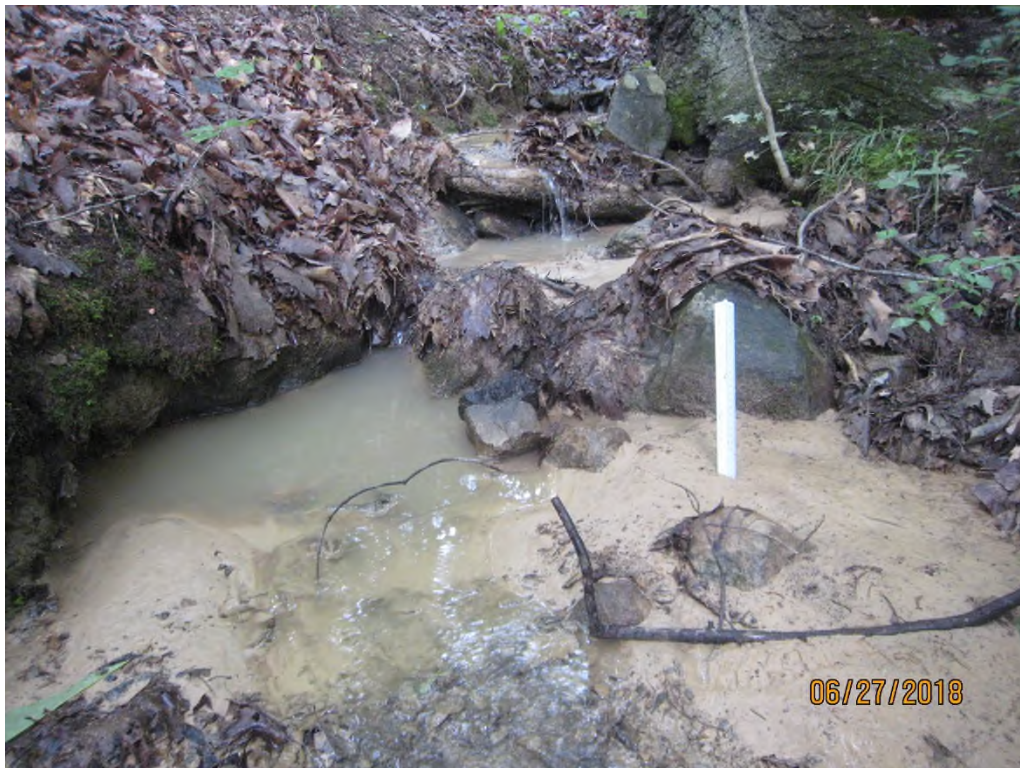
Photo 2: Sediment in stream ~685’ from LOD; Depth = 3”

Orientation: Upstream

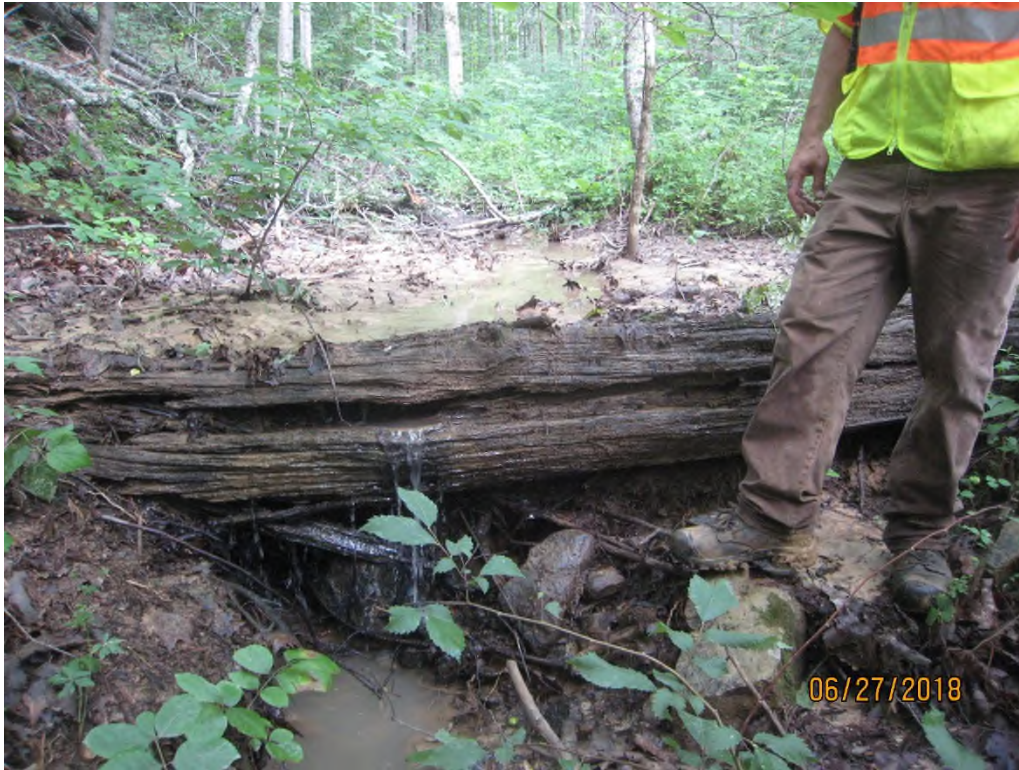
Photo 3: Sediment in stream at debris dam ~1,690' downstream of LOD; Depth = 2-7"
Orientation: Upstream

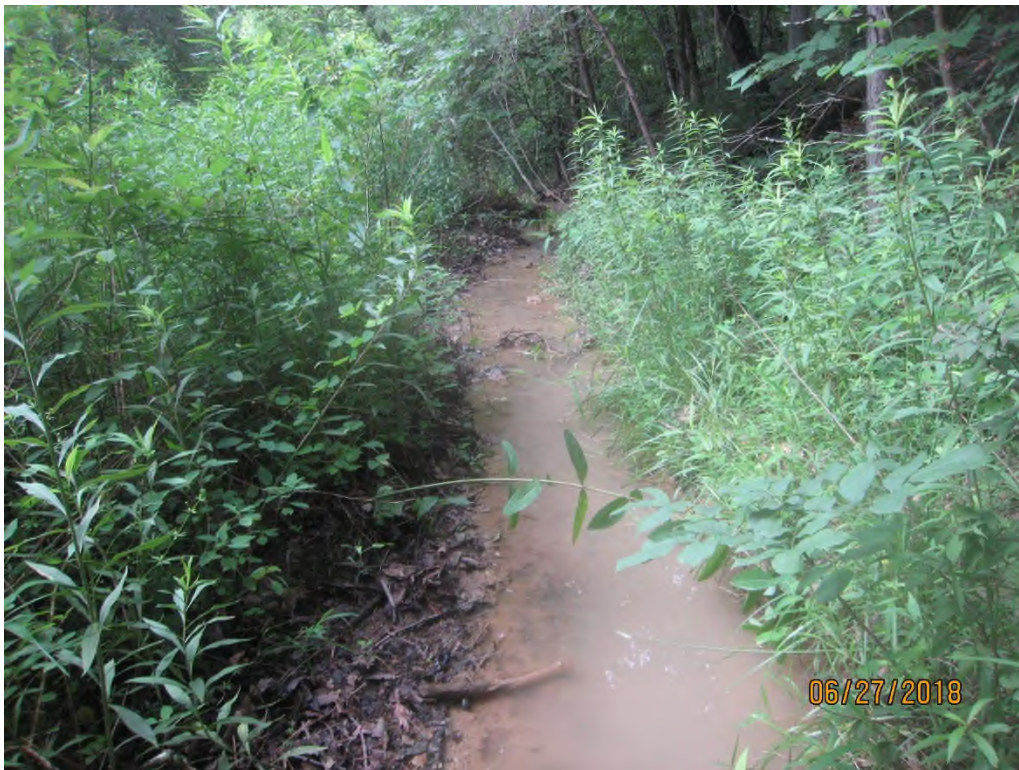
Photo 4: Sediment in stream ~3,485' from LOD near access road; Depth = 2"
Orientation: Downstream
