VWP FIELD INSPECTION CHECKLIST

Project Name	Mountain Valley Pipeline Spread I, Franklin County	VWP Permit #	N/A	Inspection Date	10/16/2018
Inspector Name	Nathan Hughes; Matt Grant	Phone # & Email Address	(804) 921-1970; Nathan.Hughes@deq.virginia.gov (804) 418-9874; Matthew.Grant@deq.virginia.gov		
Address or lat/long (if no permit no.)	Stream Crossing E-48 (BonBrook #2)	Others Present During Inspection	N/A		
Project Phase	Grading; Trenching	Reason for Inspection	Construction		
PERMIT / REGULATORY REQUIREMENT		Yes/ No/ NA	Location, Description and Other Notes		
Unauthorized impacts to surface waters, including wetlands, or upland preservation areas have occurred .* <i>(This includes sedimentation impacts due to inadequate or failed erosion controls.)</i>		Yes	Linear footage of stream channel impact unknown due to lack of adjacent landowner permission.		
Non-impacted wetlands, streams and preservation areas within 50 feet of construction are clearly marked to prevent unpermitted impacts.		Yes

Site Name: Mountain Valley Pipeline_Spread I; Stream E-48

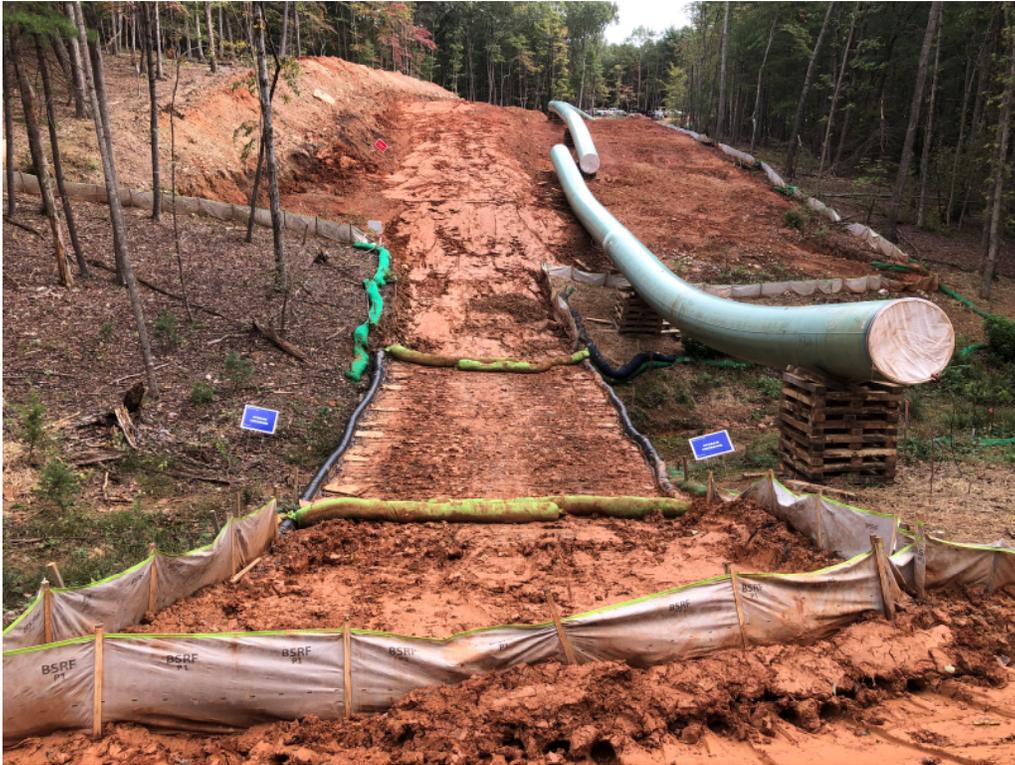
Photo 1: Overview of Stream Crossing E-48

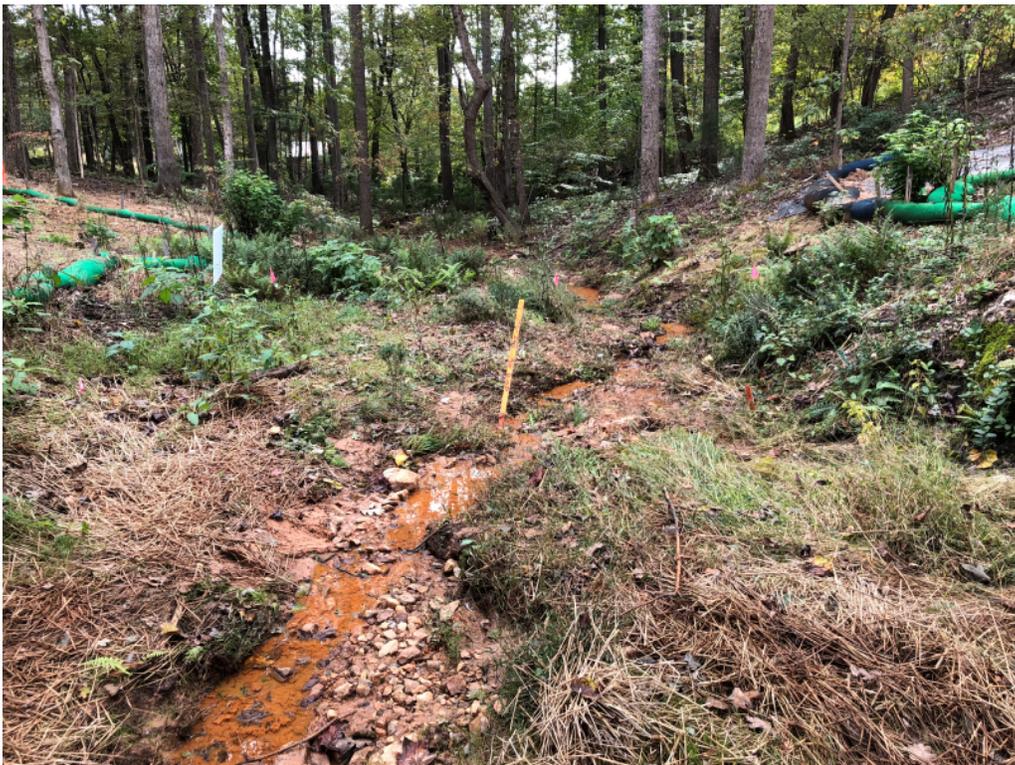
Photo 2: View downstream from bridge in Photo 1

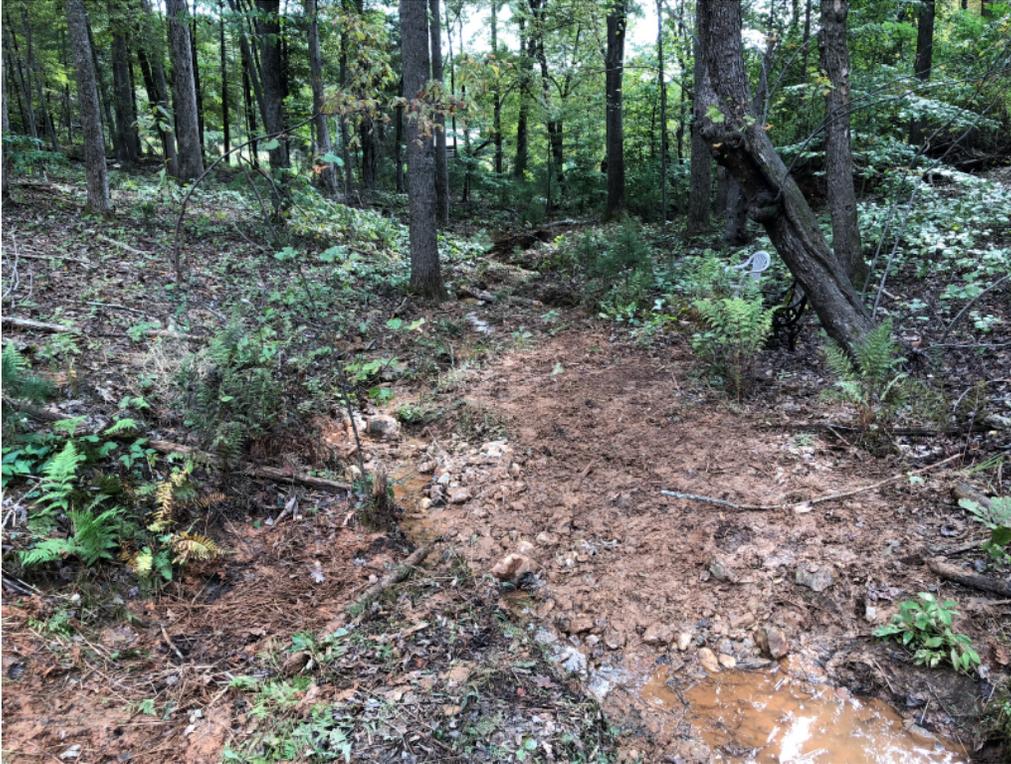
Sediment ranging from <0.5-inch to a maximum depth of 2-inches was observed. Sediment was also observed within forested buffer. Flow was present in the 1-3' wide channel at time of inspection. Sediment within the stream's thalweg was generally <1-inch in depth; sediment bars and pool deposition was generally 1 to 2-inches in depth. Landowner permission was not granted for adjacent property downstream.

Photo 3: Sediment in stream and on banks at edge of RoW; Depth = 0.5-2"
Orientation: Downstream

1. Repair erosion and sediment controls in areas where needed;
2. Stabilize all slopes above and below perimeter controls;
3. Remove sediment from impacted stream channel using hand removal methods (buckets and shovels) and stabilize with appropriate seed mix where applicable.

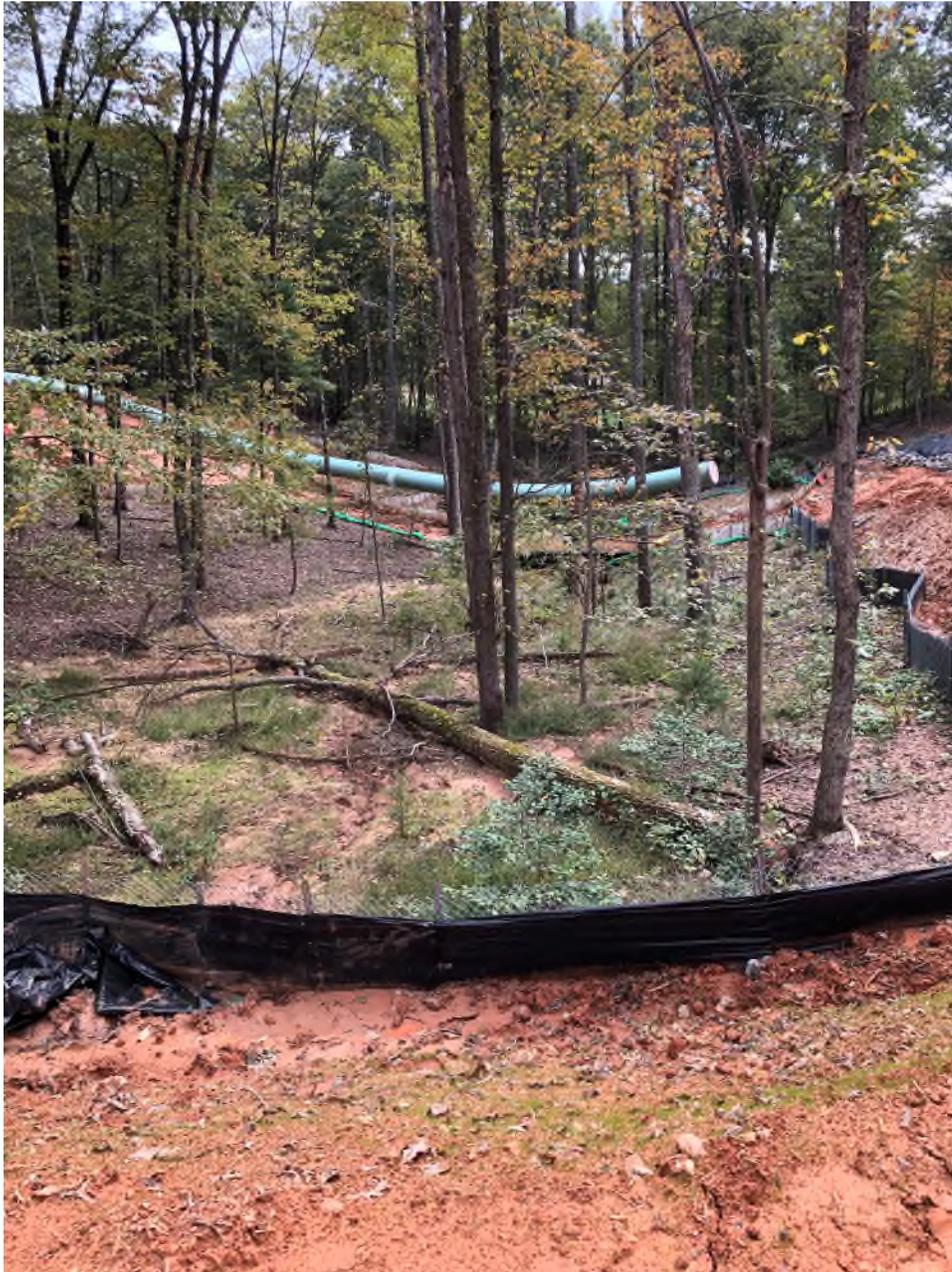
Photo 4: Overview of stream crossing and sediment within forested buffer
Orientation: SE
