Stafford County, Virginia Shoreline Inventory Report Methods and Guidelines

**Comprehensive Coastal Inventory Program
Center for Coastal Resources Management
Virginia Institute of Marine Science, College of William and Mary
Gloucester Point, Virginia
September 2015**

Special report in Applied Marine Science and Ocean Engineering No. 445 of the Virginia Institute of Marine Science

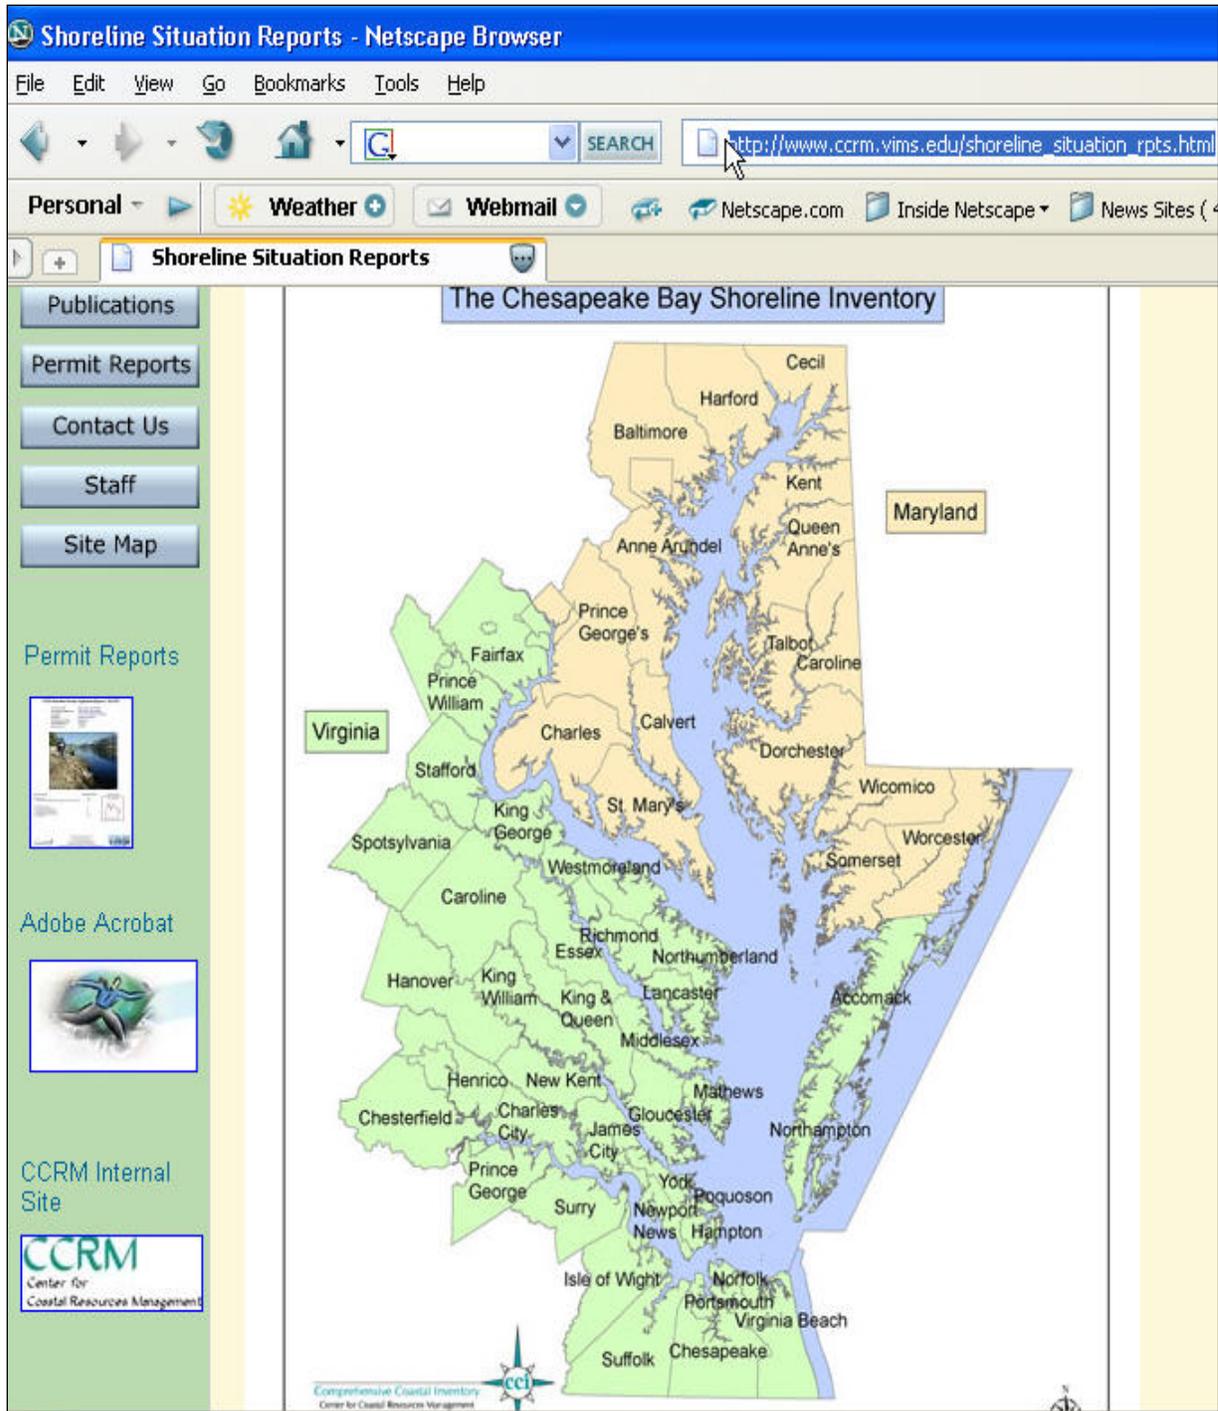
Figure 1. Shoreline Inventory Website

2.4c.) Map Viewer and Summary Tables: The Stafford County Shoreline Inventory is delivered to the end user through a website; http://ccrm.vims.edu/gis_data_maps/shoreline_inventories/index.html (Figure 1.), by clicking on Stafford County in the map or list of localities. The new format for Shoreline Inventories includes a map viewing tool rather than maps in pdf format. The map viewer allows users to interact with the datasets within a familiar “google” type map service that was developed with Javascript. Here they can view data of their choice and customize map products for printing themselves. Access to the GIS data, summary tables and methods report is also available through this website.

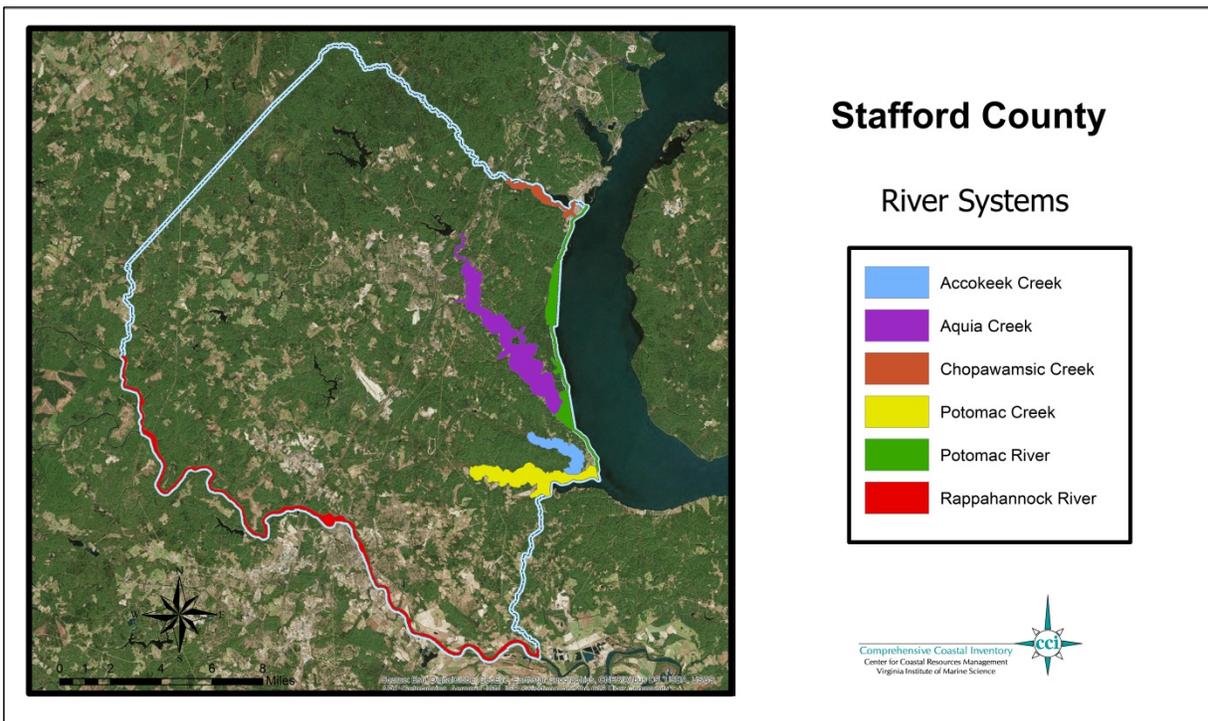
Figure 2. River Systems in Stafford County

Summary tables (Tables 4-7) quantify conditions observed on the basis of river systems (Figure 2). Refer to Figure 2 for the location of these rivers systems. Note, river systems do not correspond to watershed boundaries. They were developed for convenience in reporting data.

The top toolbar also includes tabs to access some important status information for the locality. By clicking on the “River System Pie Charts” button, users can obtain a statistical summary distribution of the riparian land use and amount of hardened shoreline for a specific water body selected from the drop down menu in the upper left (Figure 7). More detailed results in table format can be found by clicking the Stafford County Summary PDF button also in the window. The summary statistics are reported by river systems (Figure 2).

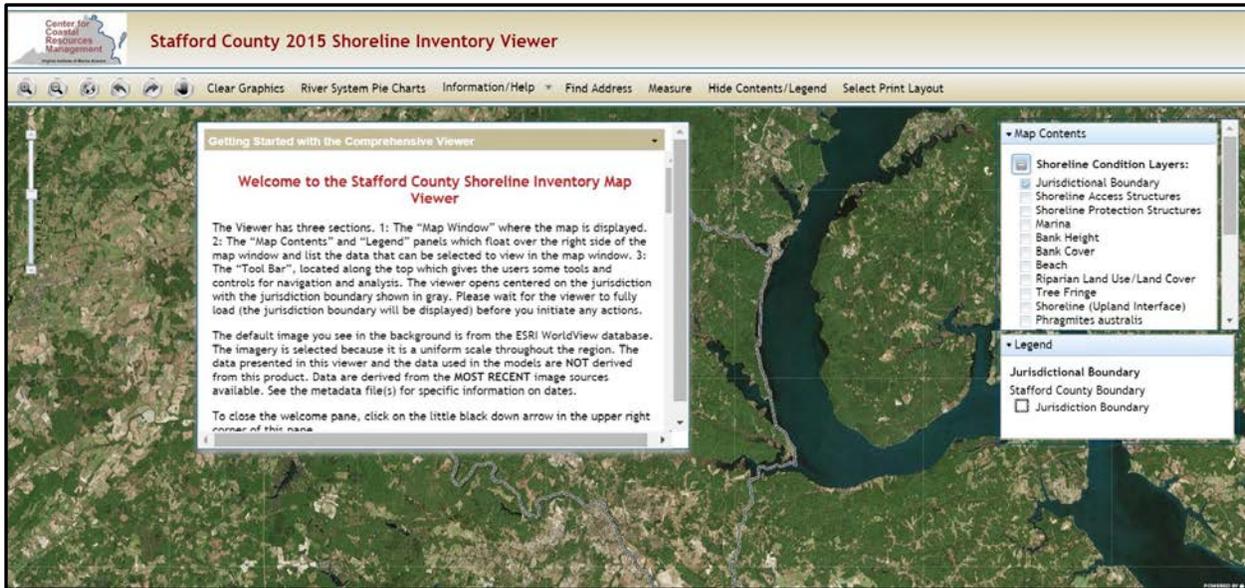
Figure 3. Opening page for the Stafford County Shoreline Inventory Viewer

The Viewer has two panels: “Map Window”, where the map is displayed and “Map Contents and Legend”, where data that can be selected and viewed in the map window are listed. A tool bar is located along the top of the “Map Window” which gives users some controls for navigation and analysis (Figure 3.).

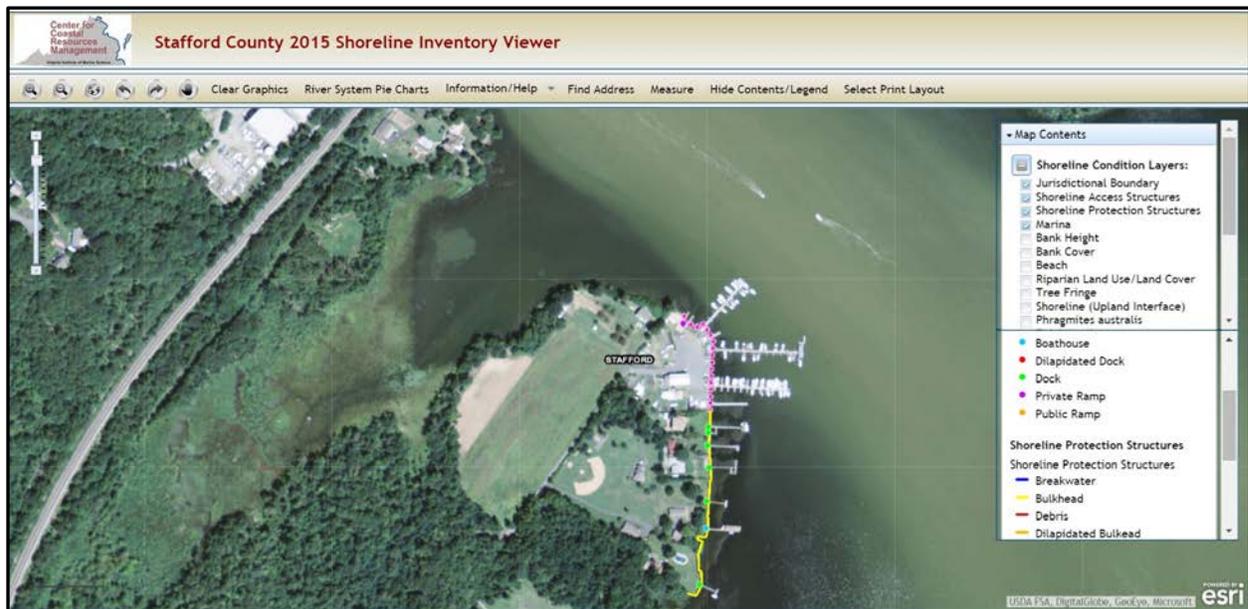
Figure 4. Map Viewer illustrates Shoreline Access and Protection Structures for a section of the County.

In Figure 4 Shoreline Access Structures, and Shoreline Protection structures are selected. Shoreline Access structures are point features that includes piers and boat ramps. The actual footprint of these structures is not measured; only their location. Shoreline Protection Structures are line features and are mapped and illustrated in the viewer to show where they occur along the shoreline. Figure 5 illustrates riparian land use in the riparian zone for the same section of the County.

From the “Map Contents” the user may check various attribute layers on or off. The user must use the scroll bar on the far right to see the complete list of layers available. When layers are turned on, the corresponding legend appears in the “Legend” panel, and the data are displayed in the “Map Window” (Figure 4).

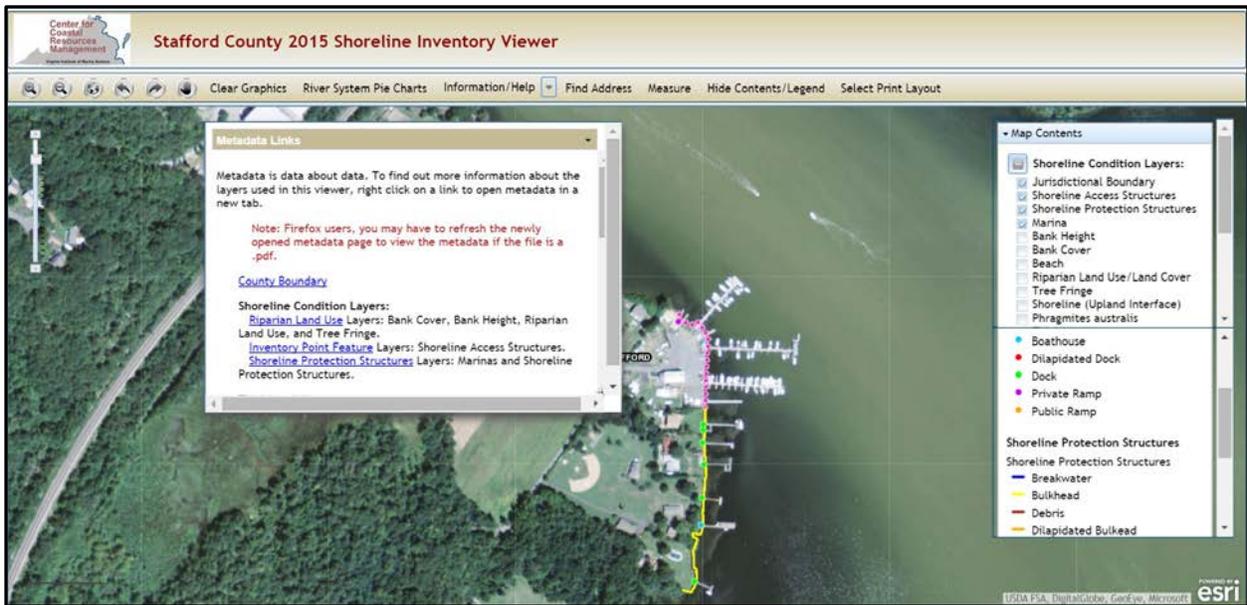
Figure 6. Link to Metadata records has been selected from the top Information tab in the toolbar.

The user can use the zoom and pan tools from the top toolbar or the slide bar on the left side of the map window to change their map extent. If the map resolution is exceeded the window will become illegible. Detailed information can be obtained about the data by selecting the "Information/Help" tab at the top of the map viewer. From here the inventory glossary and metadata records can be easily accessed. In Figure 6 the selection for metadata has been made and 5 possible records can be retrieved.

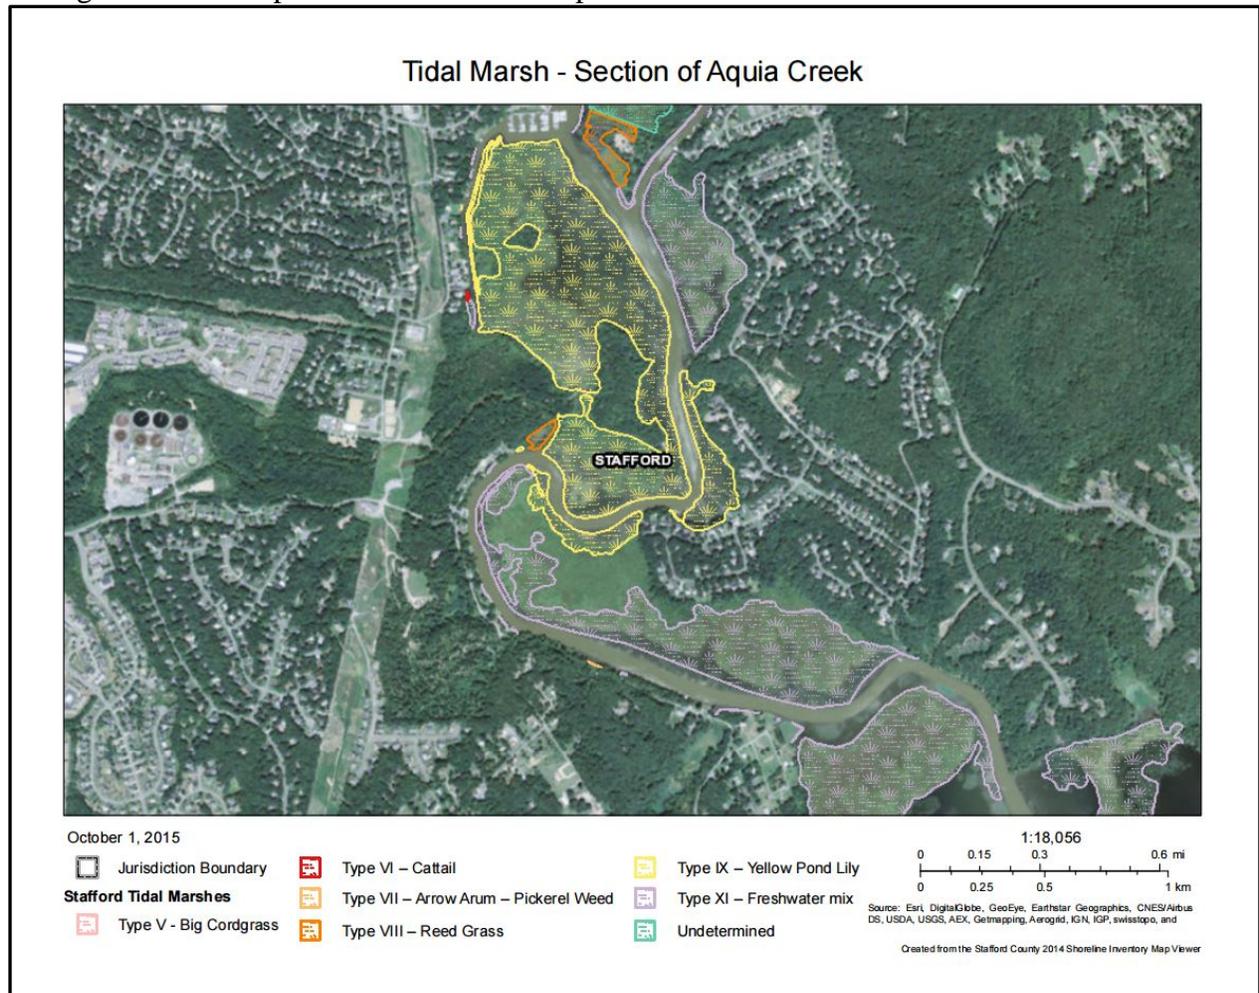
Figure 8. Customized print window for a section of Aquia Creek

Finally, users have the option to personalize their own maps (i.e. map extent, data displayed, map title, etc.) and save them as a pdf file by clicking “Select Print Layout” button. The page can be set up for printing to 8.5 x 11 portrait or landscape style. Figure 8 is an example of a customized map generated for a section of Aquia Creek. Here the tidal marsh communities are displayed, and the community type is reported in the legend beside the illustration.
