**Shoreline Situation Reports and their Application for Tidal  
Wetland Management – A Demonstration Project in  
Westmoreland County, Virginia**

**Final Technical Report Submitted to**

**Center for Coastal Resources Management  
Virginia Institute of Marine Science  
College of William and Mary**

# Westmoreland County, Virginia Shoreline Situation Report

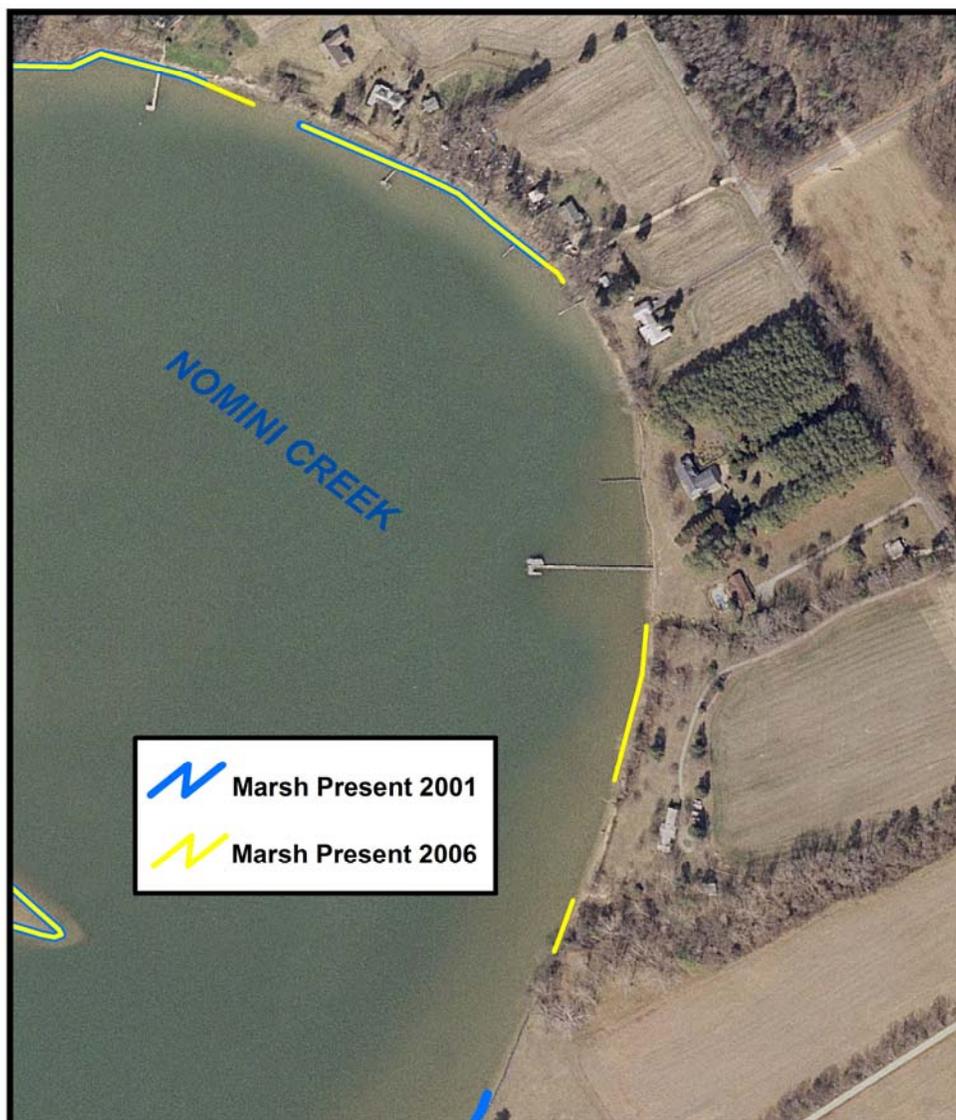
Figure 1. Narrow fringe marsh has increased along this section of Nomini Creek since the shoreline was surveyed in 2001.

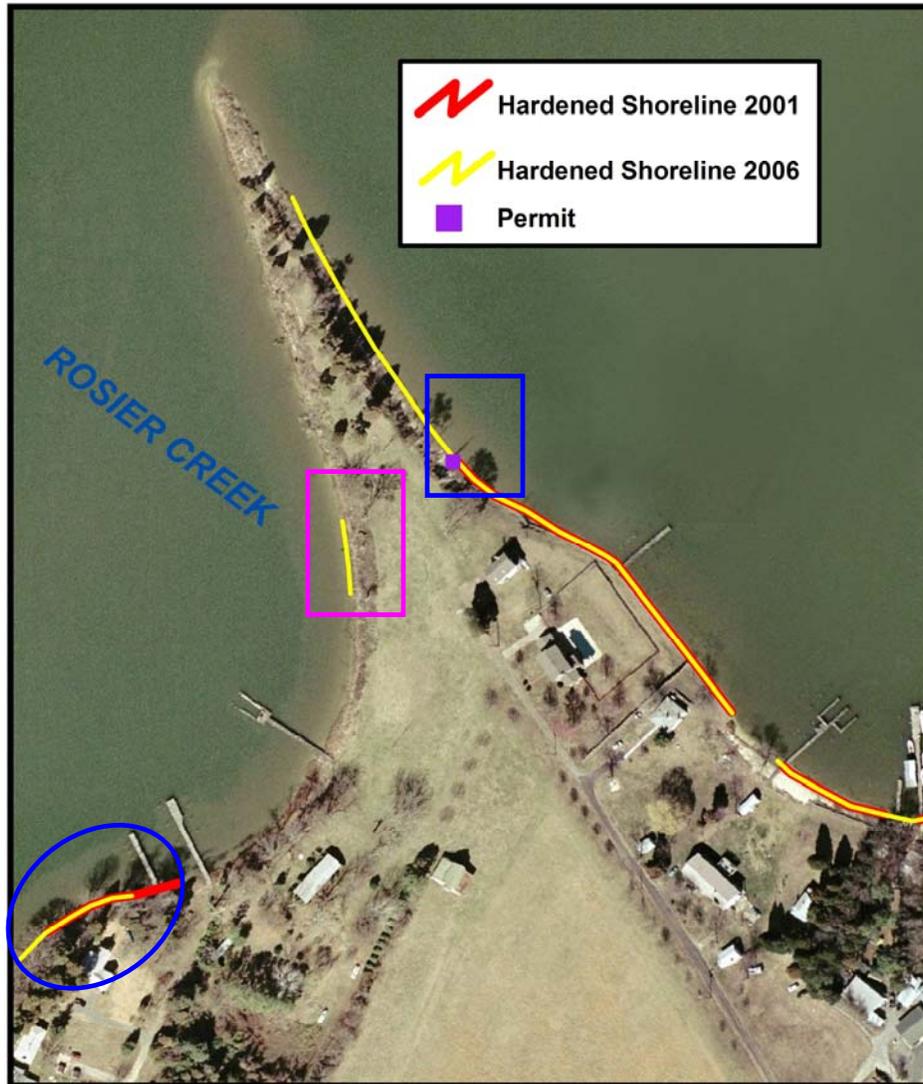
Figure 2. The geographic correlation between new construction and permit locations varies greatly in this study. Within the blue box the permit location associated with the extension of the erosion control structure is clearly visible. Meanwhile, no permit was found in the wetlands permit database to be associated with the structure highlight in the pink box.

Some minimum criteria were established to search conditions illustrated in maps as a mechanism to identify possible areas where collection or processing errors may have occurred. Short breaks in long stretches of structures with no apparent change in property boundary were identified. Offsets in the overlap of structures between the two years with the 2001 inventory extending a greater distance along shore suggest the operator closed the feature on the GPS unit too soon or the processor did not accurately transpose the feature to the new baseline. The area within the blue circle shown on

Figure 2 may be an area where an operator or processing error generated an offset between the delineation in 2001 and 2006. Since no permit is associated with the extension, this is a site which could be flagged as a violation, but most likely is not. Five miles of shoreline were found to have possible processing errors. Without an extensive recall effort, these locations cannot be verified, but we accept some of these sites might account for a percentage of the total 8.65 miles (13.92 km) of structures found to be constructed after 2001 without permits.

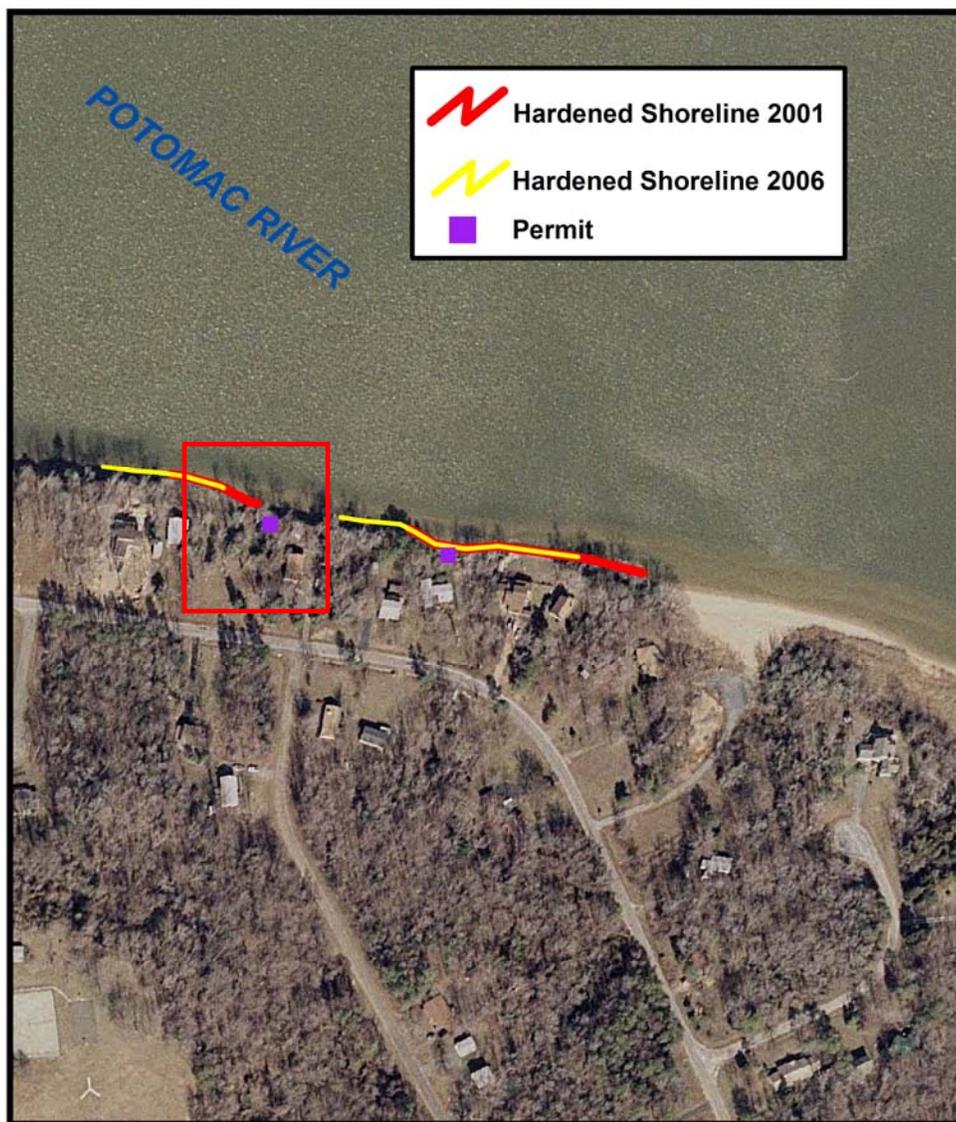
Figure 3. The permit highlighted in the box is most likely associated with the new construction shown to the west.

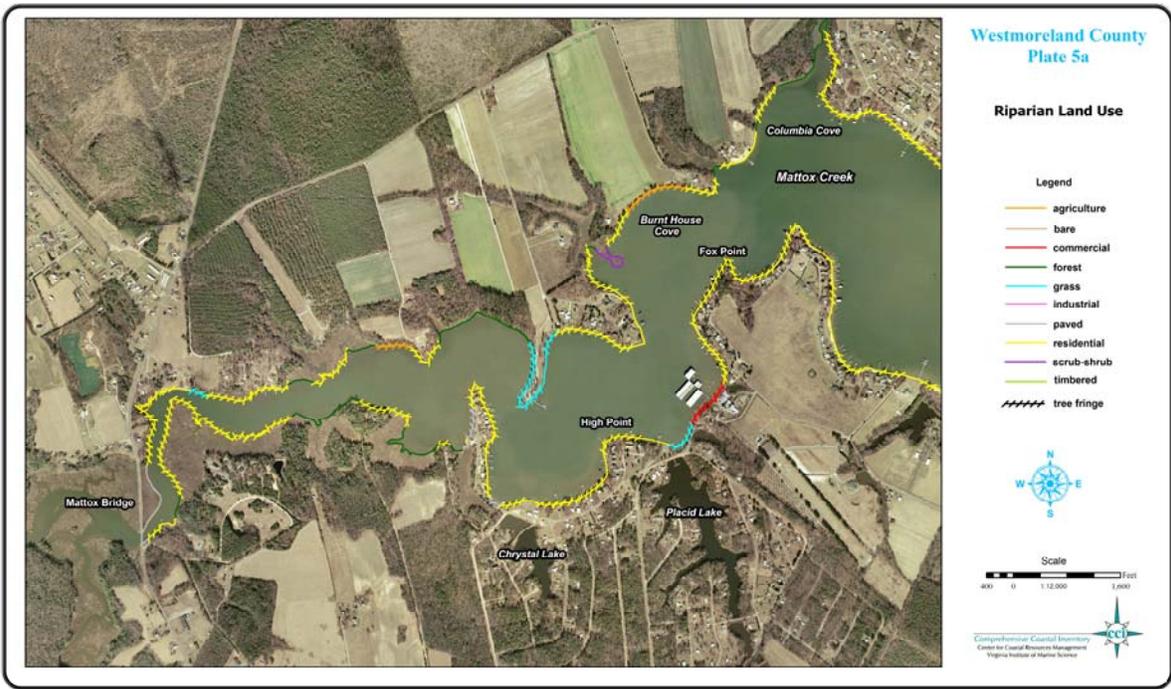
Figure 4. Sample riparian land use map for Westmoreland County

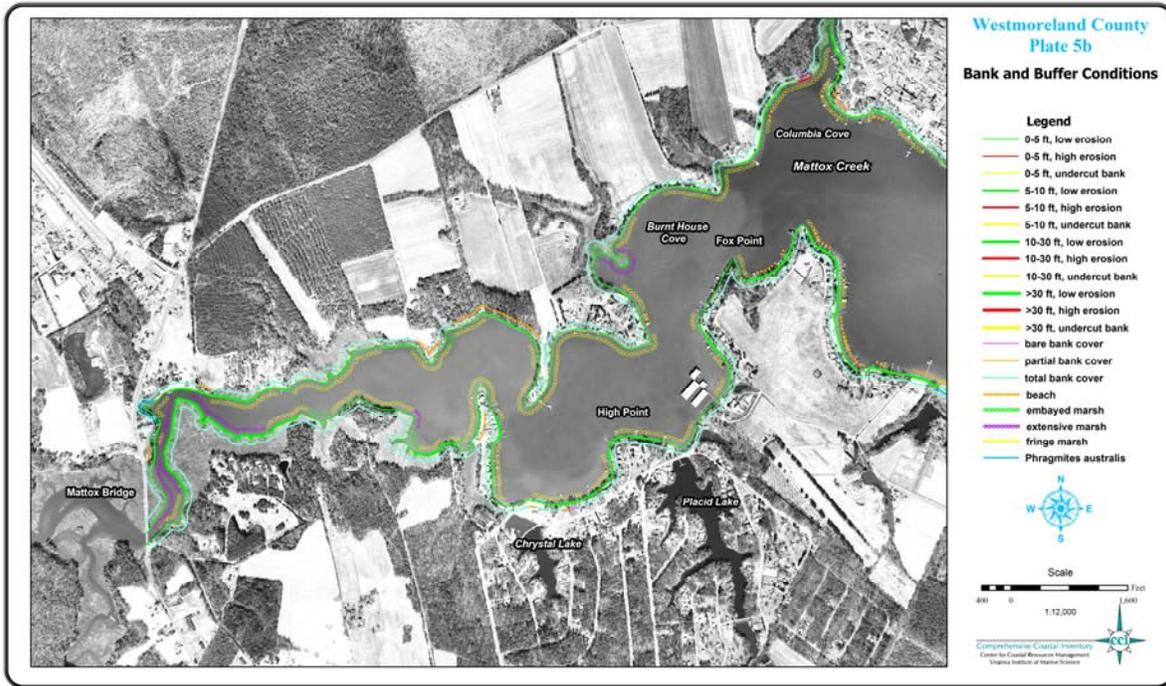
Figure 5. Map illustrating bank and buffer conditions for plate 5 in Westmoreland County

Plate B depicts the condition of the bank and any natural buffers present. Four lines, and a combination of color and pattern symbology give rise to a vast amount of bank and natural buffer information. The line furthest inland describes the bank cover. Bank cover is distinguished by colors. Bare banks (<25% cover) are illustrated in fuschia, partial cover (25-75%) is pale orange line, and total cover (>75%) is indicated by a light blue line. Moving toward the water, a darker blue line may be illustrated if *Phragmites australis* is present. This line will be absent if no *Phragmites* is detected. Bank height and stability is the next line sequence seaward. These are red, green or yellow lines with a red line indicating an unstable bank, a green line indicating stability, and a yellow line indicating evidence of undercutting. Bank height varies with the thickness of the line; where the thickest lines designate the highest banks (> 30

feet). A pattern of small colored circles just channel ward of the shoreline describes any natural buffers present. Open circles represent a natural embayed (green), extensive (fuschia), or fringe (yellow) marsh along the base of the bank. Solid orange circles indicate a sand beach buffer at the base of the bank. It is possible to have both. The length of the each of these symbols described along the shore reflects the length alongshore that the features persist. The symbology changes as conditions change. Plate B uses a grey scale version of the natural color image for the backdrop.

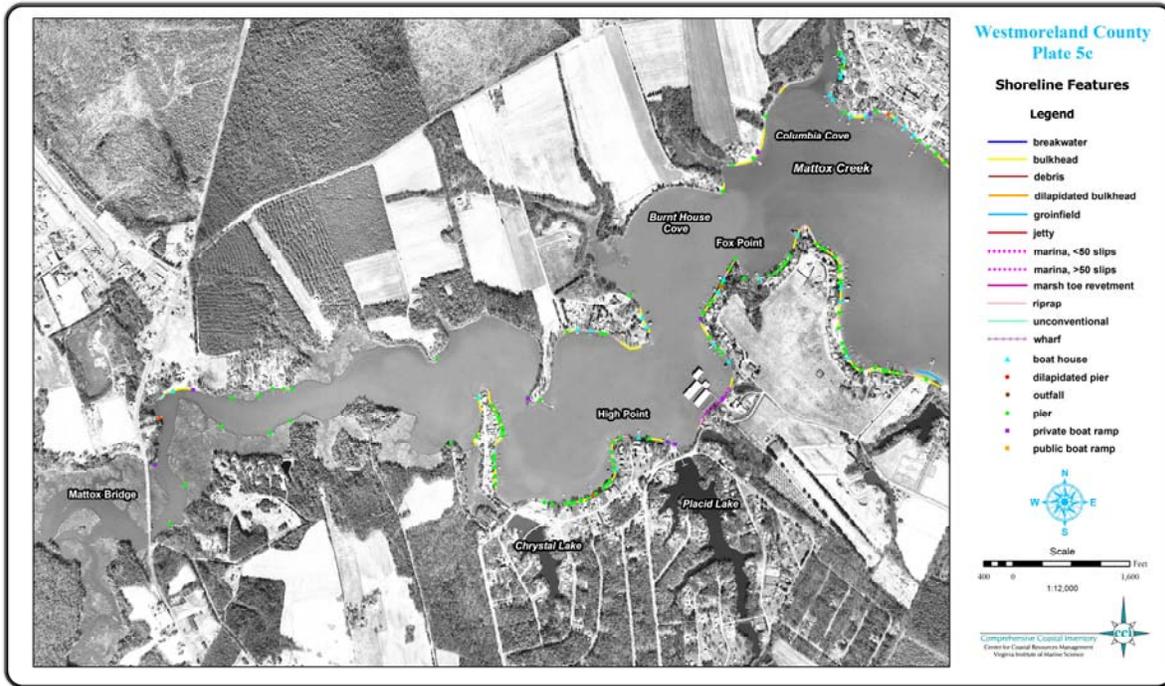
Figure 6. Map illustrating shoreline features for plate 5 in Westmoreland County
