Water Quality Assessment Report

**Chesterfield County Airport (FCI) Environmental Assessment
Perennial Stream Determination and Resource Protection Area
Designation**

**Prepared By
Matt Neely
Mill Creek Environmental Consultants, Ltd
For
Chesterfield County Water Quality**

28 August 2013

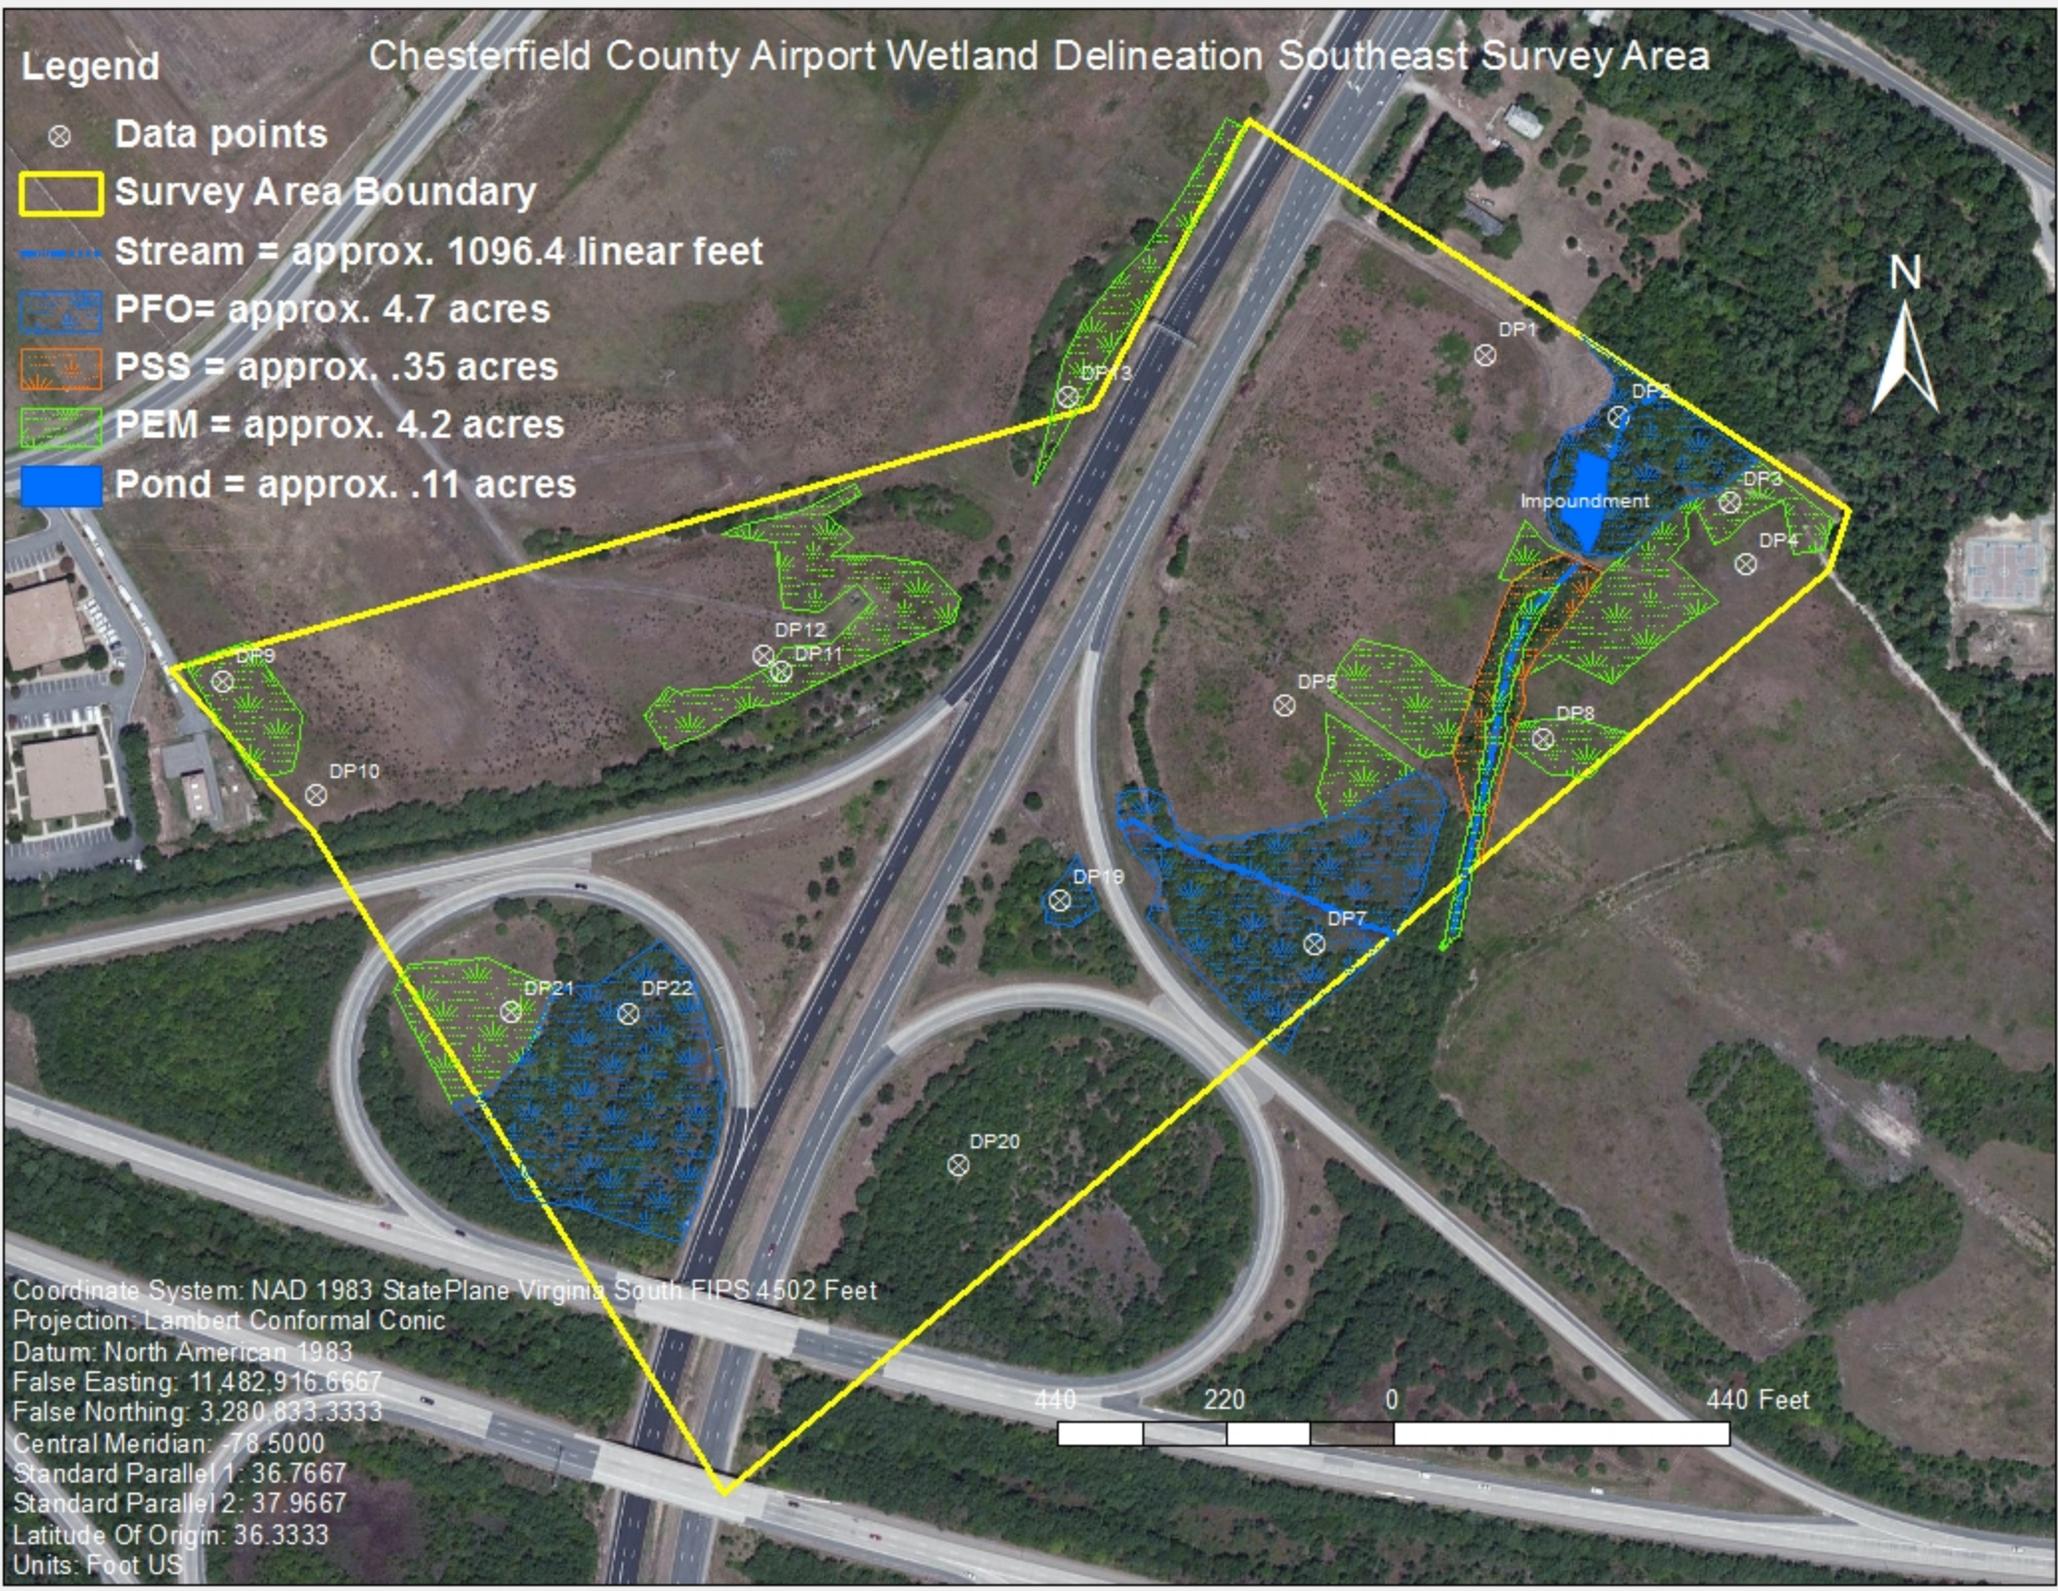
Chesterfield County Airport Wetland Delineation Southeast Survey Area

- ⊗ Data points
- ▭ Survey Area Boundary
- Stream = approx. 1096.4 linear feet
- ▭ PFO = approx. 4.7 acres
- ▭ PSS = approx. .35 acres
- ▭ PEM = approx. 4.2 acres
- ▭ Pond = approx. .11 acres

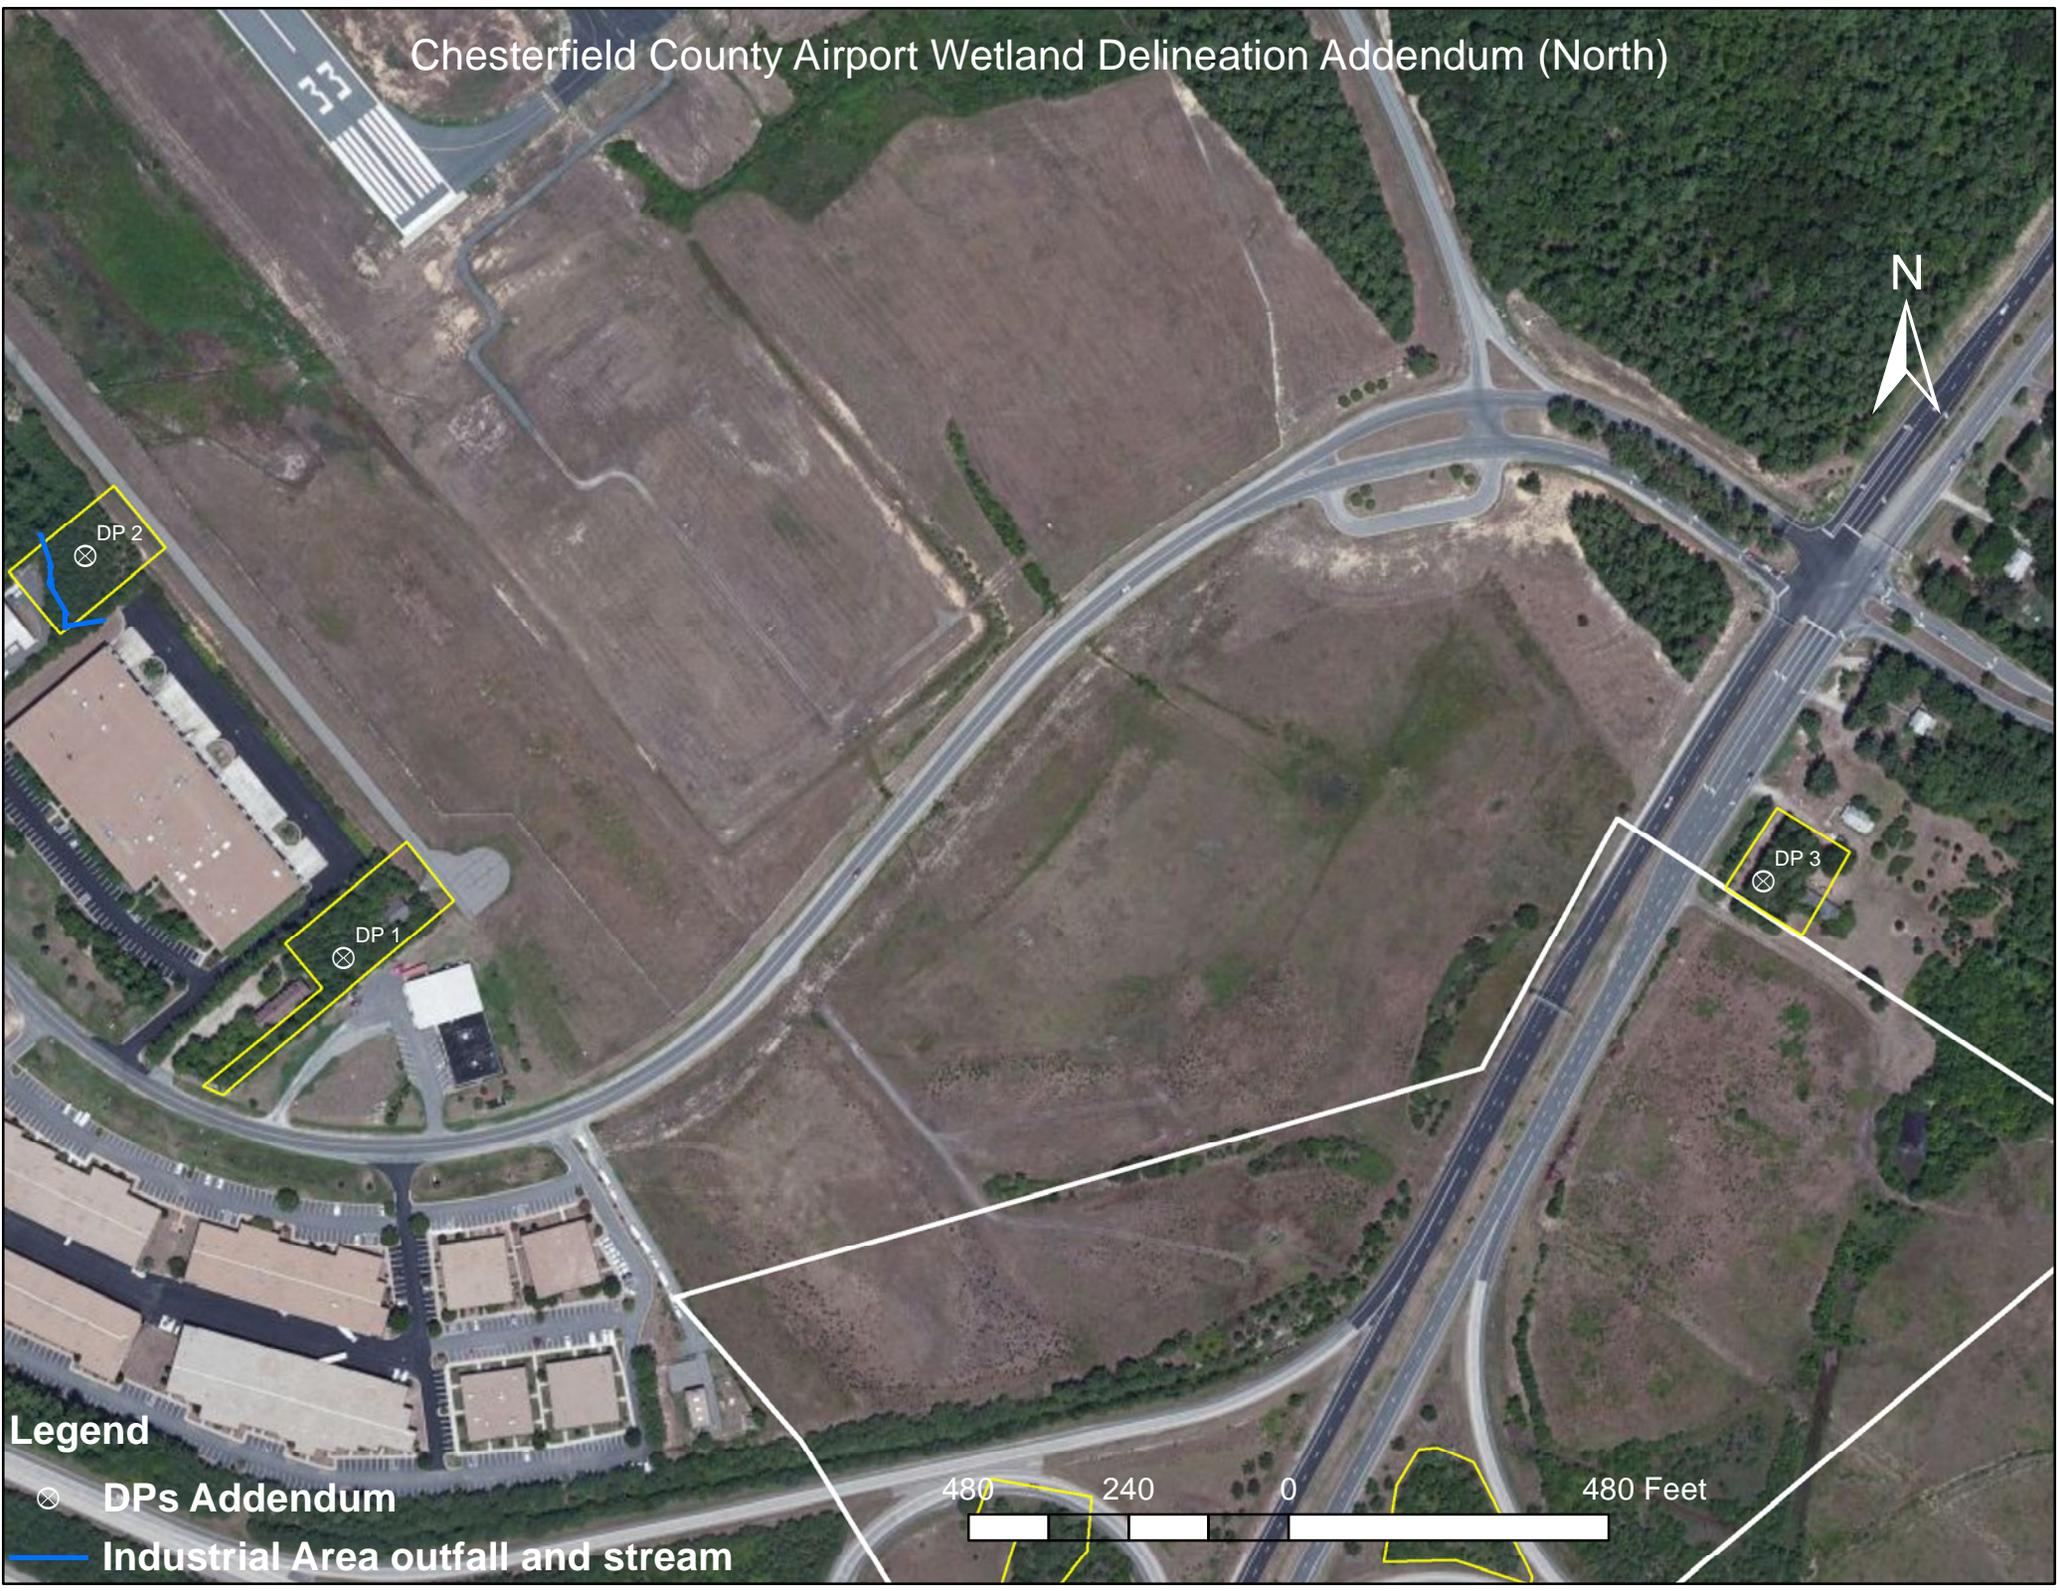
Chesterfield County Airport Wetland Delineation Addendum (North)

- ⊗ DPs Addendum
- Industrial Area outfall and stream

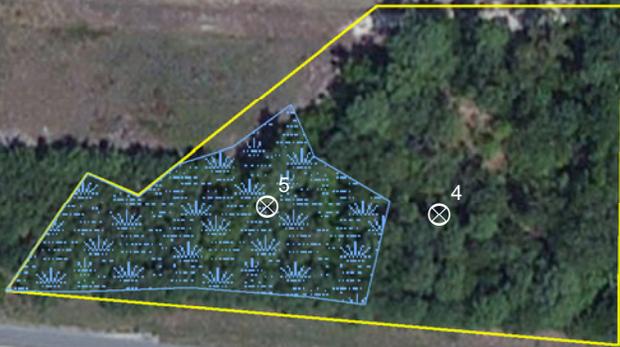
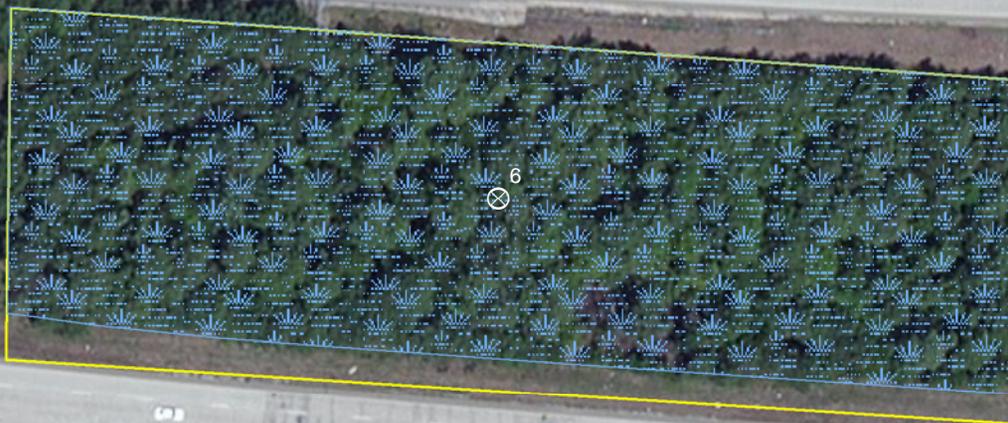
Chesterfield County Airport Wetland Delineation Addendum (East)

Addendum PFO wetlands

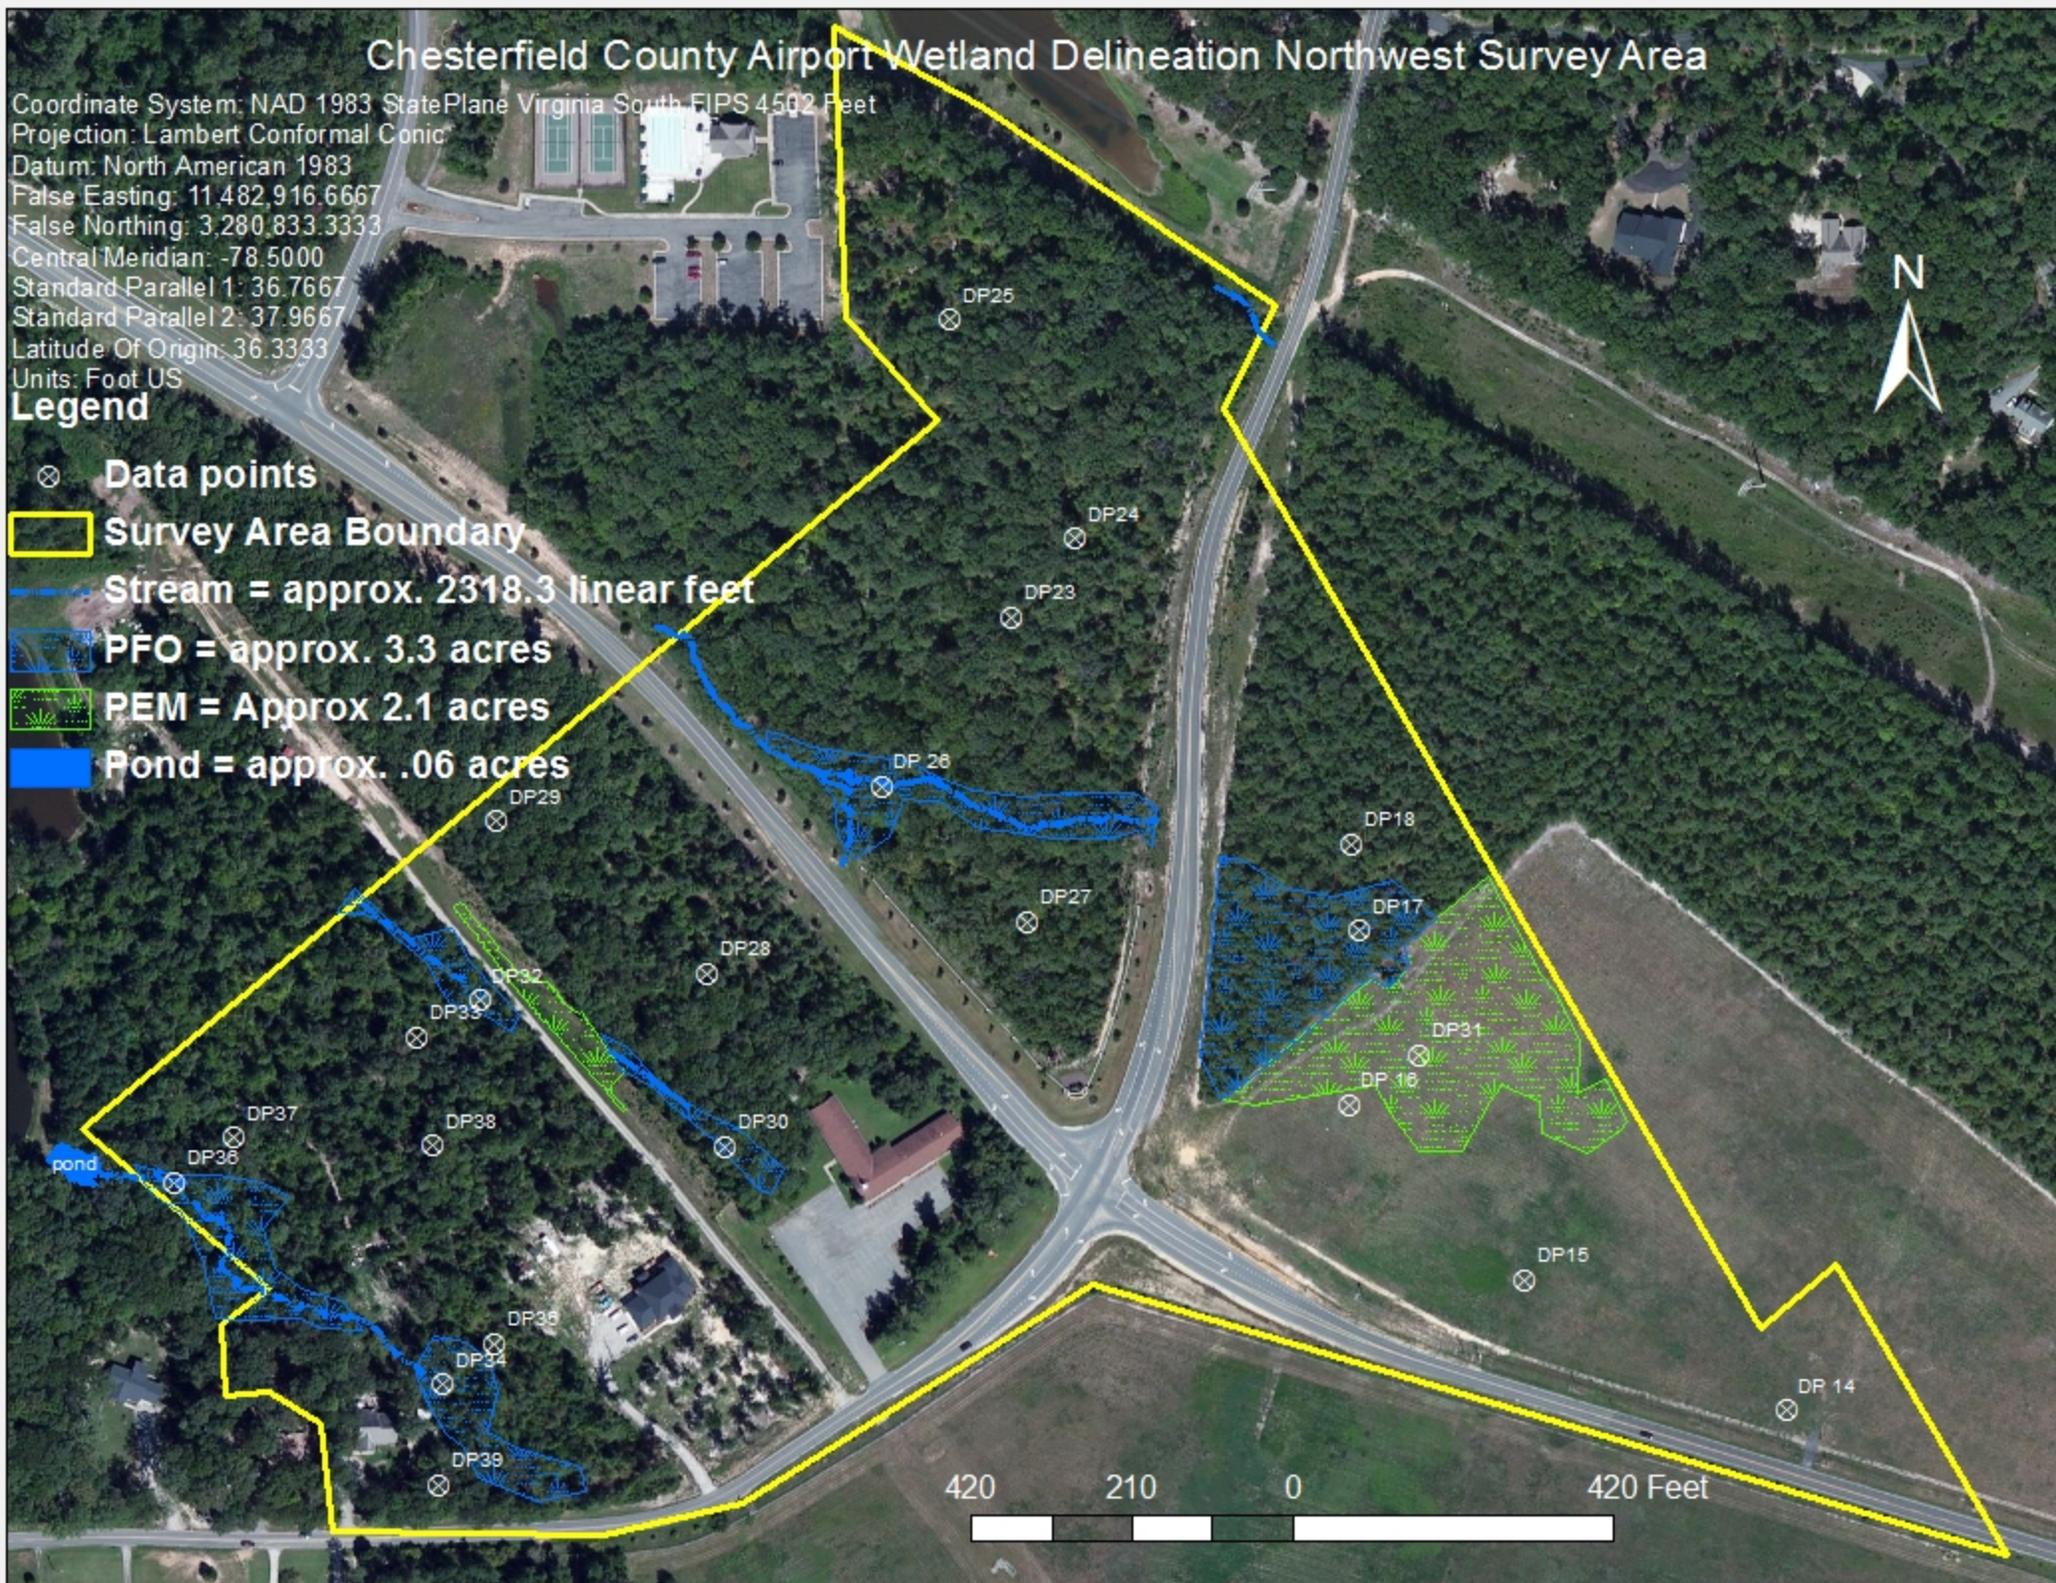
Chesterfield County Airport Wetland Delineation Northwest Survey Area

- ⊗ Data points
- ▭ Survey Area Boundary
- Stream = approx. 2318.3 linear feet
- ▭ PFO = approx. 3.3 acres
- ▭ PEM = Approx 2.1 acres
- ▭ Pond = approx. .06 acres

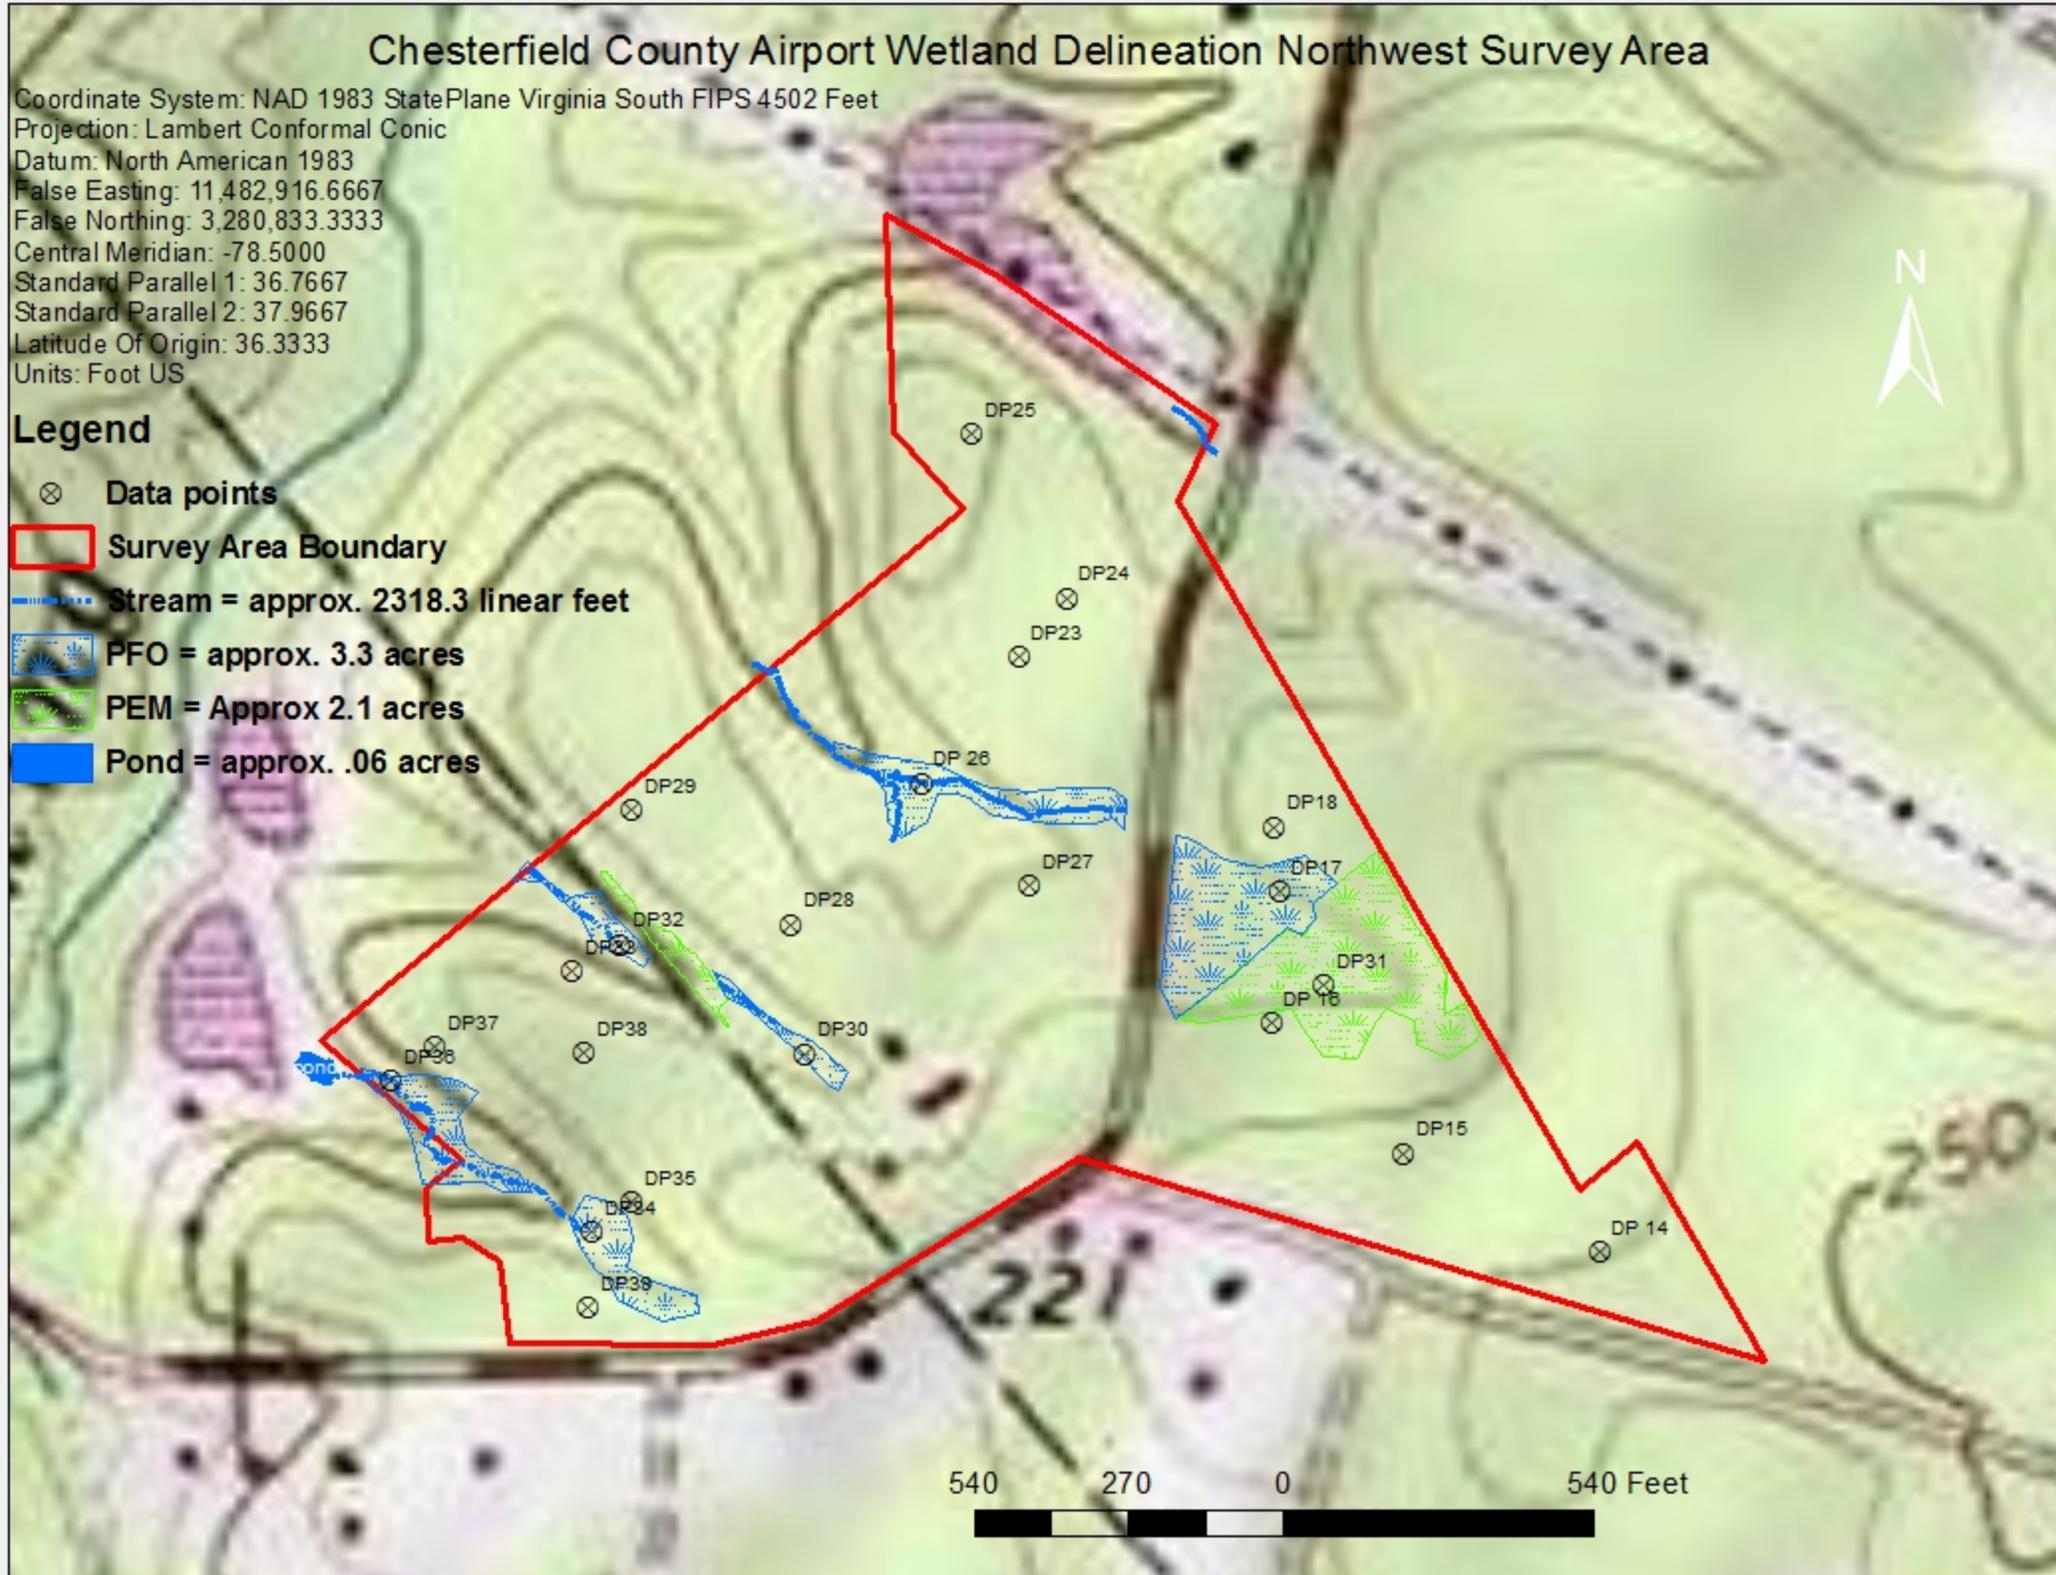
Chesterfield County Airport Stream Assessment Reaches (NW)

- ⊗ Data points
- ▭ Survey Area Boundary
- Stream = approx. 2318.3 linear feet
- ▭ PFO = approx. 3.3 acres
- ▭ PEM = Approx 2.1 acres
- ▭ Pond = approx. .06 acres

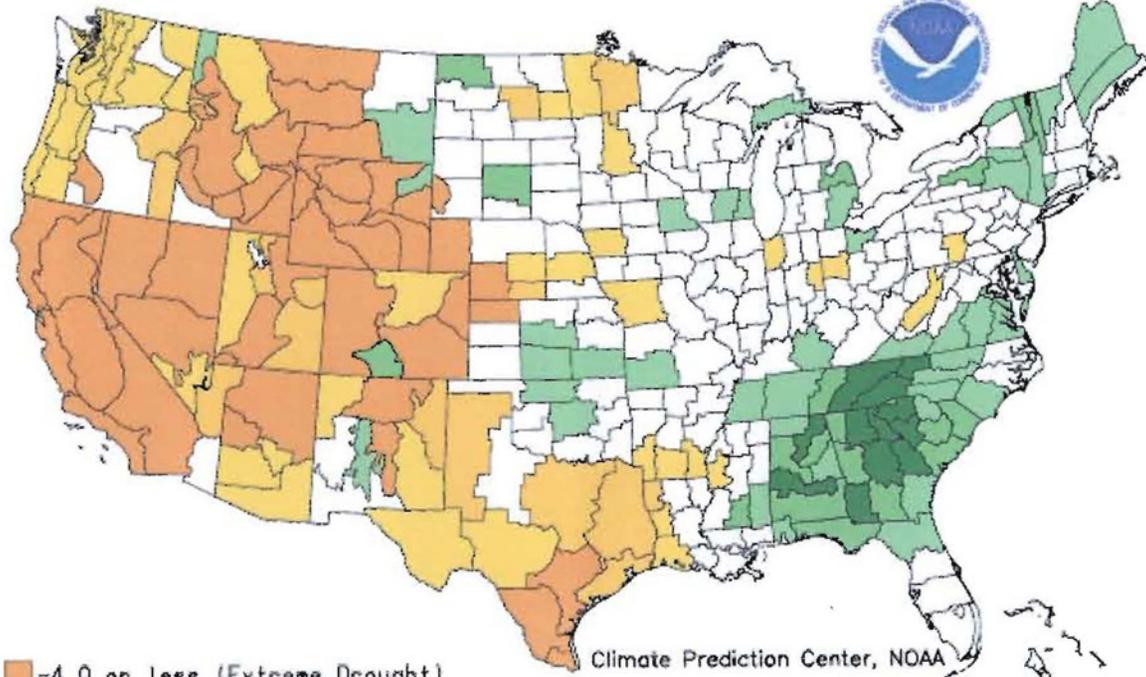
Drought Severity Index by Division
Weekly Value for Period Ending AUG 24, 2013
Long Term Palmer

| ■ -4.0 or less (Extreme Drought) | ■ +2.0 to +2.9 (Unusual Moist Spell) |
| ■ -3.0 to -3.9 (Severe Drought) | ■ +3.0 to +3.9 (Very Moist Spell) |
| ■ -2.0 to -2.9 (Moderate Drought) | ■ +4.0 and above (Extremely Moist) |

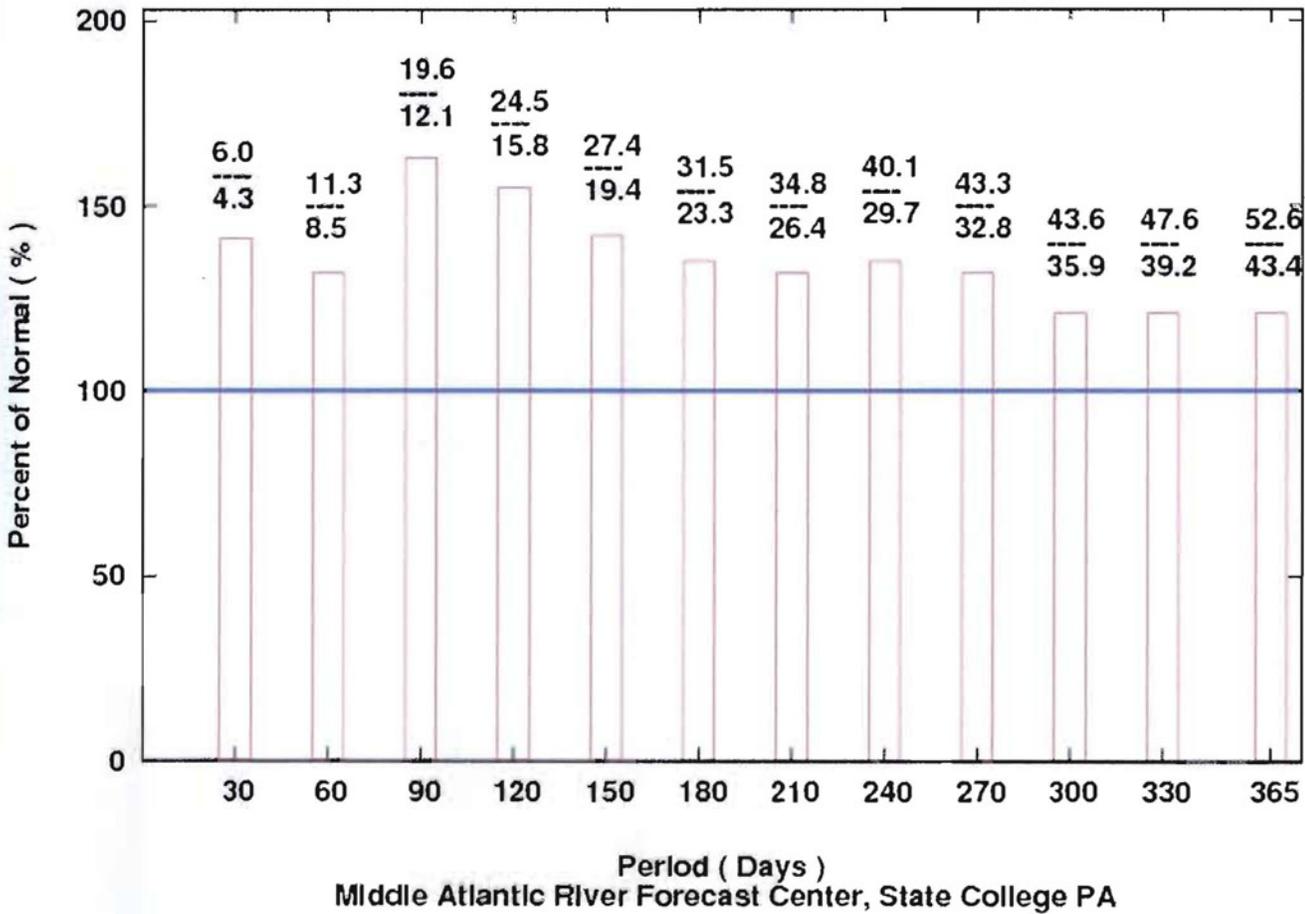
Percent of Normal Barchart for Chesterfield County, VA

Percent of Normal for Chesterfield County, VA ----- Ending August 26, 2013

Starting Date	Ending Date	# of Days	Actual Pcpn	Normal Pcpn	Surplus / Deficit	% of Normal
07/28/13	08/26/13	30	6.0	4.3	1.8	141
06/28/13	08/26/13	60	11.3	8.5	2.8	132
05/29/13	08/26/13	90	19.6	12.1	7.6	163
04/29/13	08/26/13	120	24.5	15.8	8.7	155
03/30/13	08/26/13	150	27.4	19.4	8.0	142
02/28/13	08/26/13	180	31.5	23.3	8.2	135
01/29/13	08/26/13	210	34.8	26.4	8.4	132
12/30/12	08/26/13	240	40.1	29.7	10.4	135
11/30/12	08/26/13	270	43.3	32.8	10.5	132
10/31/12	08/26/13	300	43.6	35.9	7.7	121

The North Carolina Division of Water Quality, Identification Methods for the Origins of Intermittent and Perennial Streams, (Version 3.1, Feb. '05) was the Perennial Flow Field Indicator Protocol used for the assessment of all streams within this report. Score sheets and photos for these streams can be found in this report in Appendix F. The Stream assessments began at approximately 0900 on Monday, 26 August 2013. The weather was mostly sunny with a temperature in the low 70s at the start of the evaluation and mid 80s when the assessments were complete. The date of last rainfall was 24 August 2013. The Palmer Drought Severity Index Conditions (Weekly Value for Period Ending Aug 24, 2013) is +2.0 to +2.9, classified as Unusual Moist Spell. Additionally, Chesterfield County has experienced above normal precipitation over the course of the past year. Precipitation data from NOAA's Mid Atlantic River Forecast Center shows that from the period of 27 August 2012 to 26 August 2013, the county is at 141% of normal. Climate data can be found in Appendix E.

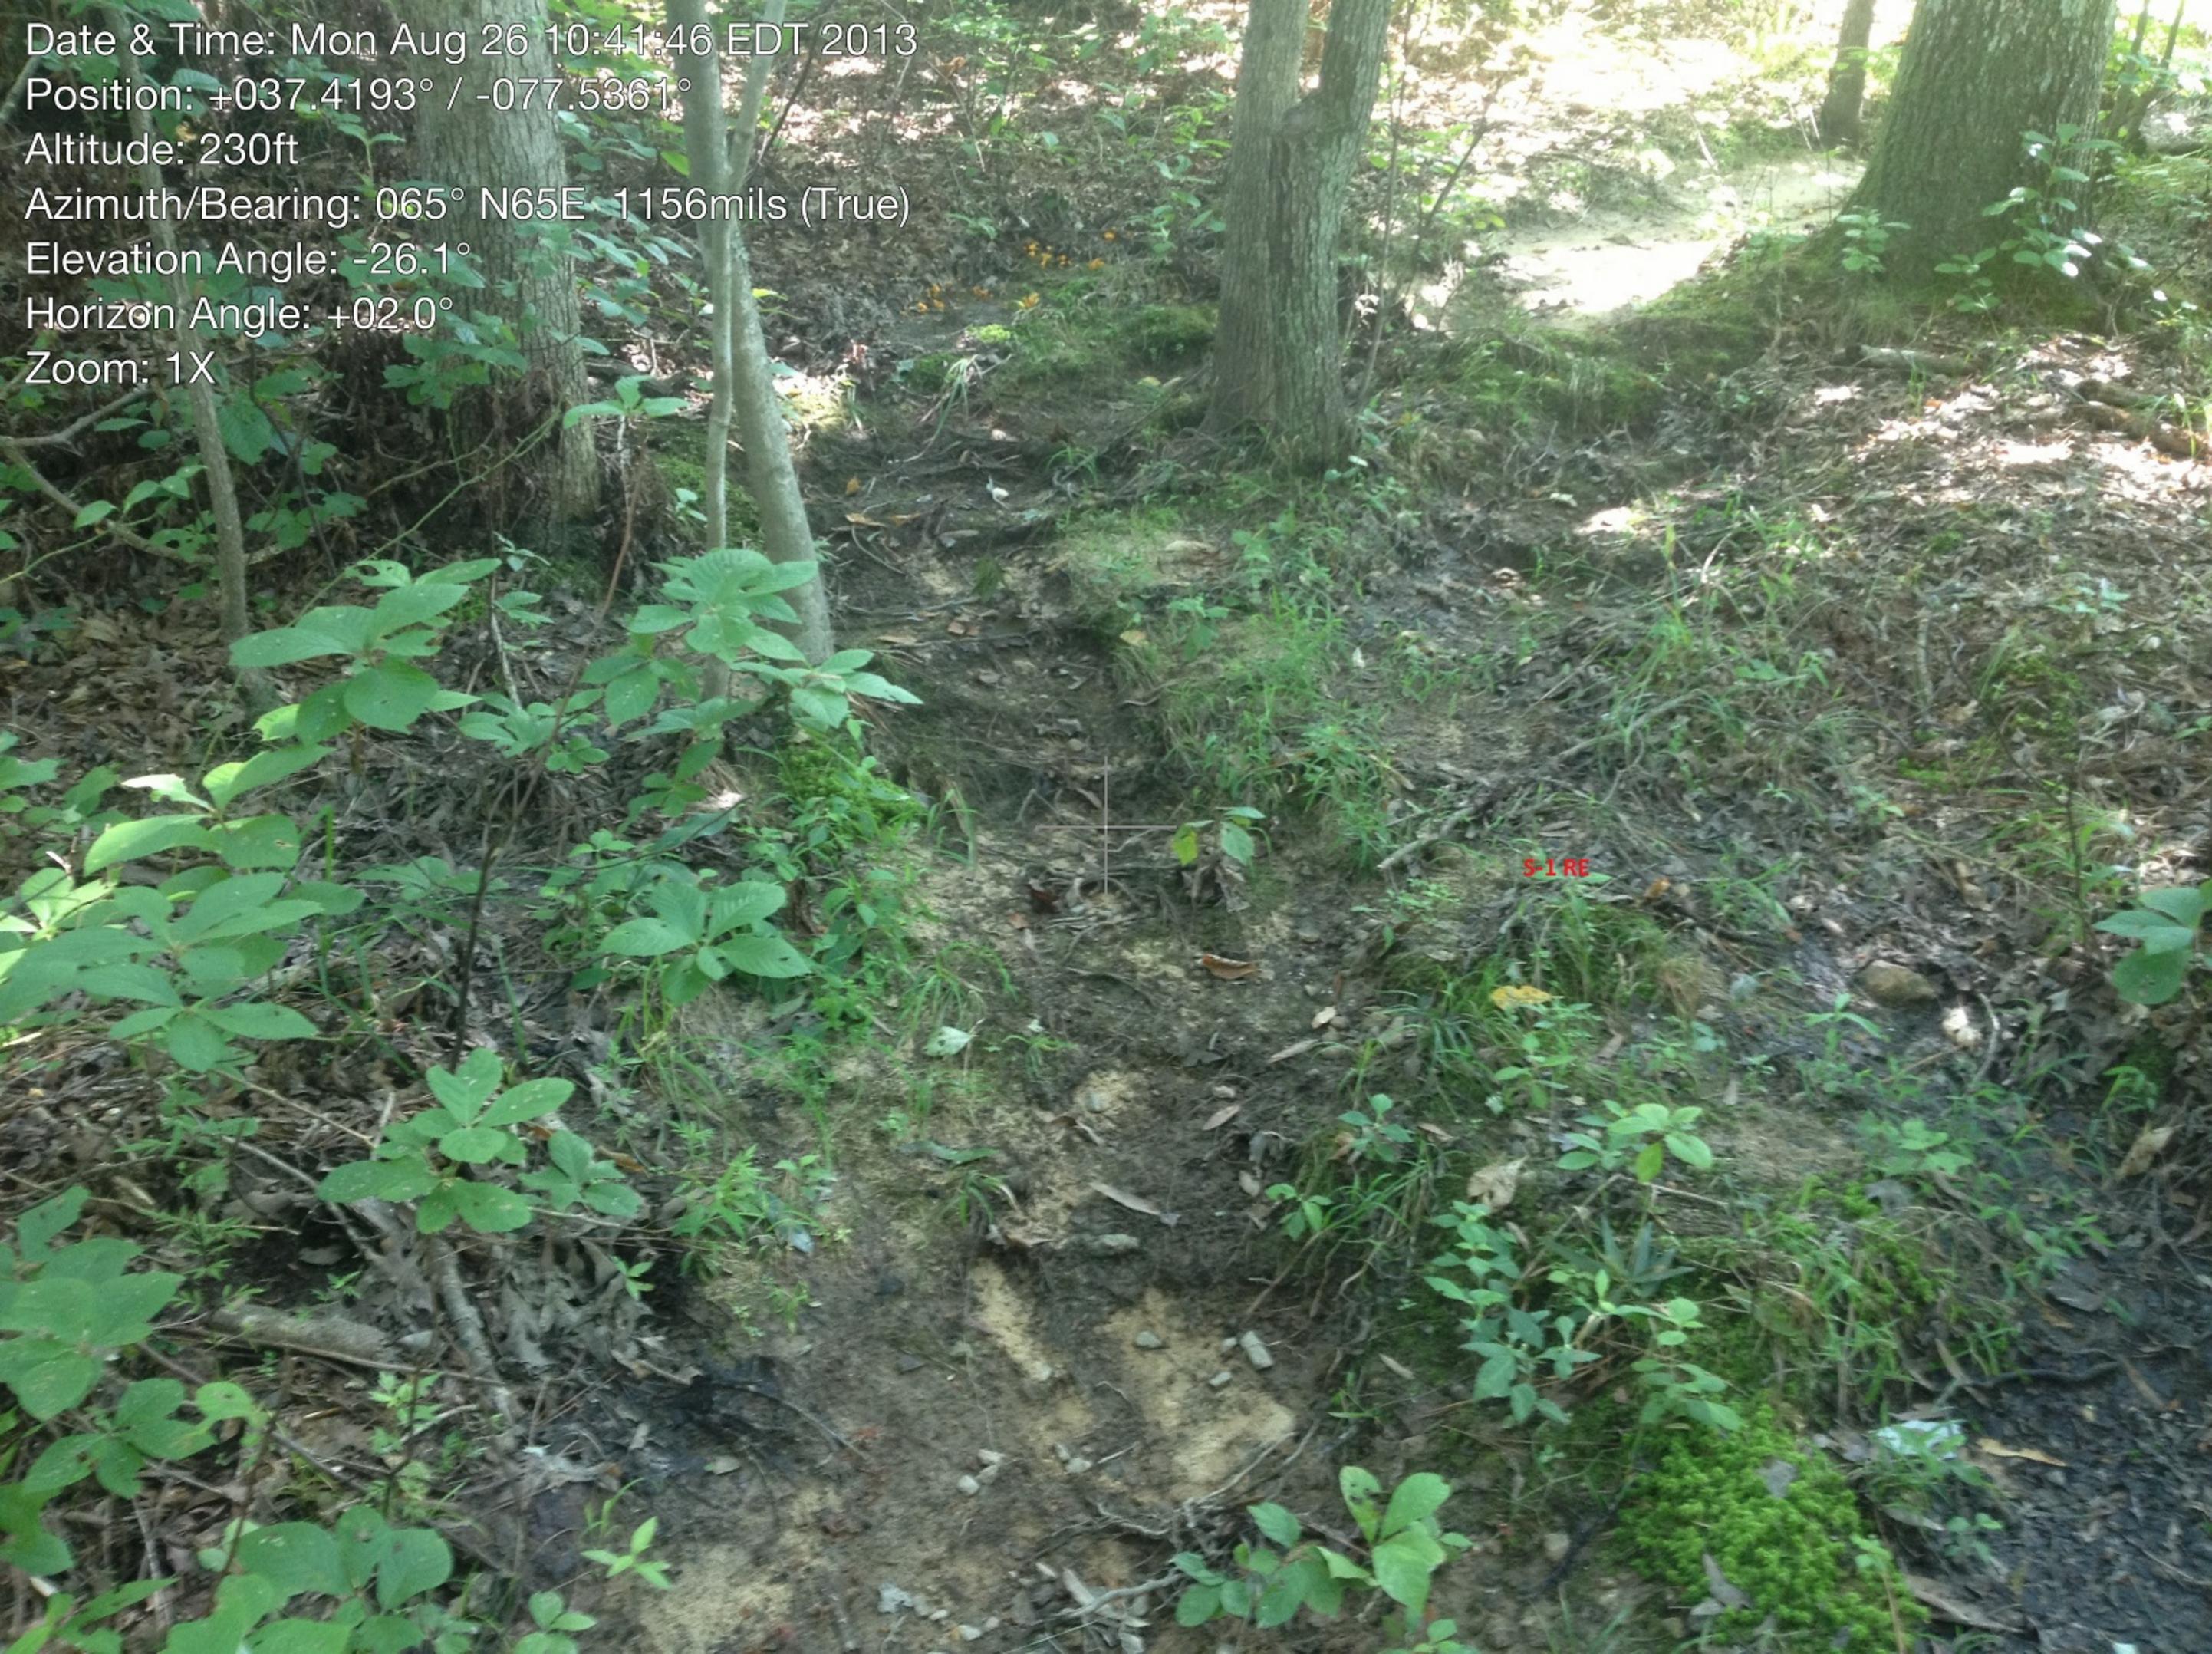
Stream reach one (1) is broken up into two different sections. The upper portion of the segment, named S-1 RE, is approximately 293± linear feet of ephemeral stream segment that originates at a pipe under Belmont Road that serves as a grade control point. This pipe carries storm-water away from areas upstream and on the other side of Belmont Road, down the topographical gradient to the northwest (NW). This segment of the stream ends at a small head cut, where the flow regime changes to intermittent. S-1 RE received a score of **15.75** on the North Carolina Division of Water Quality – Stream Identification Form; Version 3.1. The reach of S-1 was scored on two different sheets, one for the upper ephemeral segment and one for the lower intermittent segment. The photos and score sheet for S-1 RE can be seen in Appendix F.
