Water Quality Assessment Report

**Chesterfield County Airport (FCI) Environmental Assessment
Perennial Stream Determination and Resource Protection Area
Designation**

**Prepared By
Matt Neely
Mill Creek Environmental Consultants, Ltd
For
Chesterfield County Water Quality**

28 August 2013

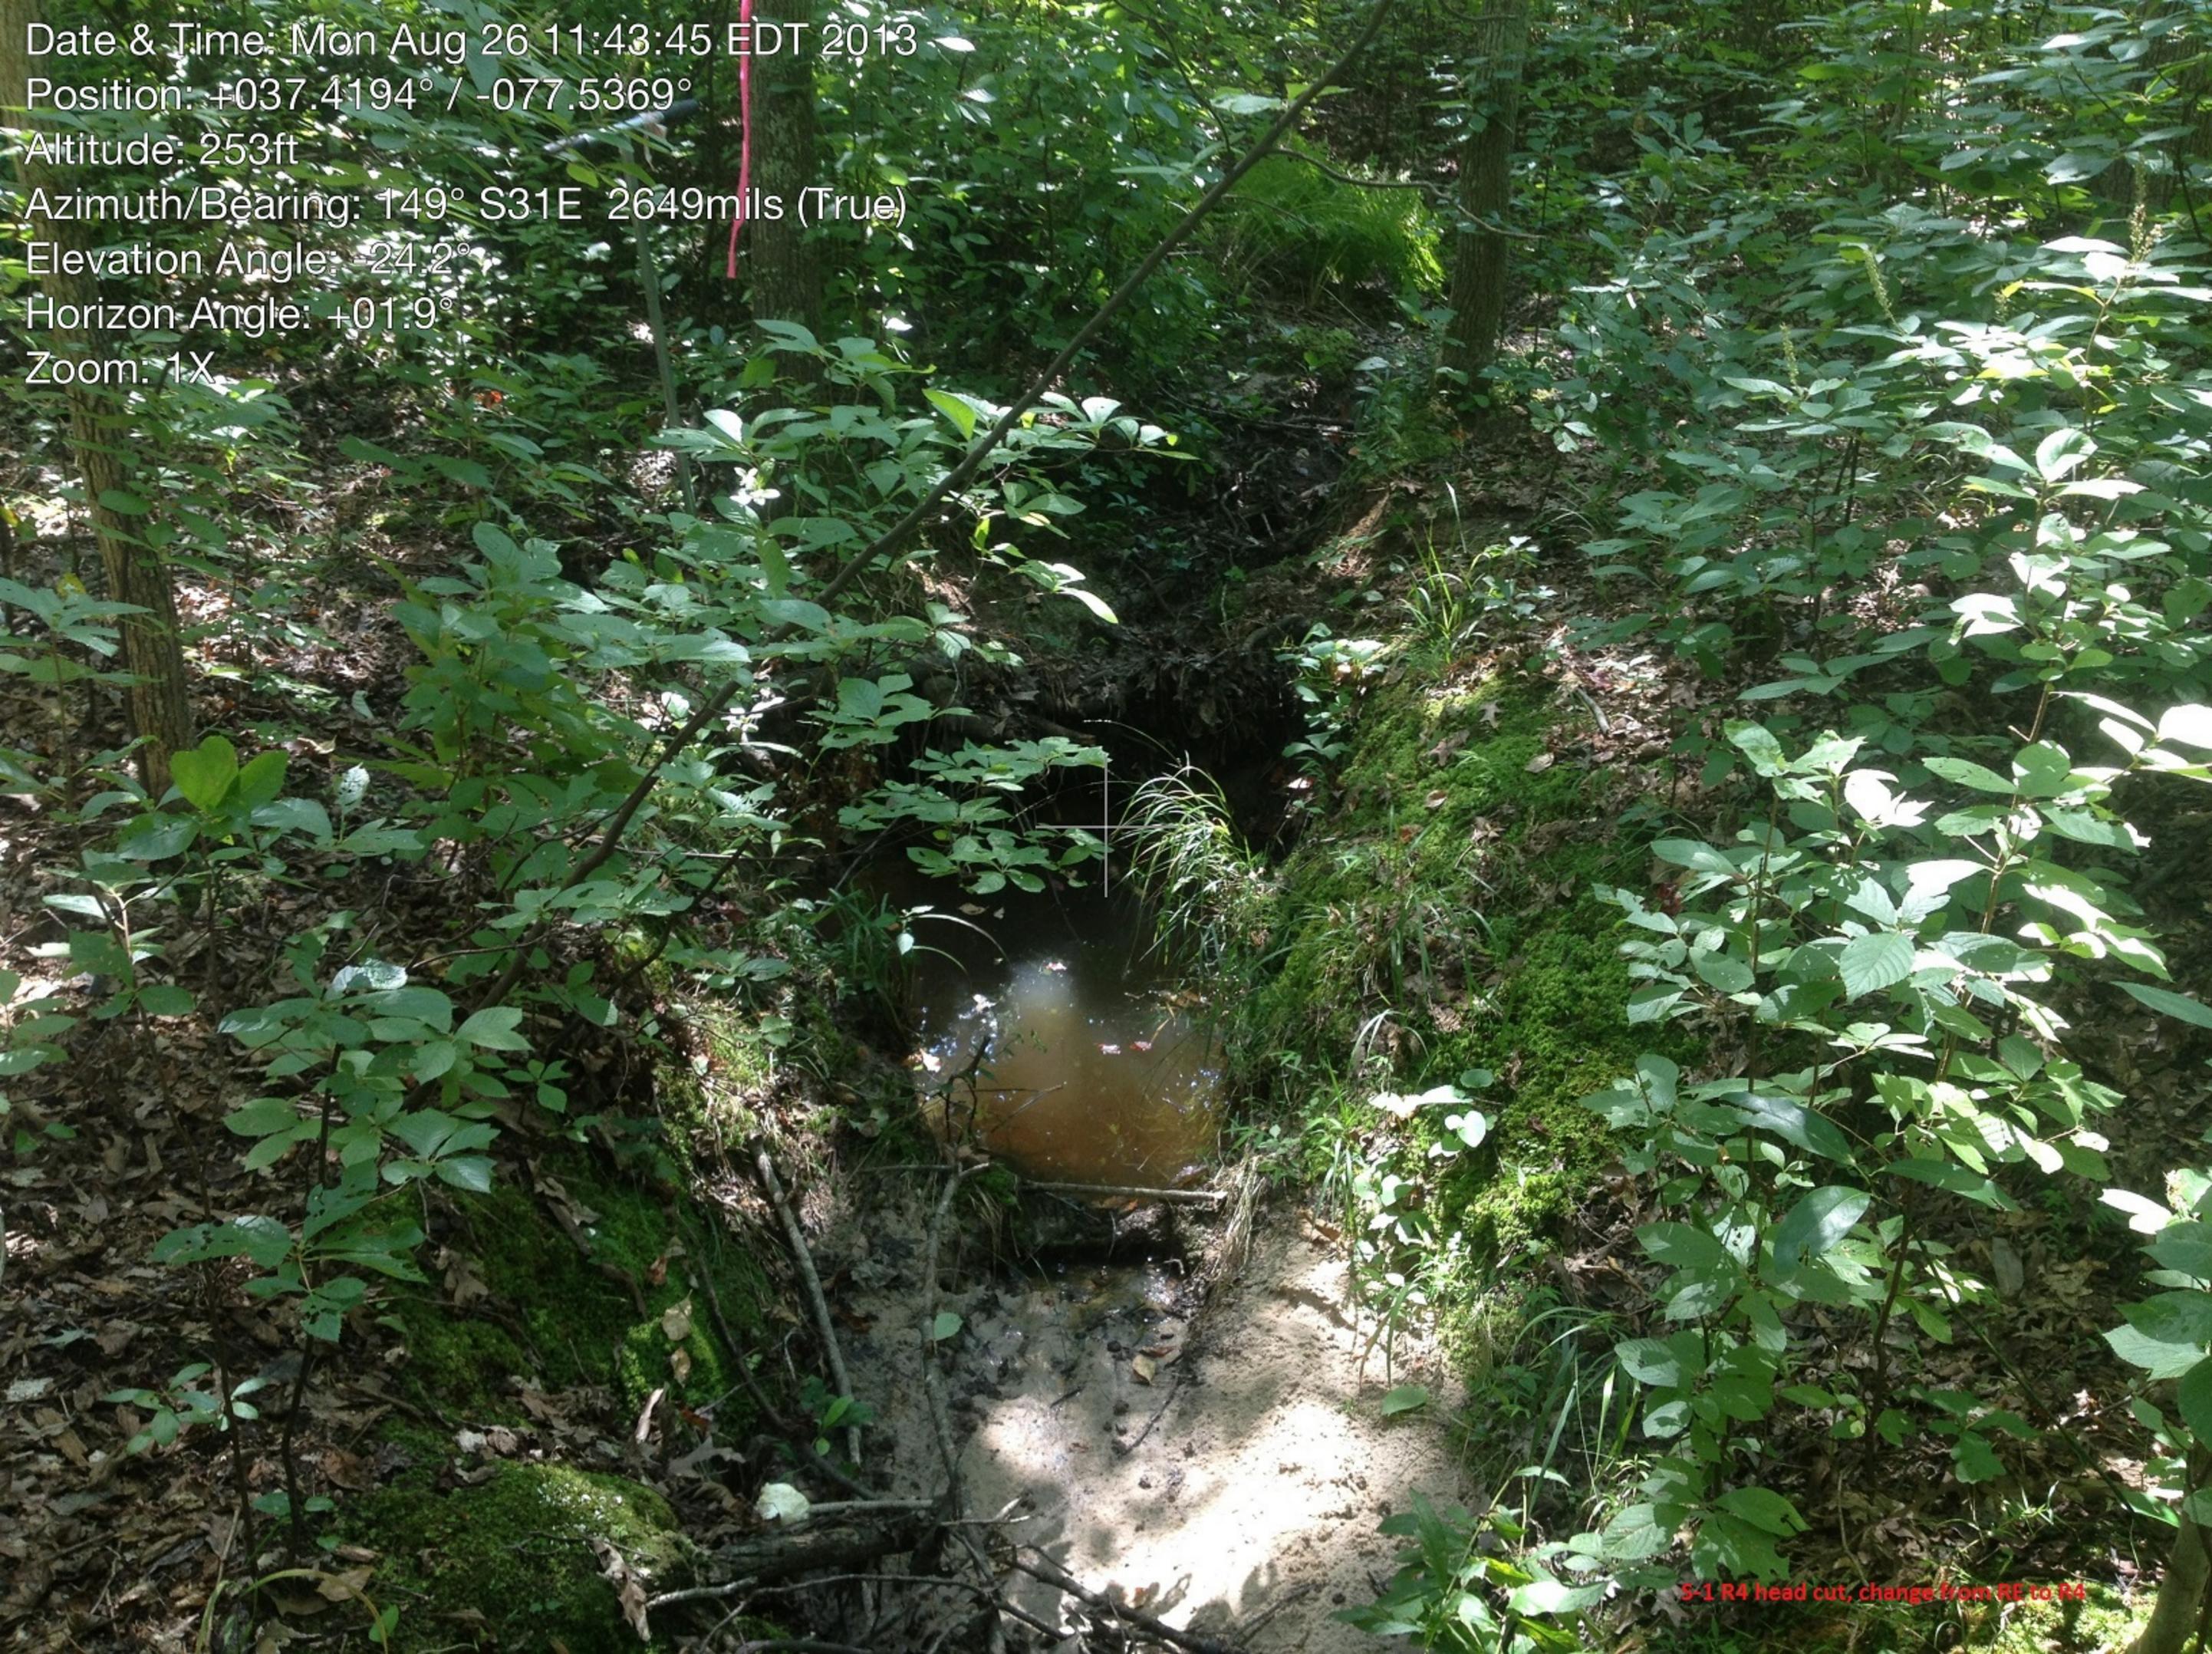
S-1 R4 head cut, change from RE to R4

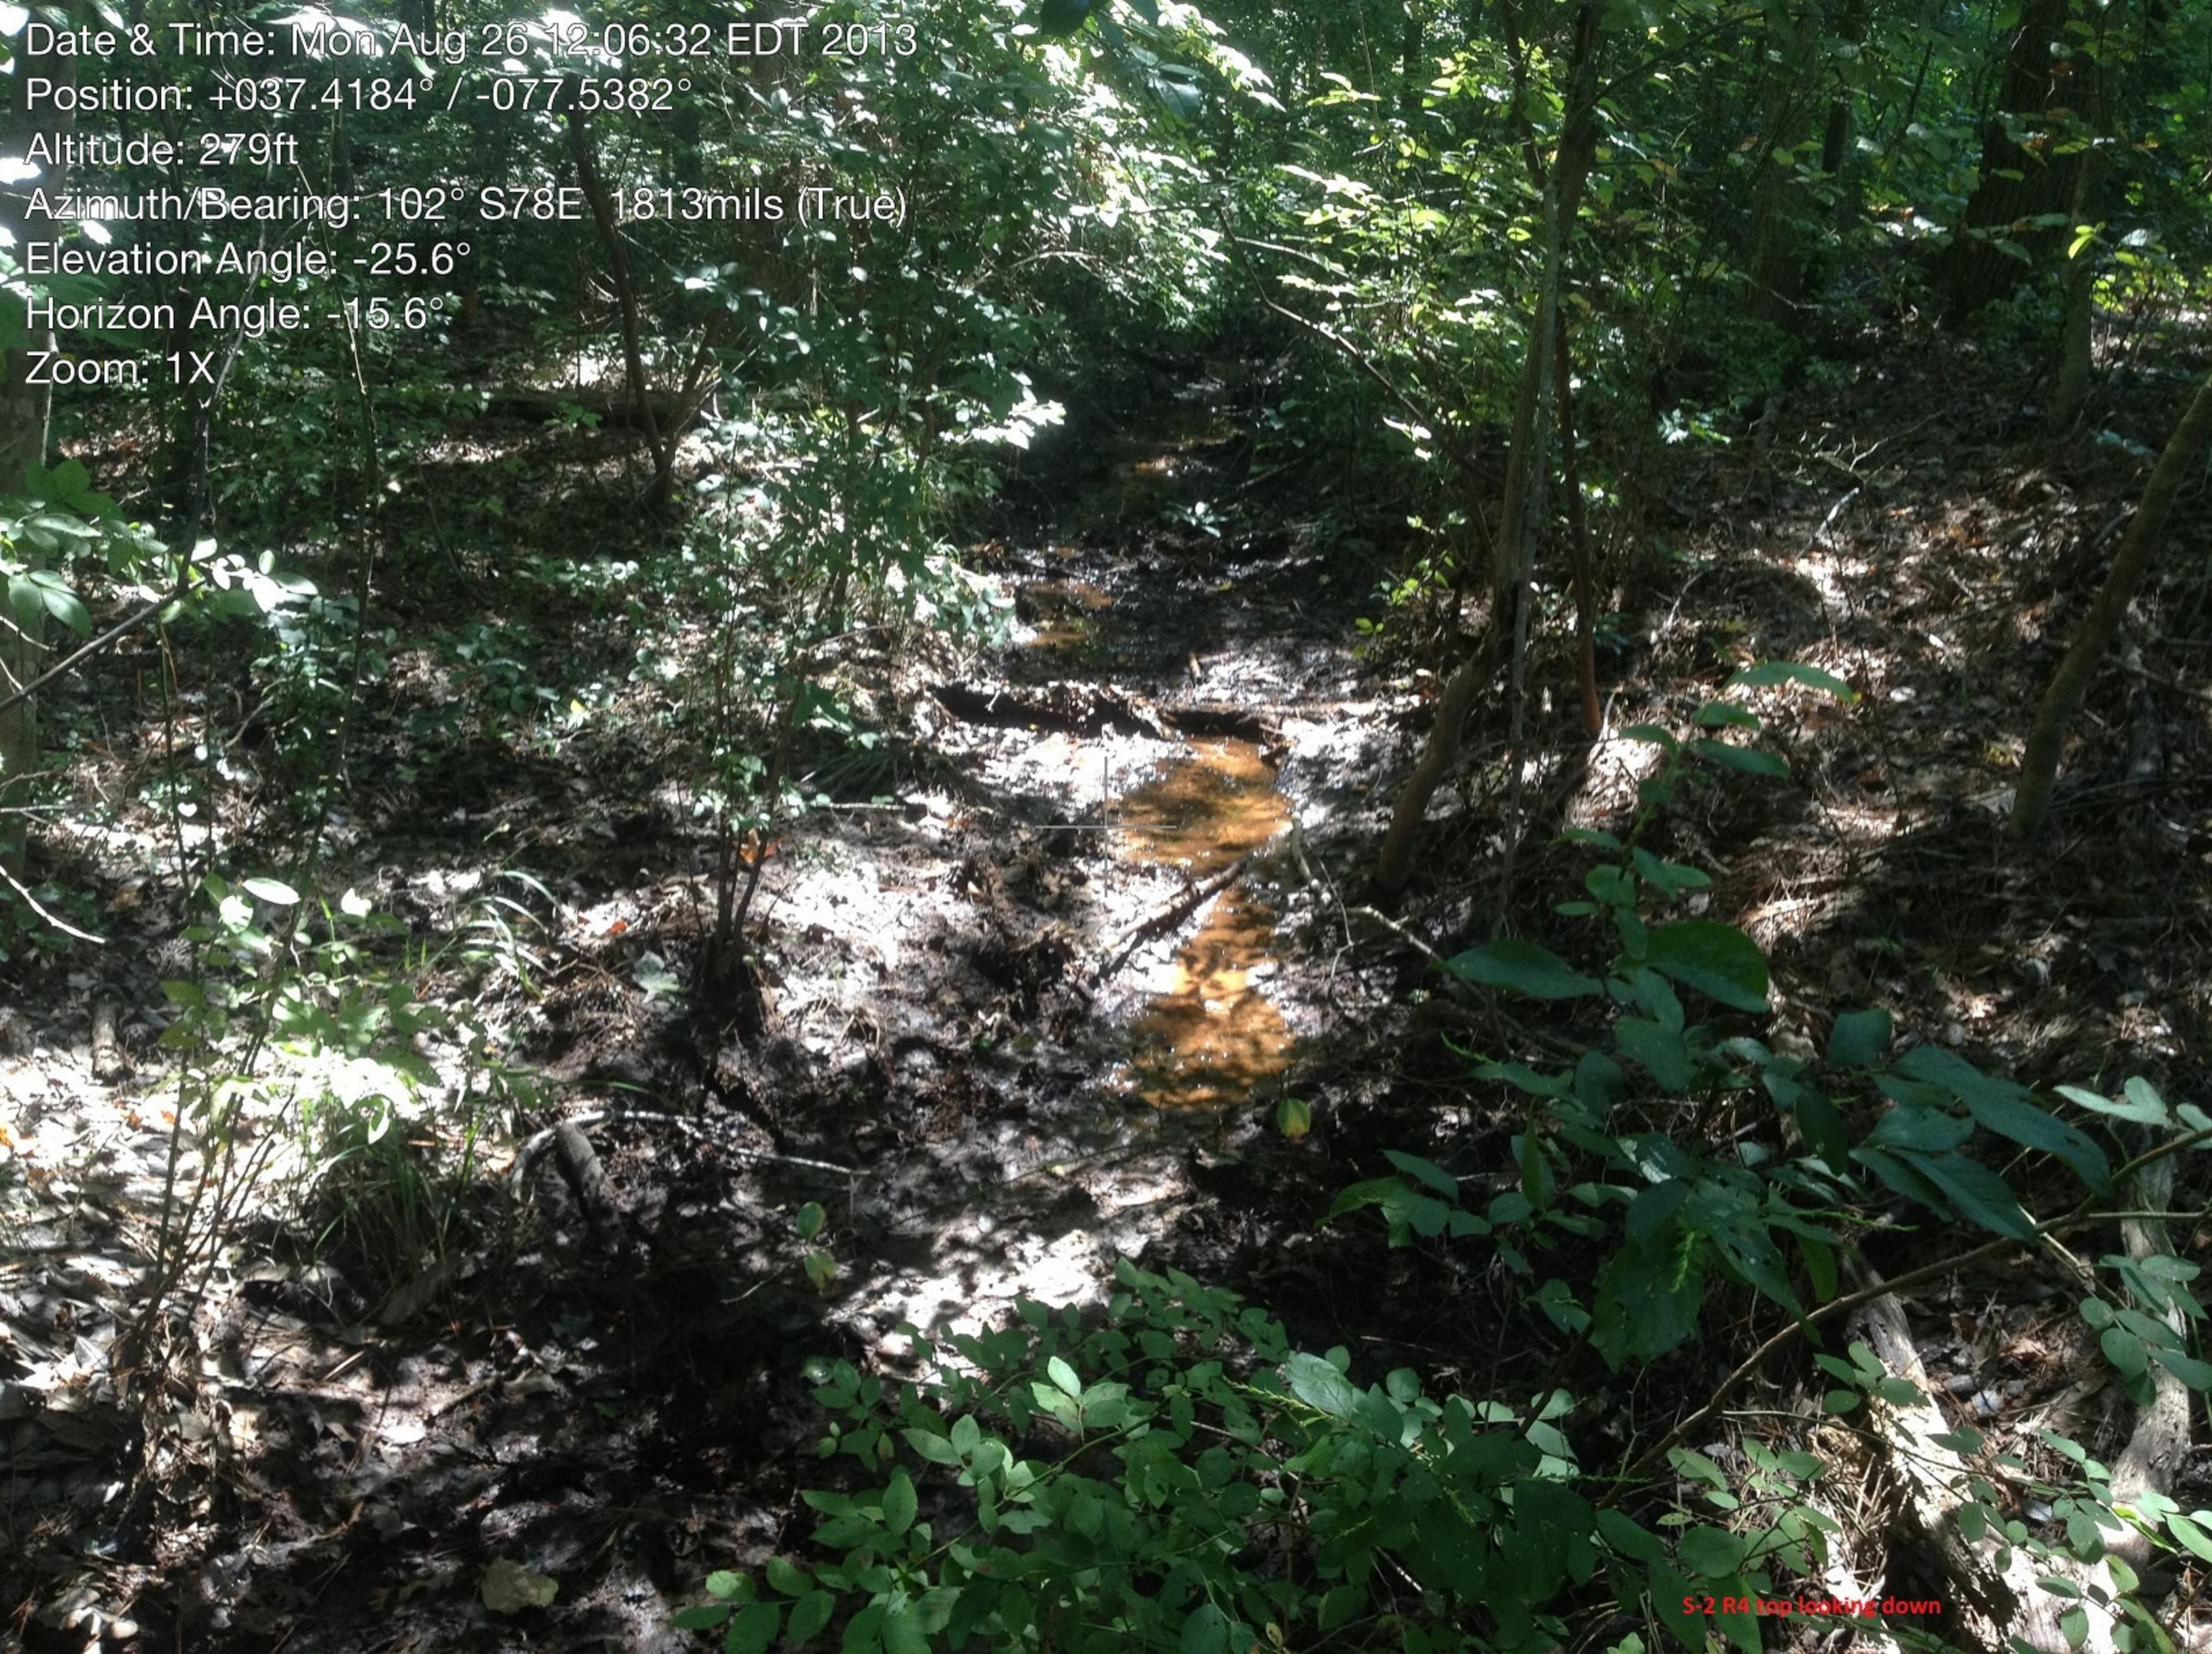
S-2 R4 top looking down

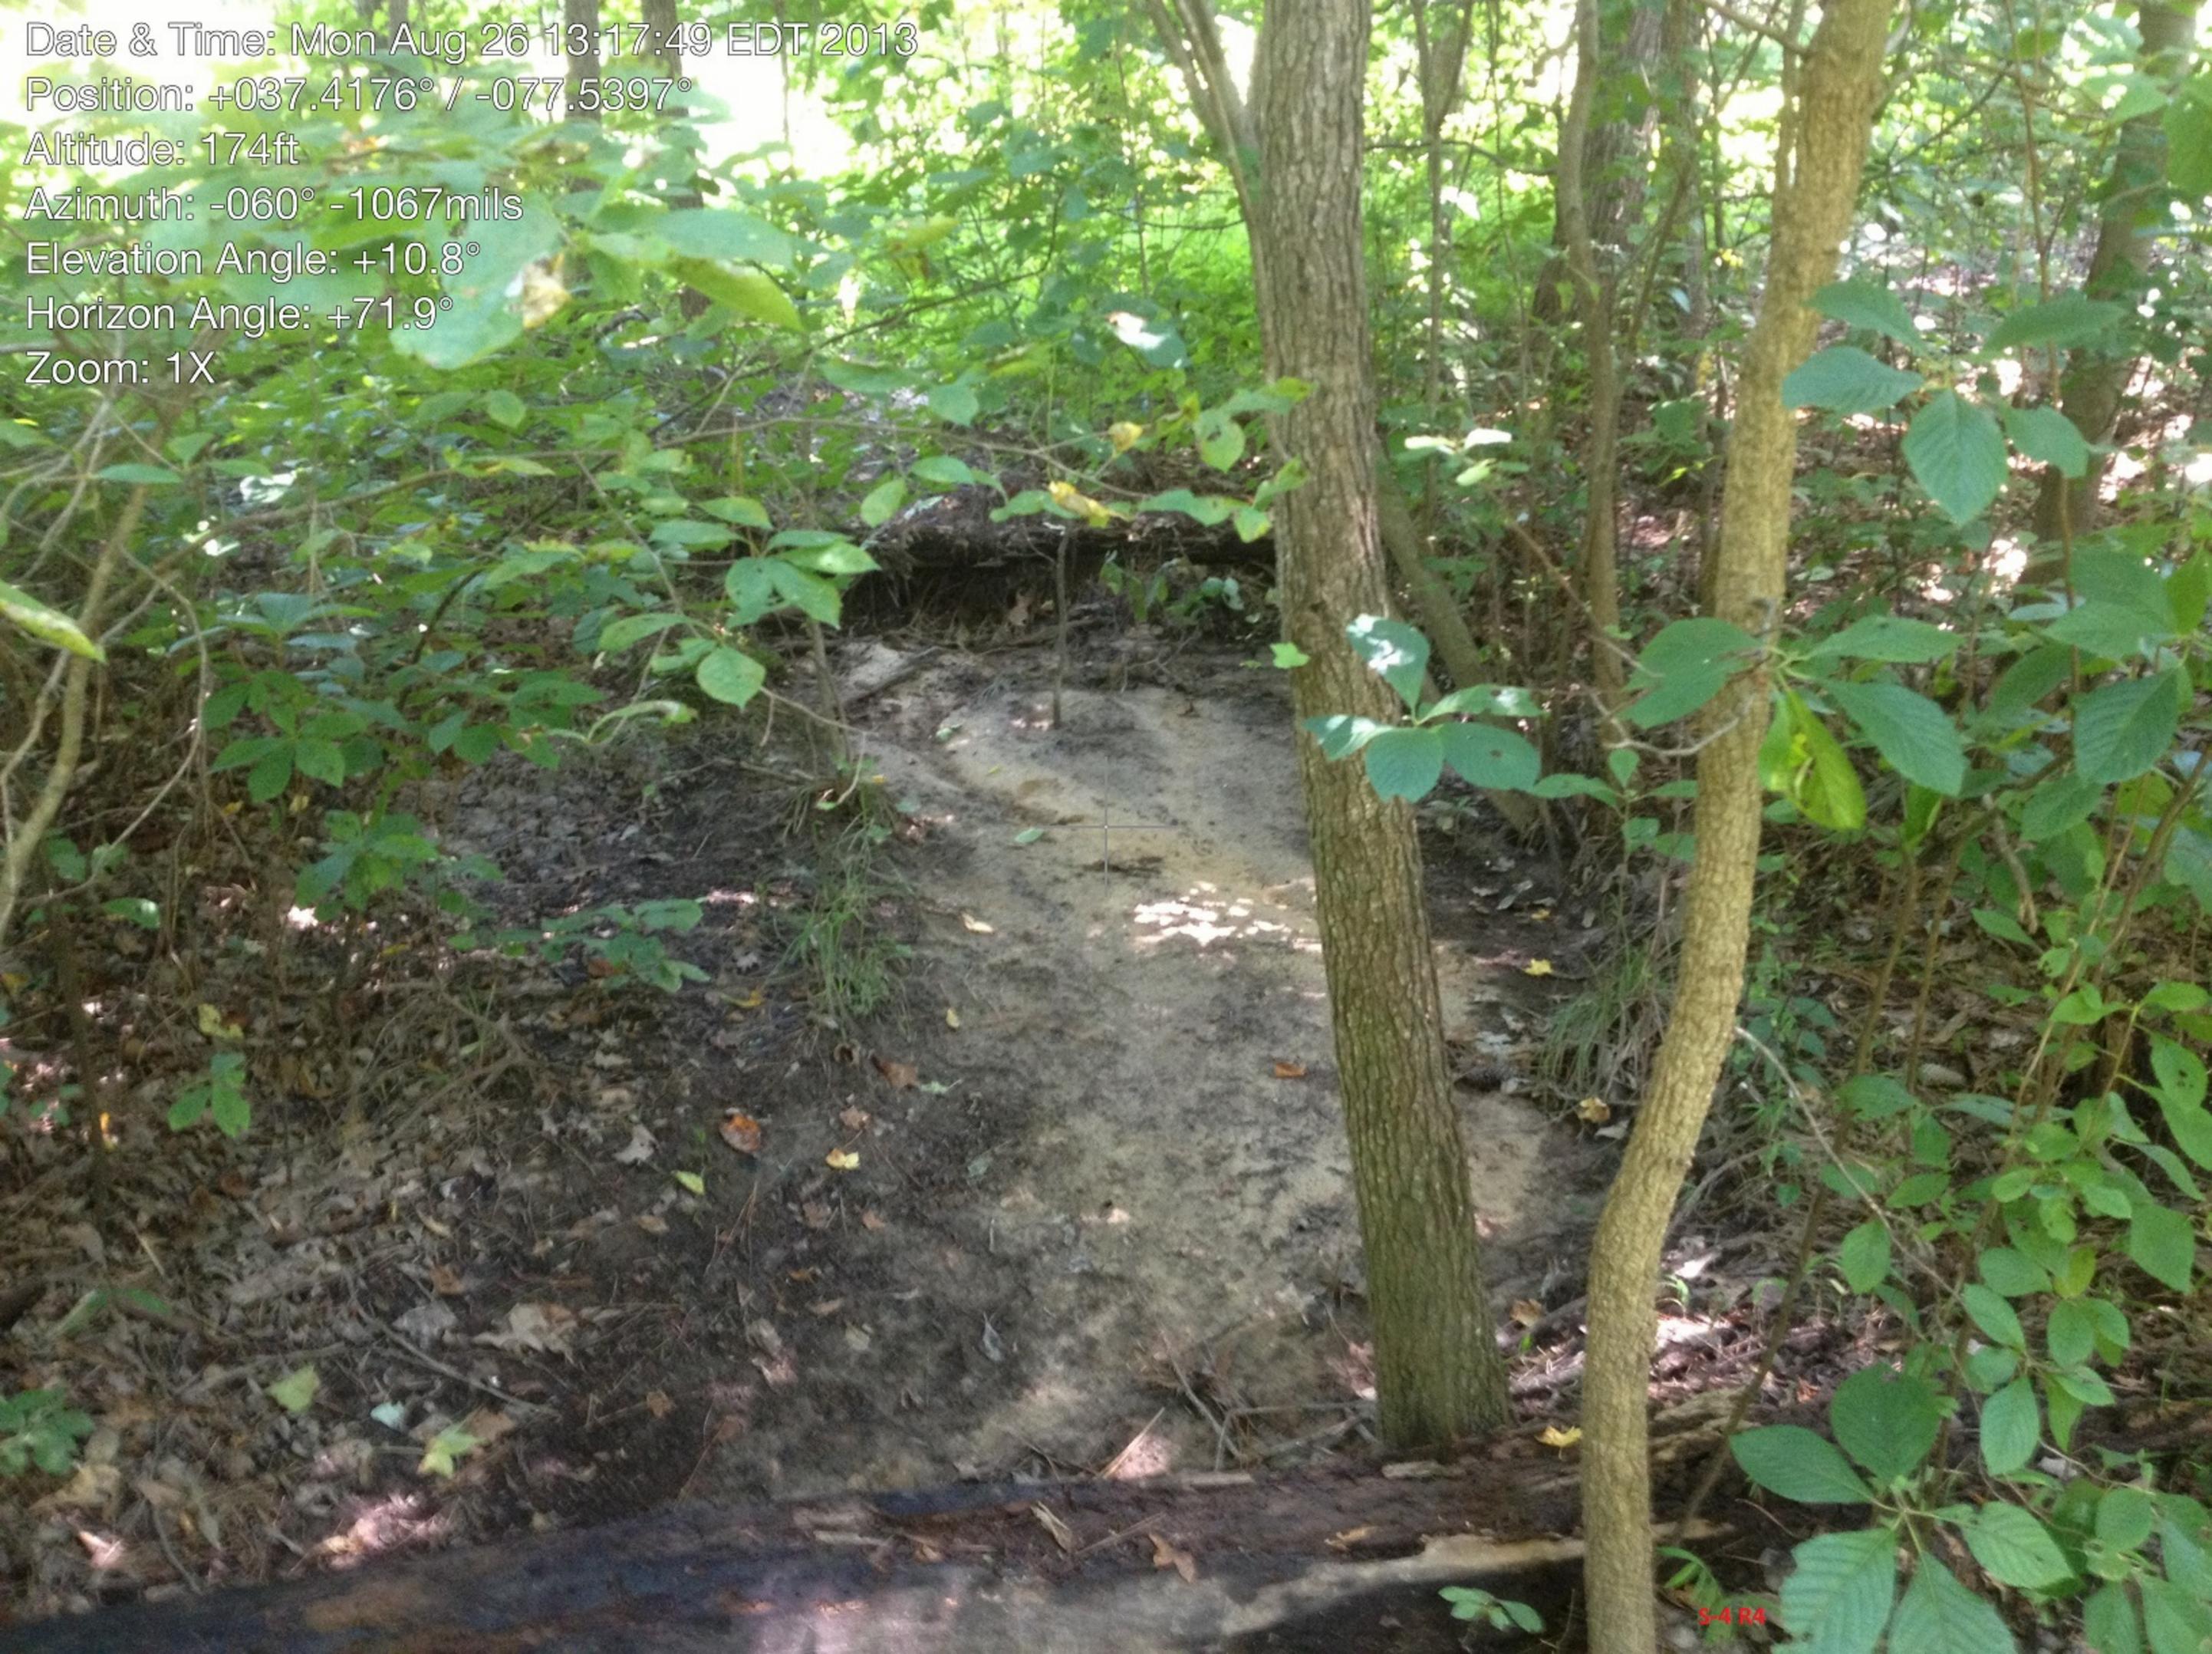
S-4 R4

Date: 26 August 2013	Project: 0040CE	Latitude: N 3677043.285
Evaluator: Matthew Neely	Site: S-4 R4, Belmont/Cogbill	Longitude: W11761755.567
Total Points: 27.25 <i>Stream is at least intermittent if ≥ 19 or perennial if ≥ 30</i>	County: Chesterfield, VA	Other US State Plane , VA South e.g. Quad Name:

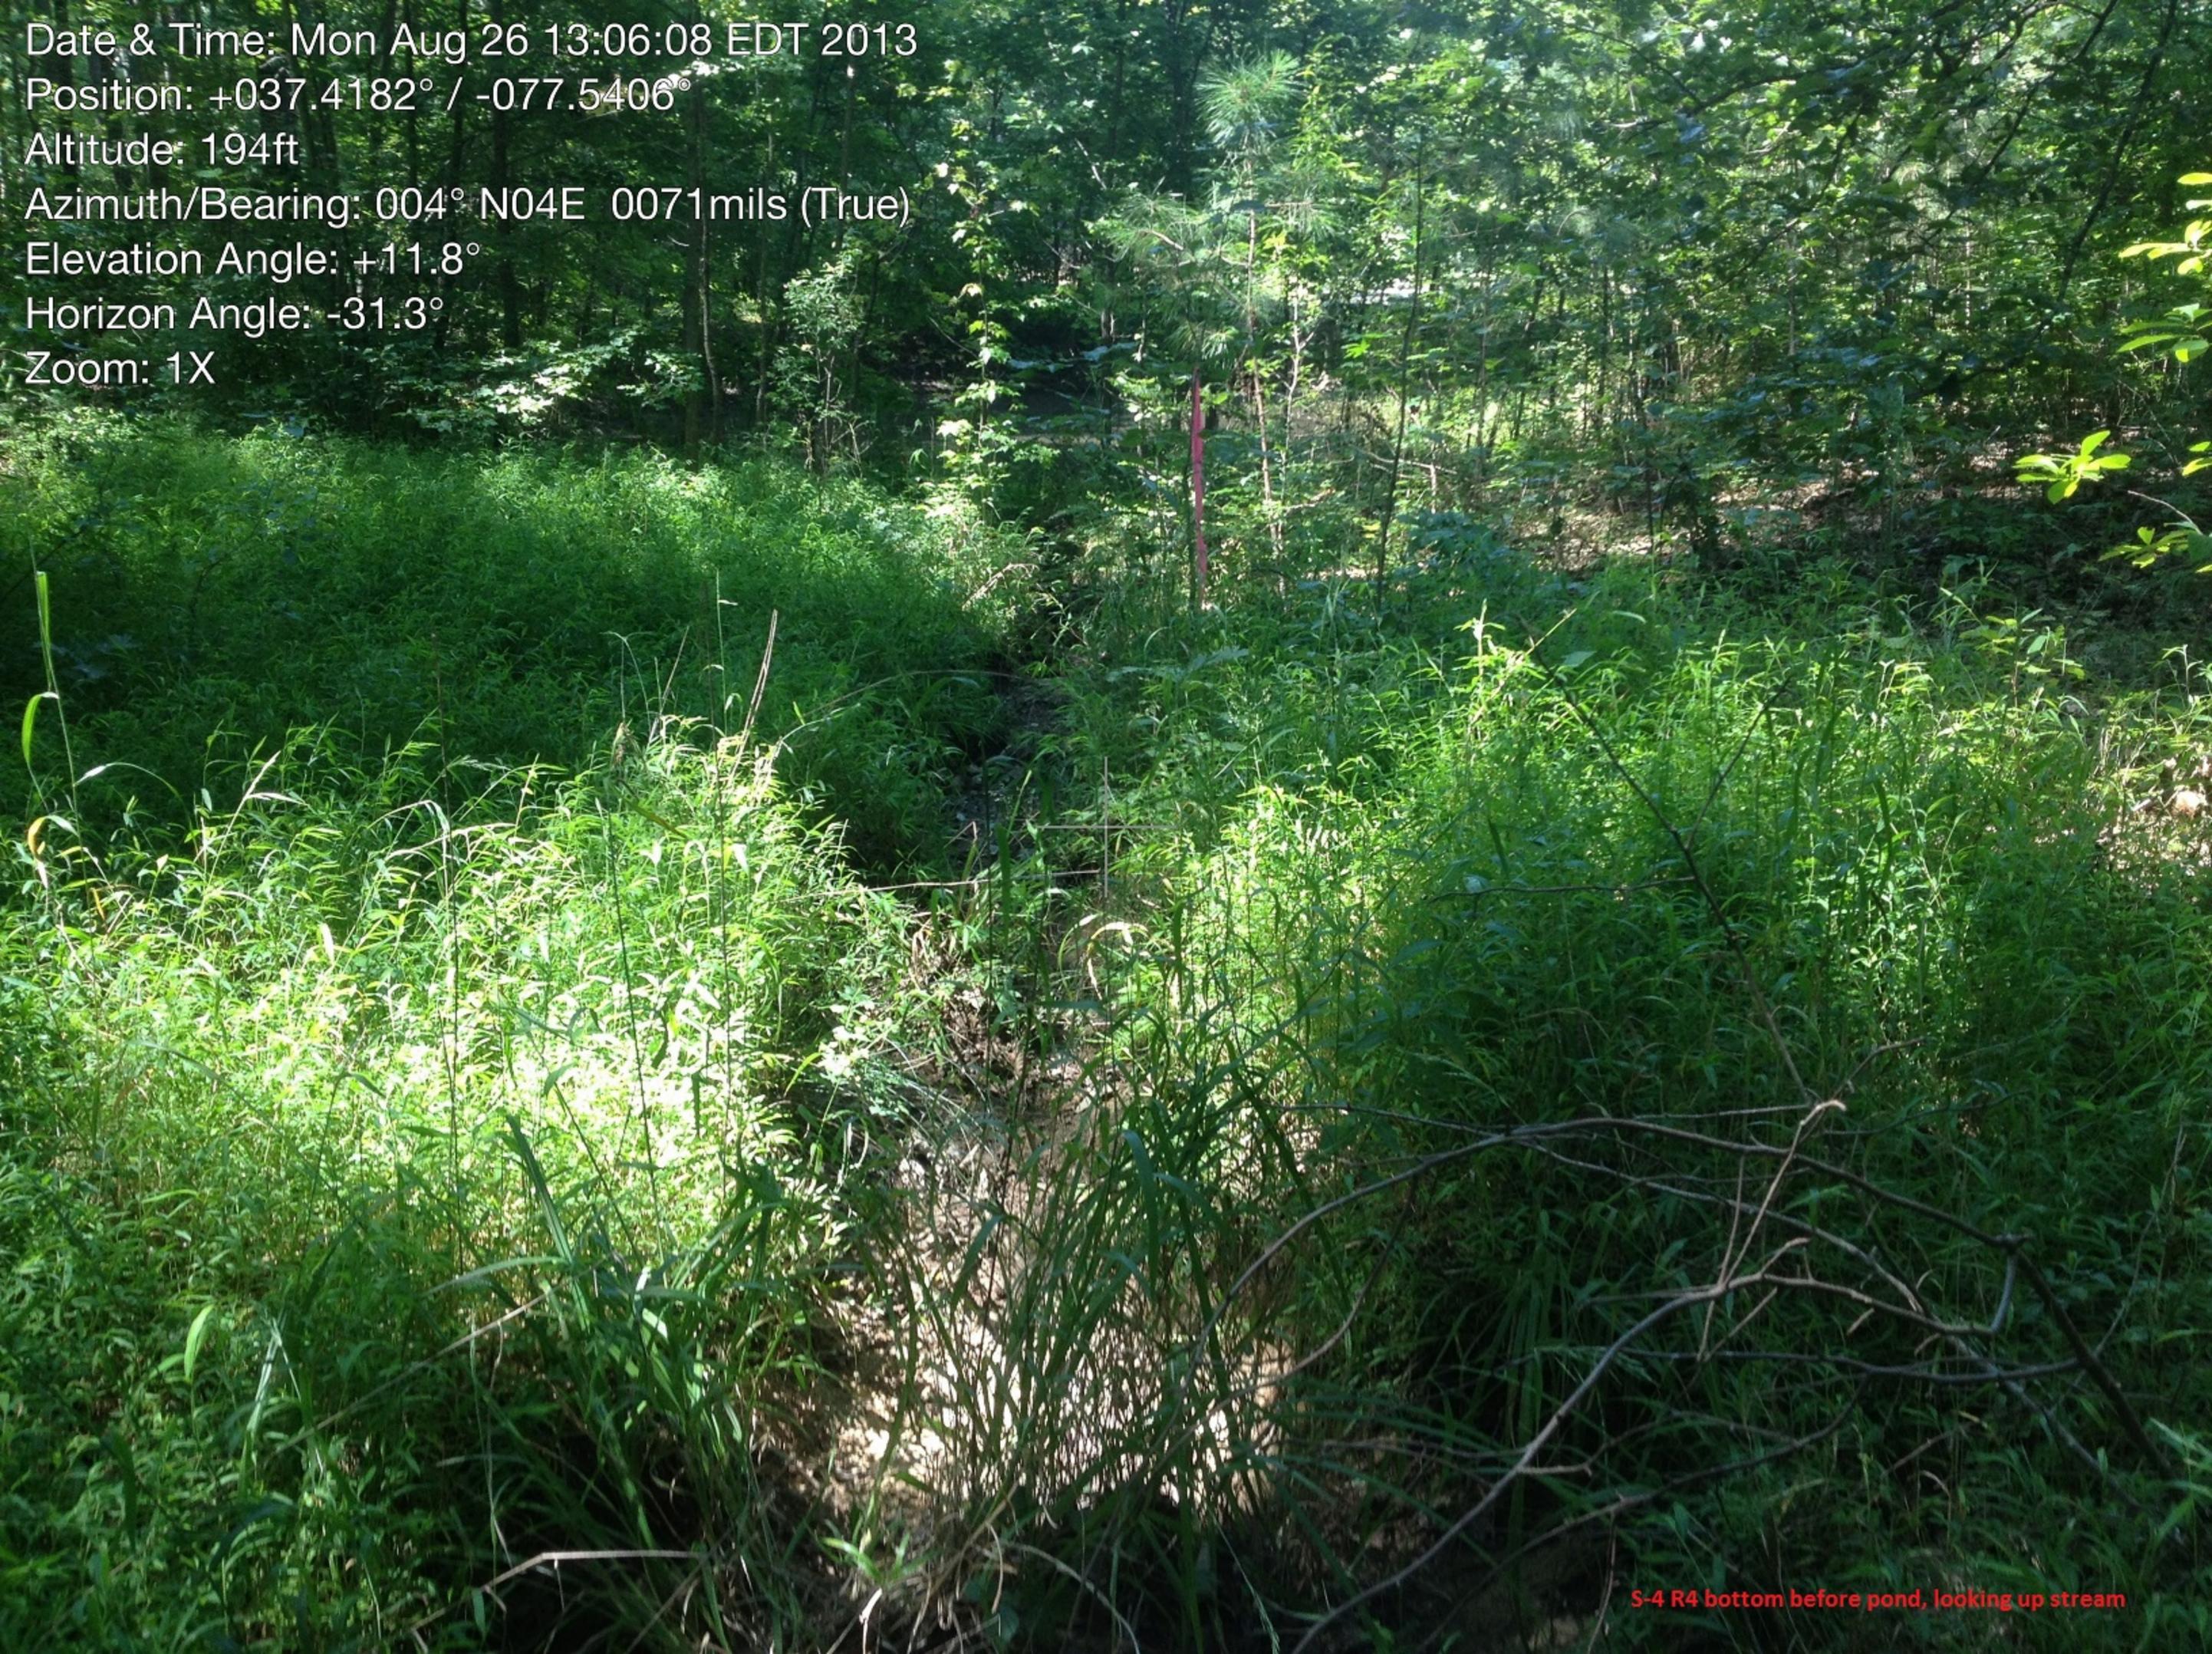
S-4 R4 bottom before pond, looking up stream
