Cunningham Creek Benthic Stressor Analysis

Technical Advisory Committee Meeting

Gene Yagow and Karen Kline

March 22, 2016

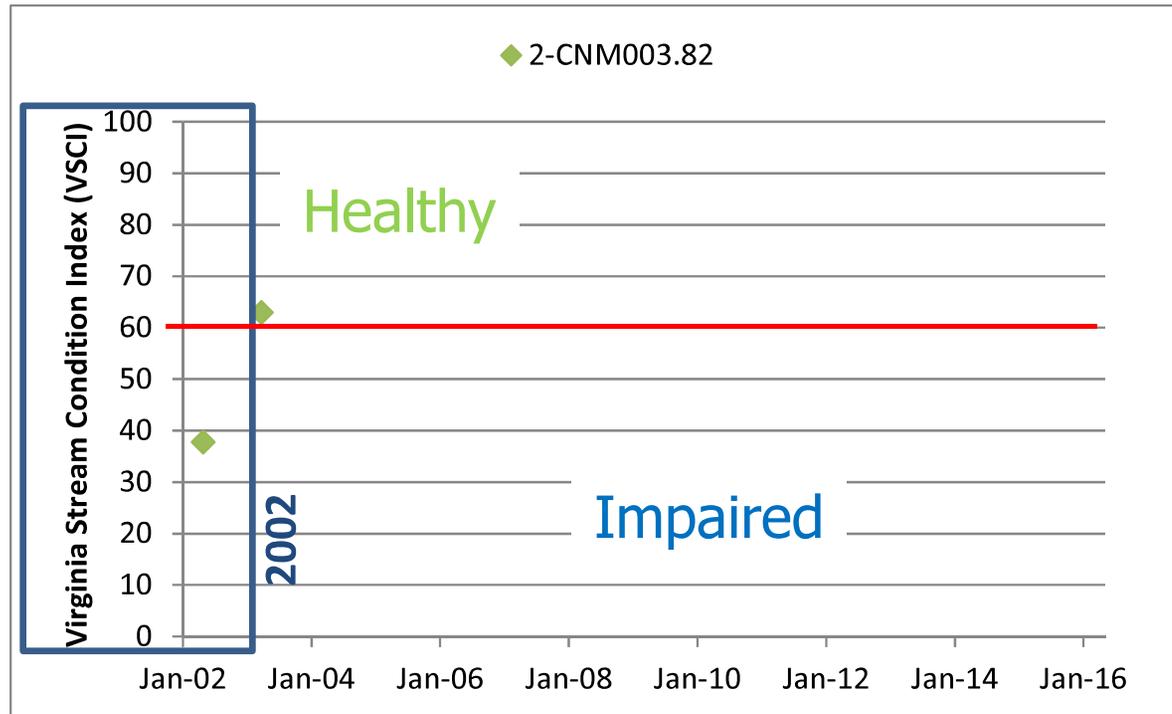
Upper MF Cunningham Creek

DEQ biologist notes (04/29/02 sample): "Poor score due to large number of midges during drought, but there was still a good diversity of sensitive taxa".

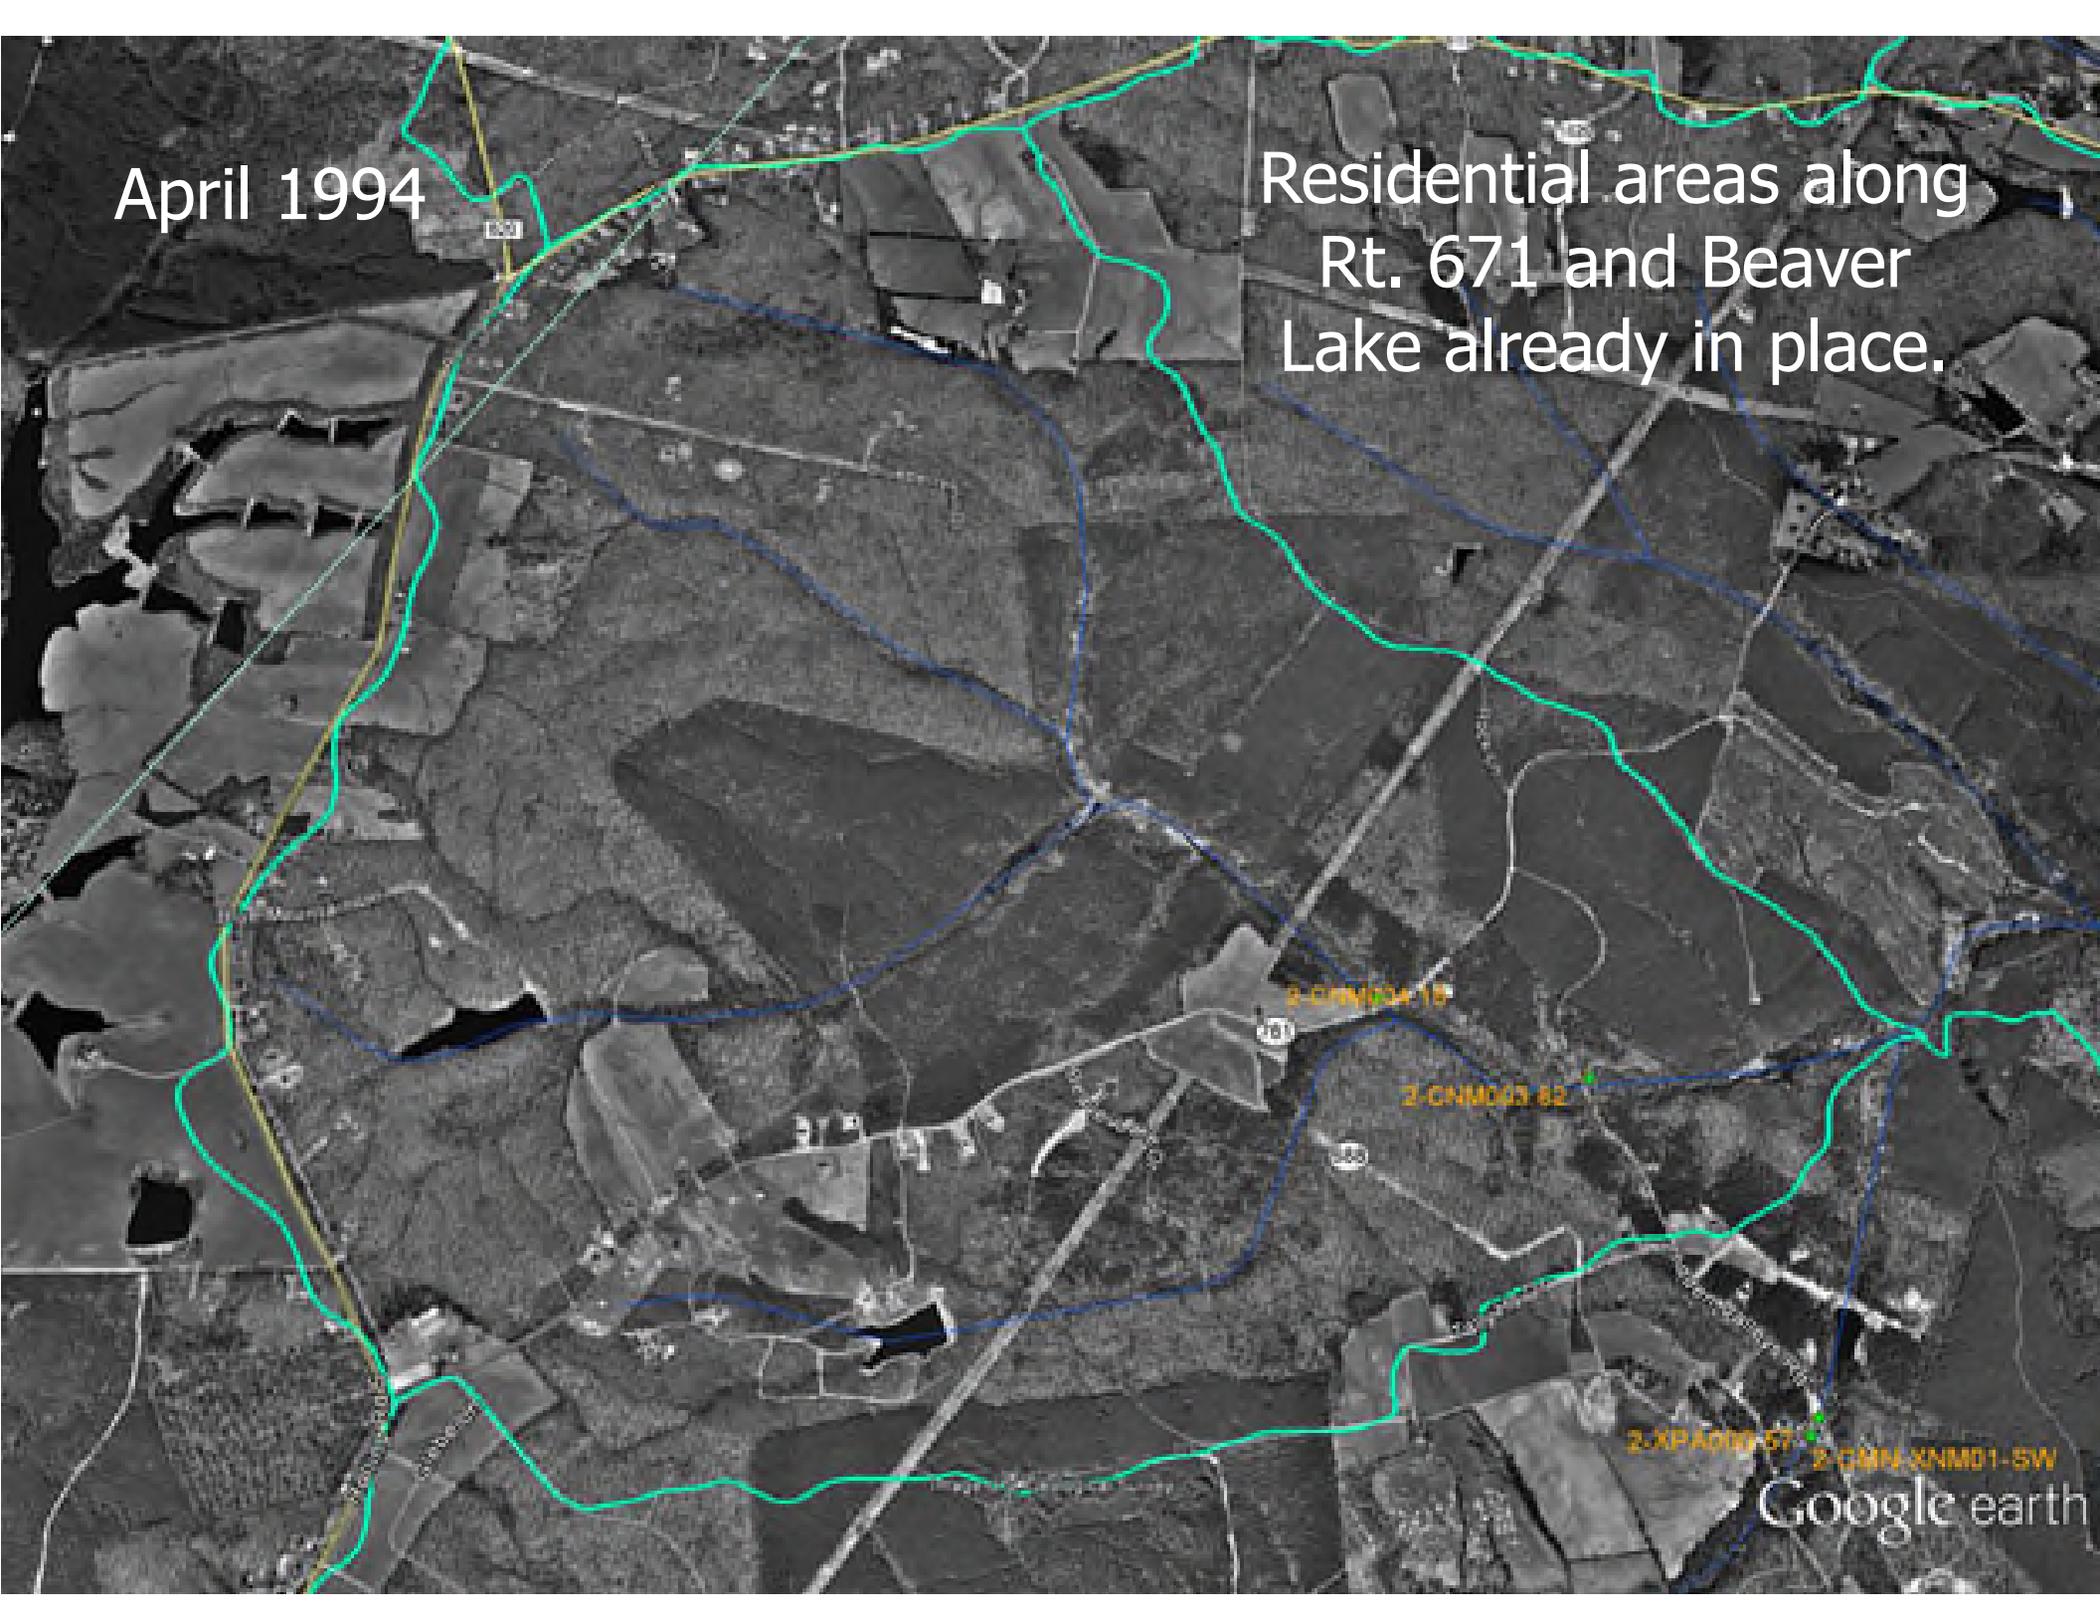
April 1994

Residential areas along
Rt. 671 and Beaver
Lake already in place.

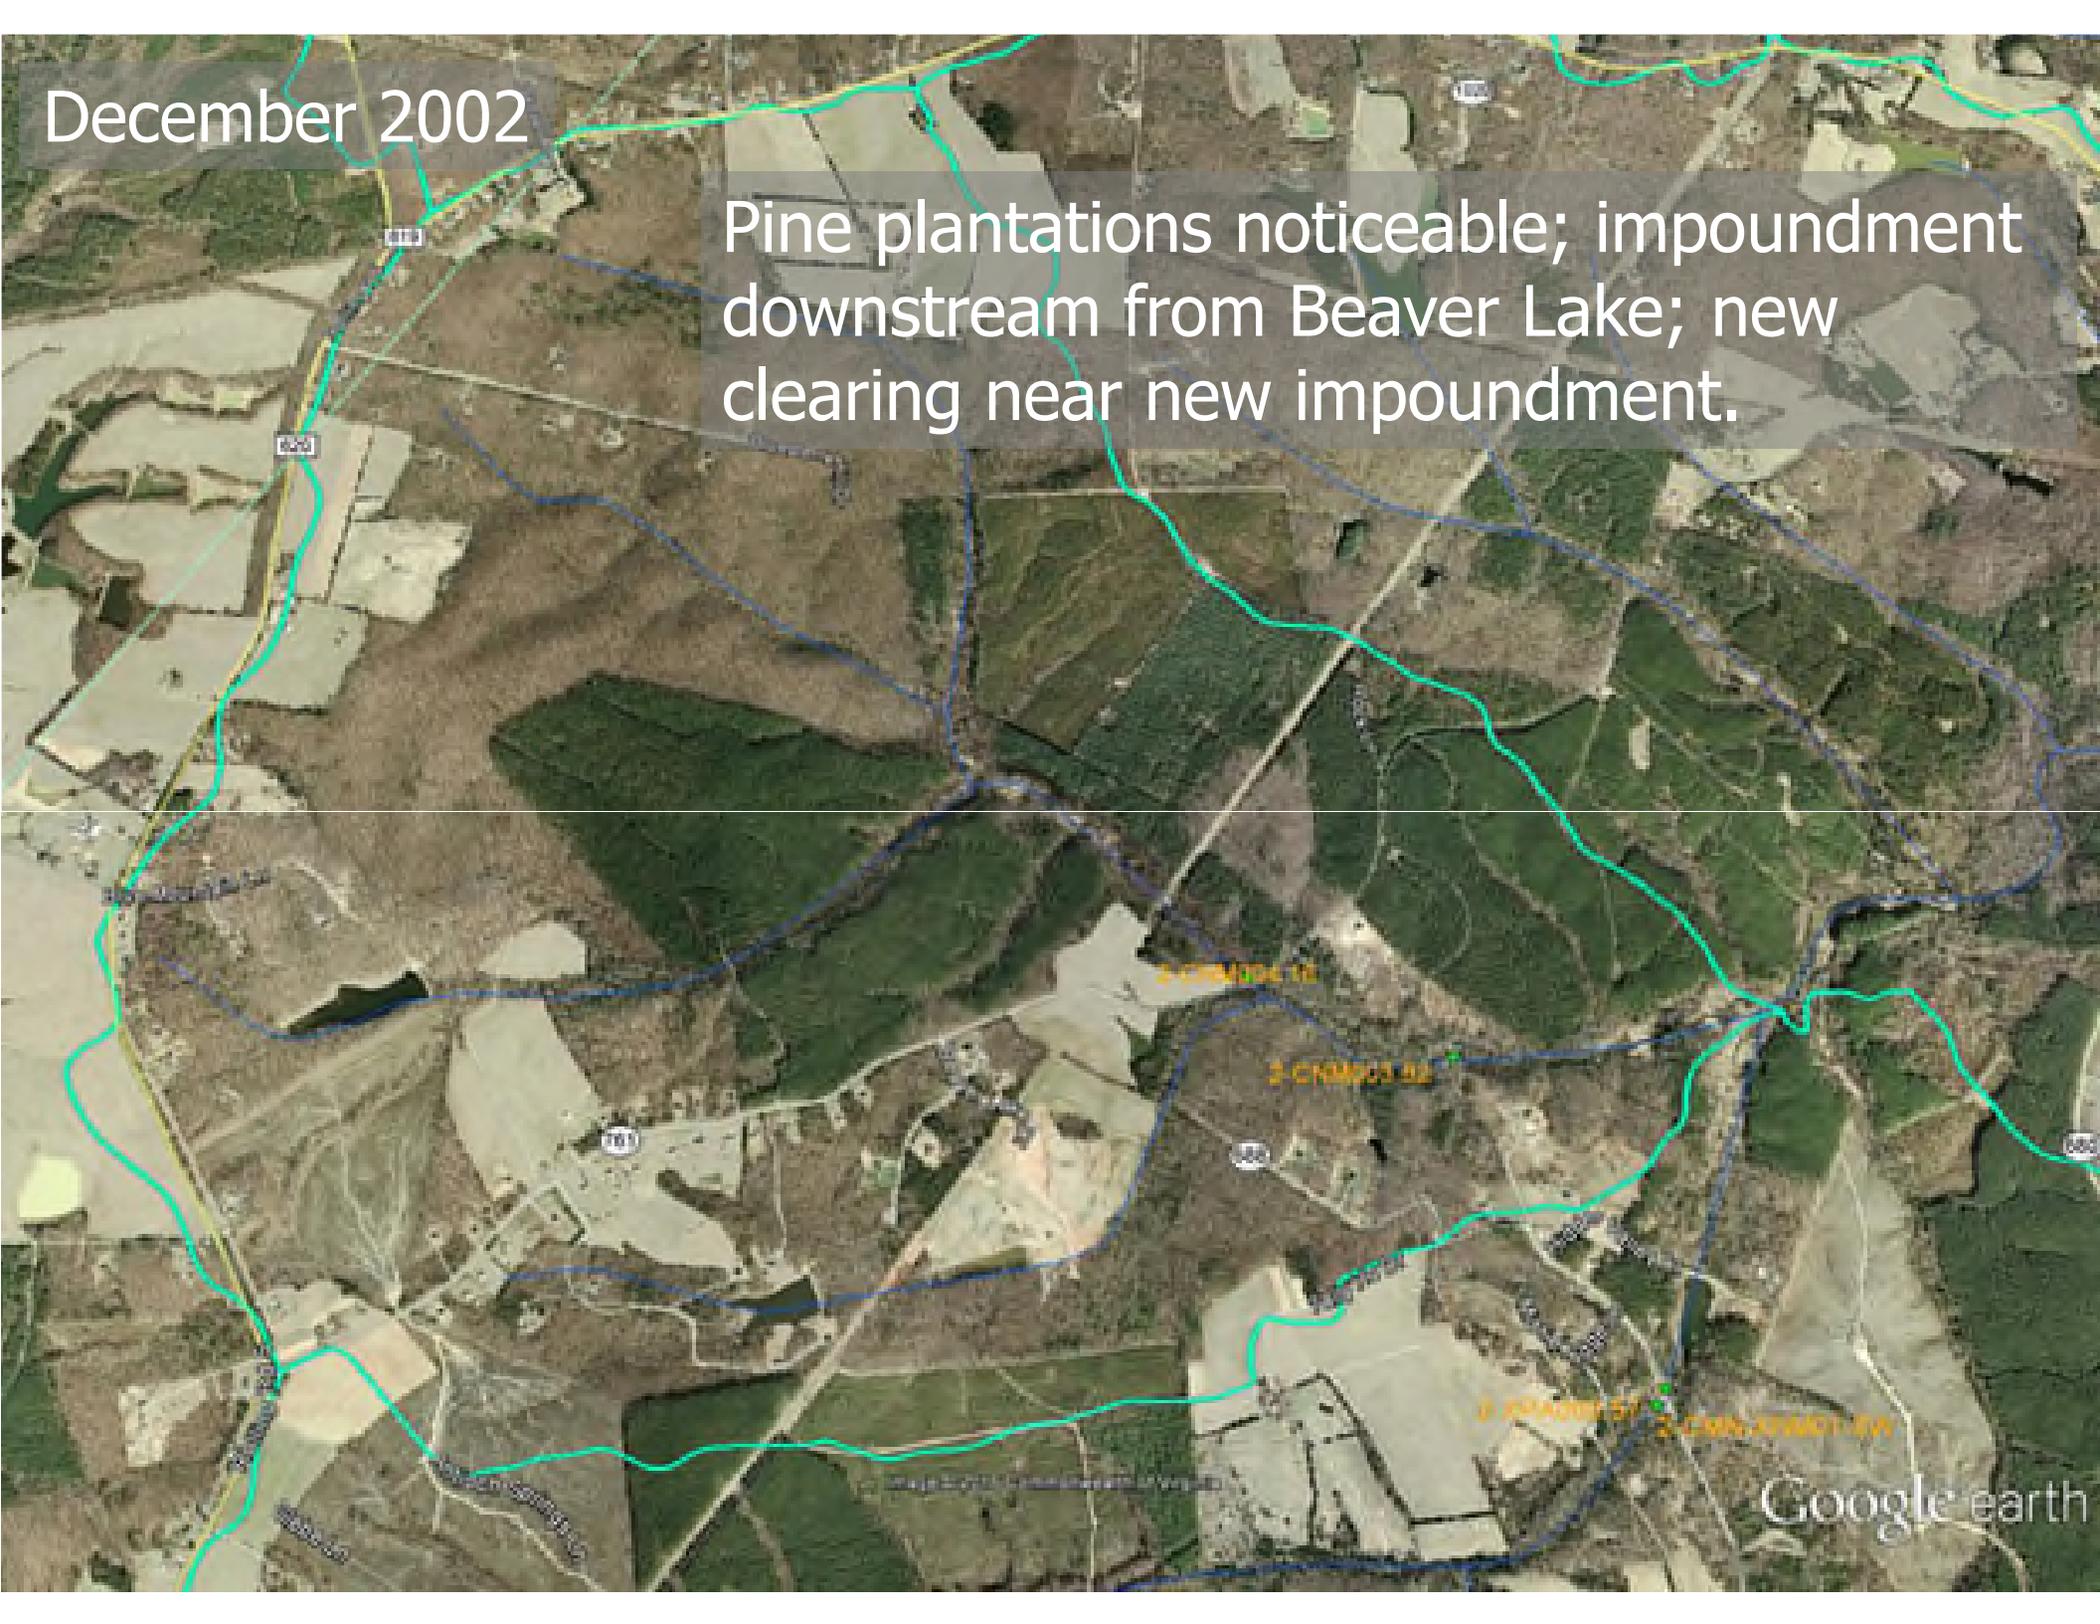
December 2002

Pine plantations noticeable; impoundment downstream from Beaver Lake; new clearing near new impoundment.

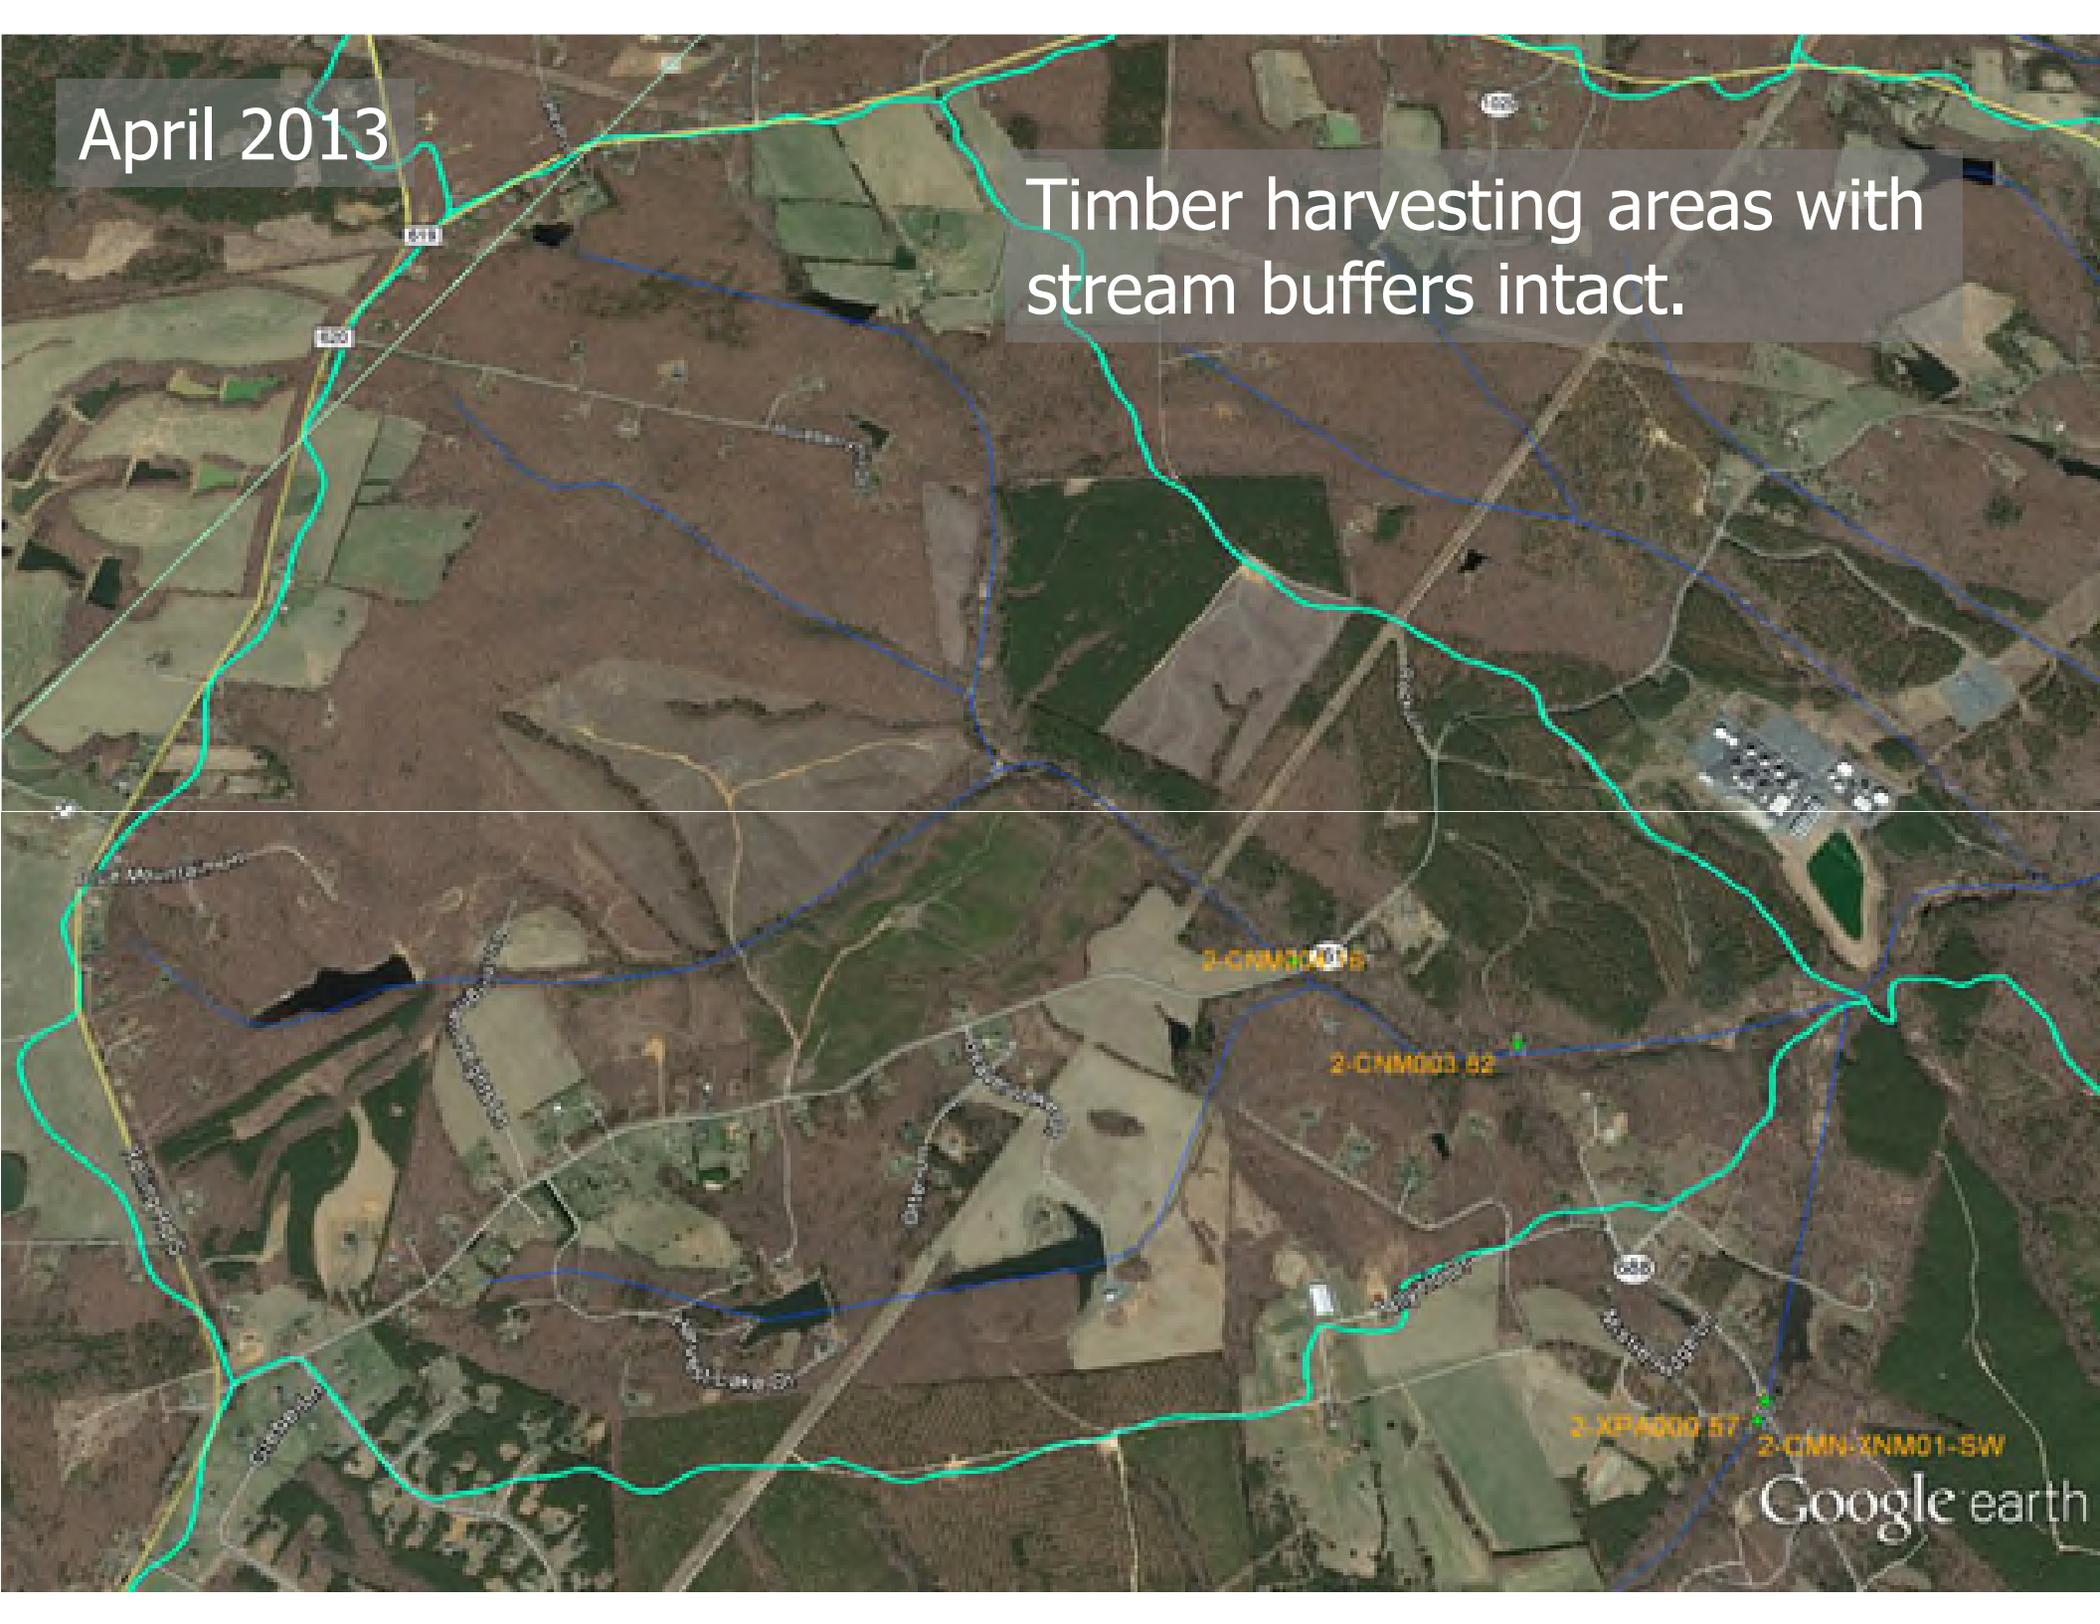
April 2013

Timber harvesting areas with stream buffers intact.

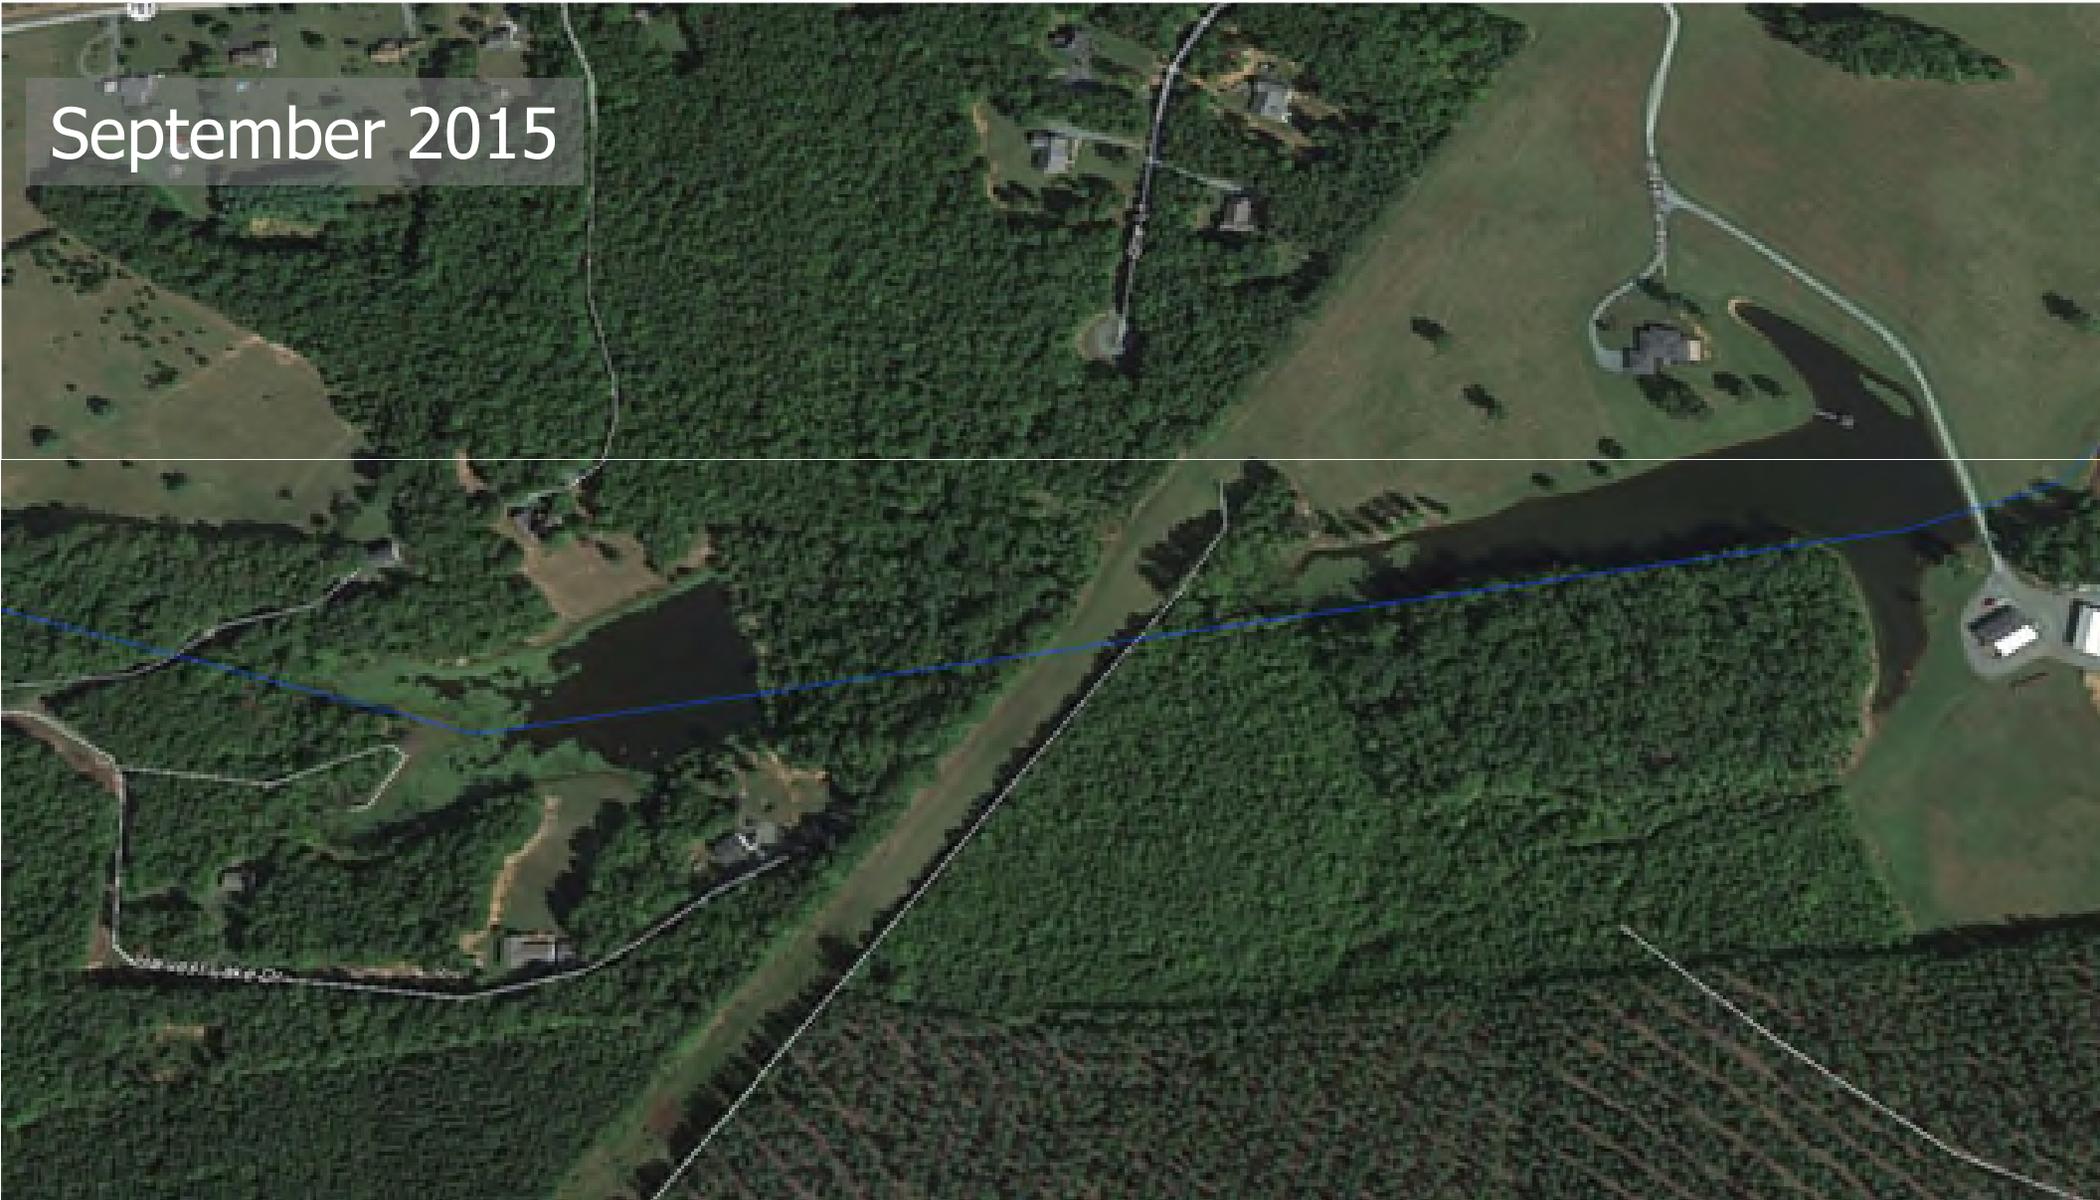
September 2015

Significant amounts of algae visible on Beaver Lake and downstream impoundment: 2005-2008, 2011, and 2015.

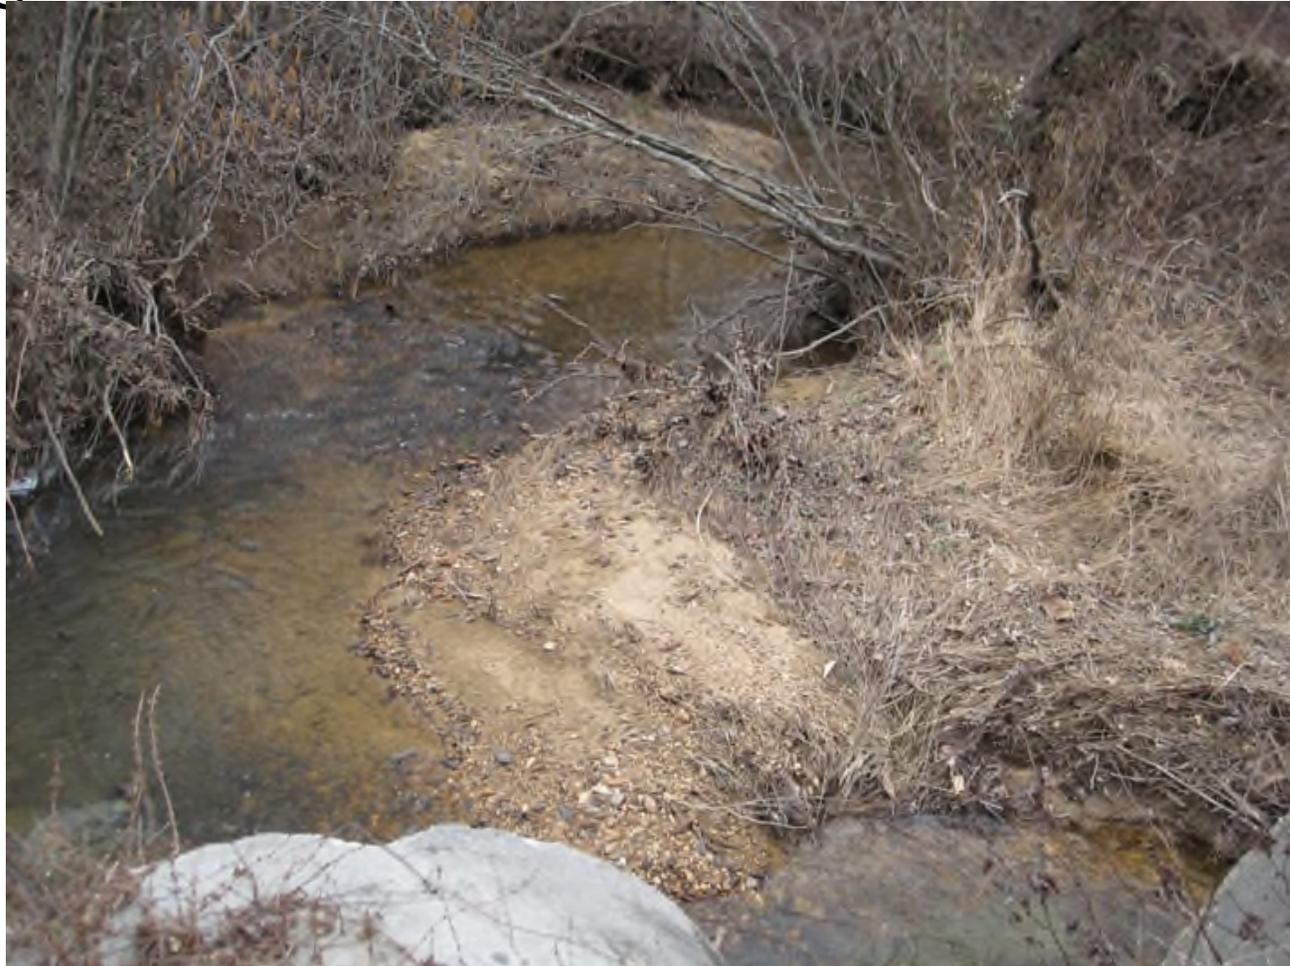
Sediment deposition,
but clear flow,
2-CNM004.16,
03/03/16

Most probable stressor currently: sediment from land disturbance, possibly also affected by nutrients from older septic systems or fertilization from residential lawns.

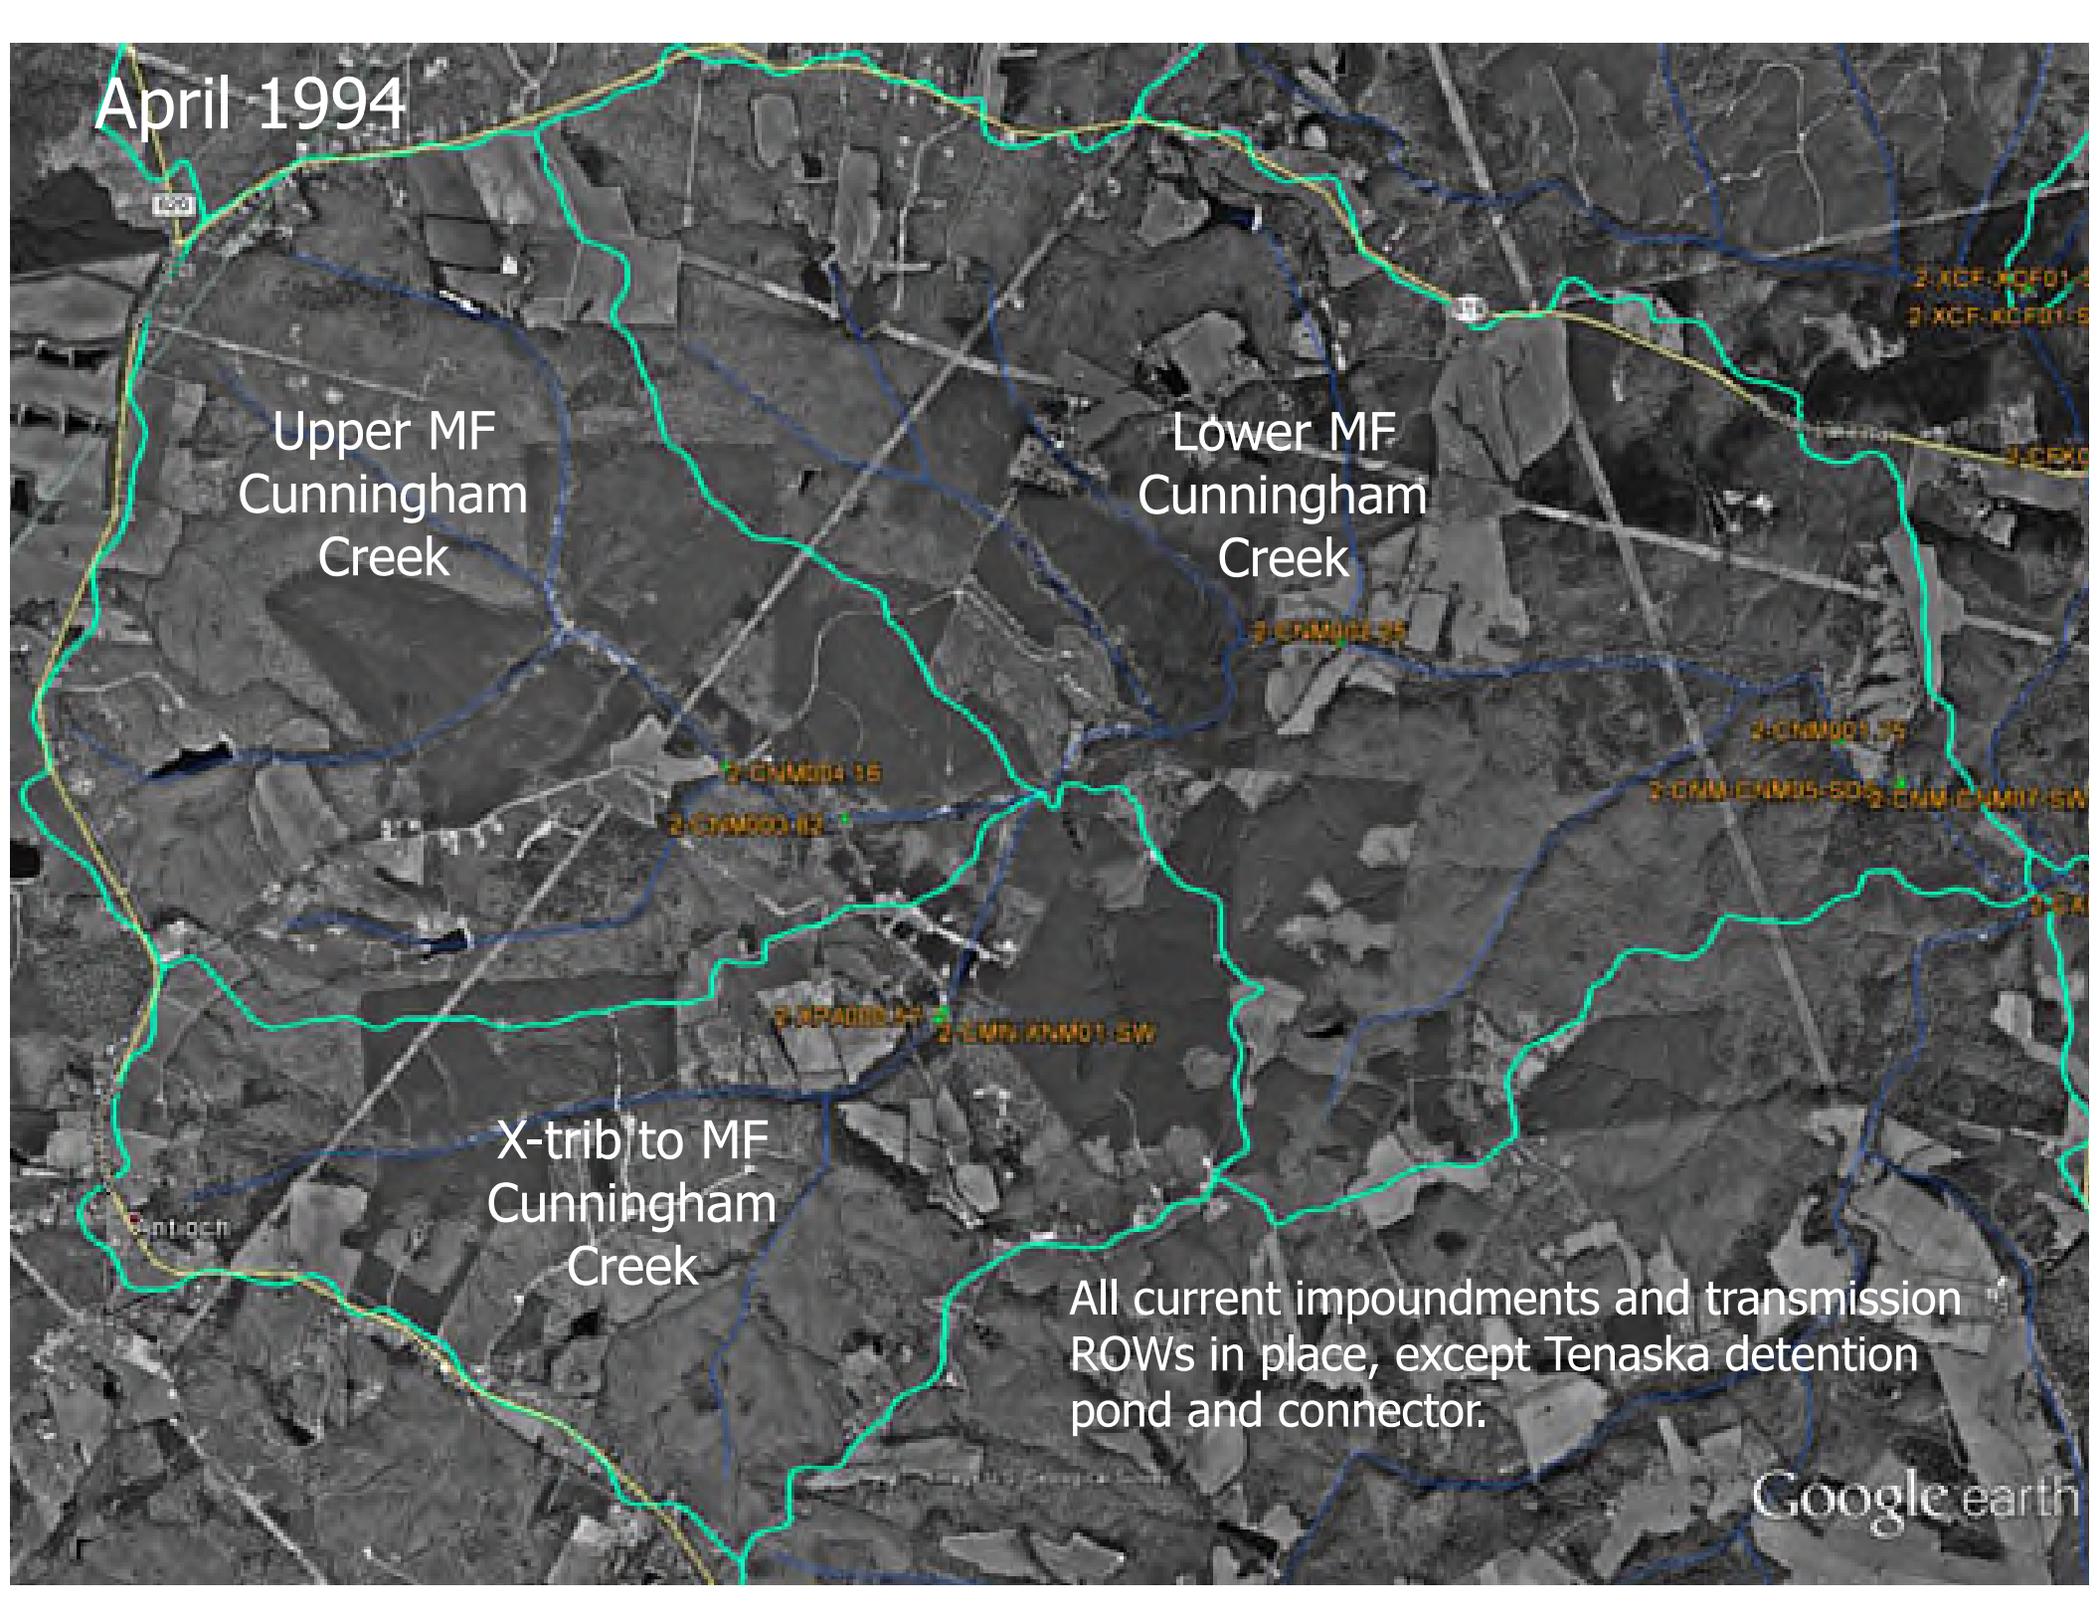
April 1994

All current impoundments and transmission
ROWs in place, except Tenaska detention
pond and connector.

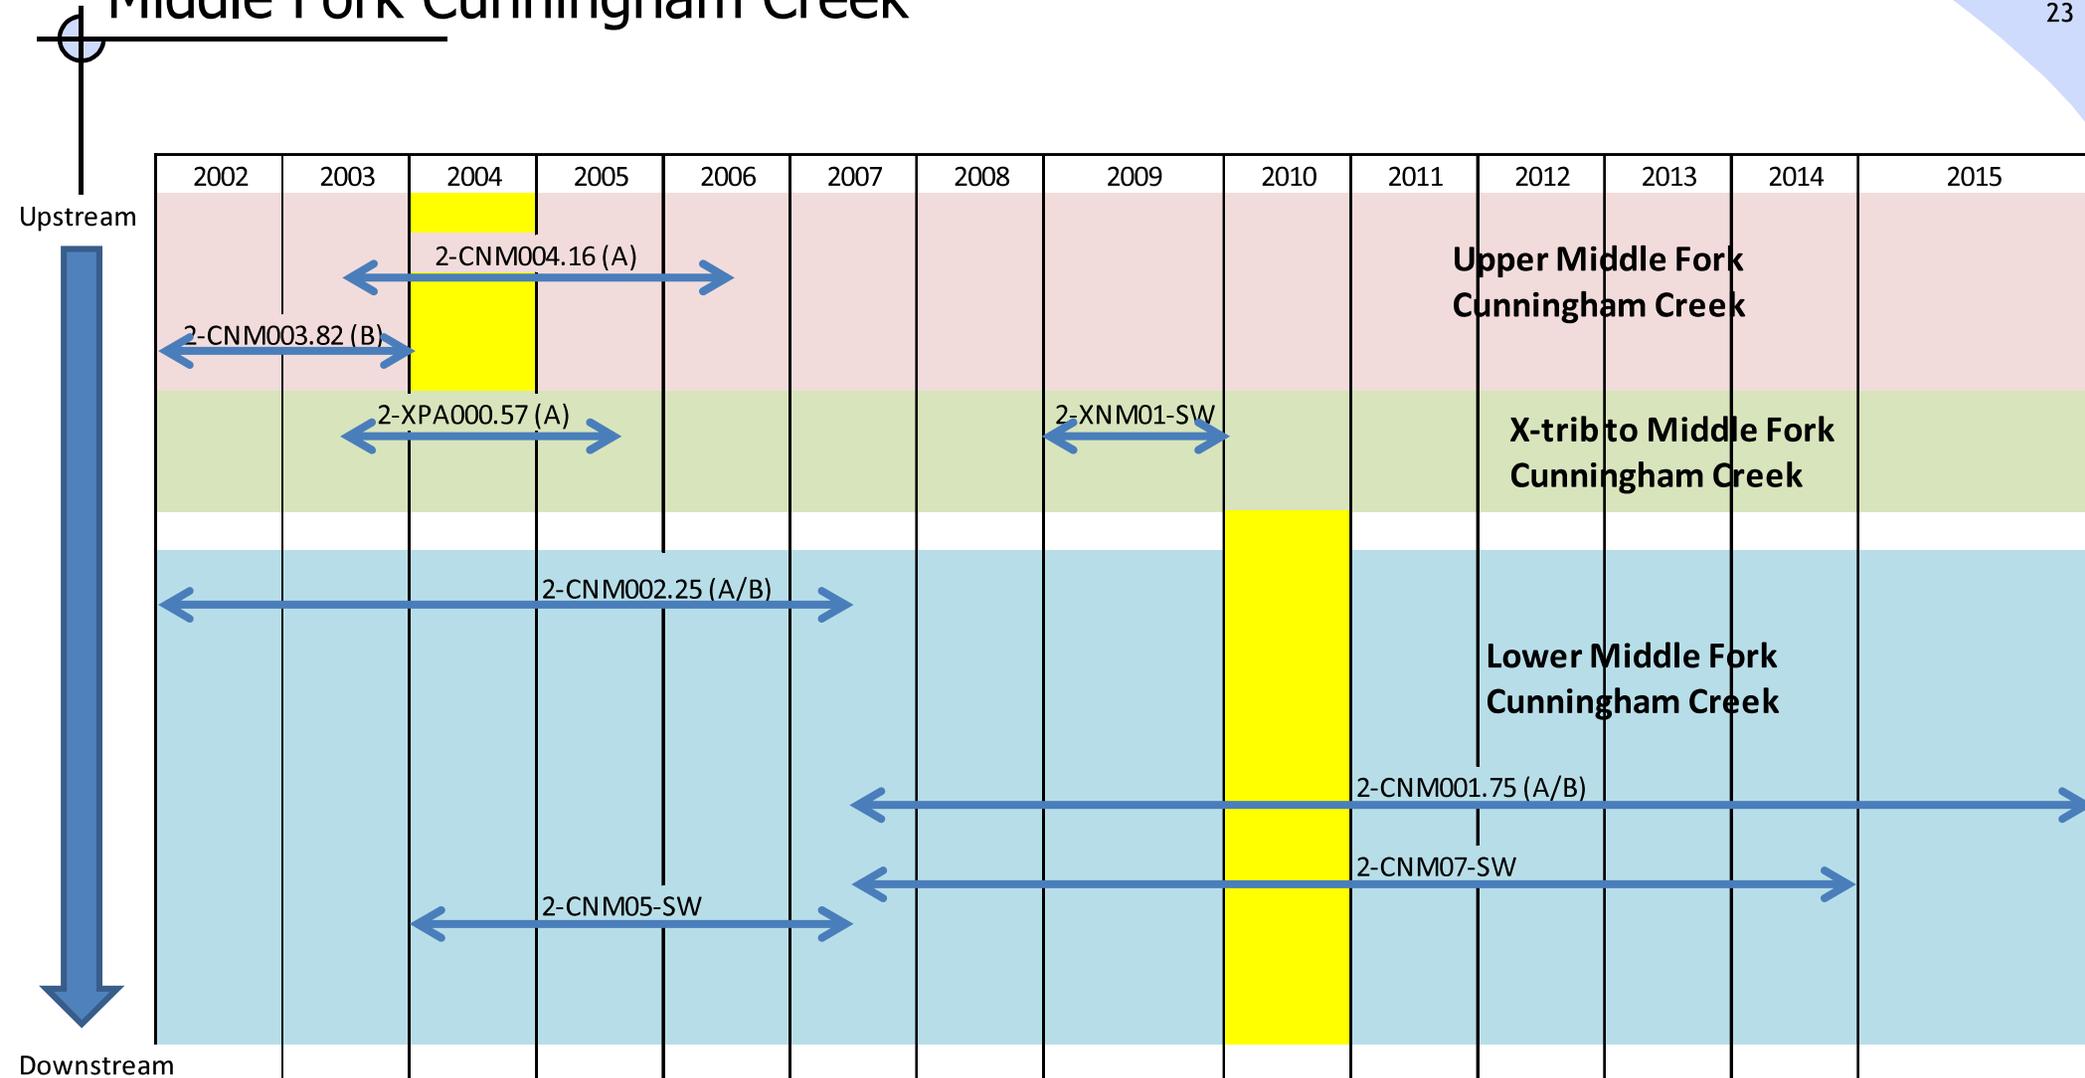
Monitoring Matrix

All StreamWatch (SW) and Save Our Streams (SOS) stations monitor benthic inventories only.

DEQ monitoring stations may be: A= ambient water column water quality; and/or B=benthic monitoring.
