Cunningham Creek Benthic Stressor Analysis

Technical Advisory Committee Meeting

Gene Yagow and Karen Kline

March 22, 2016

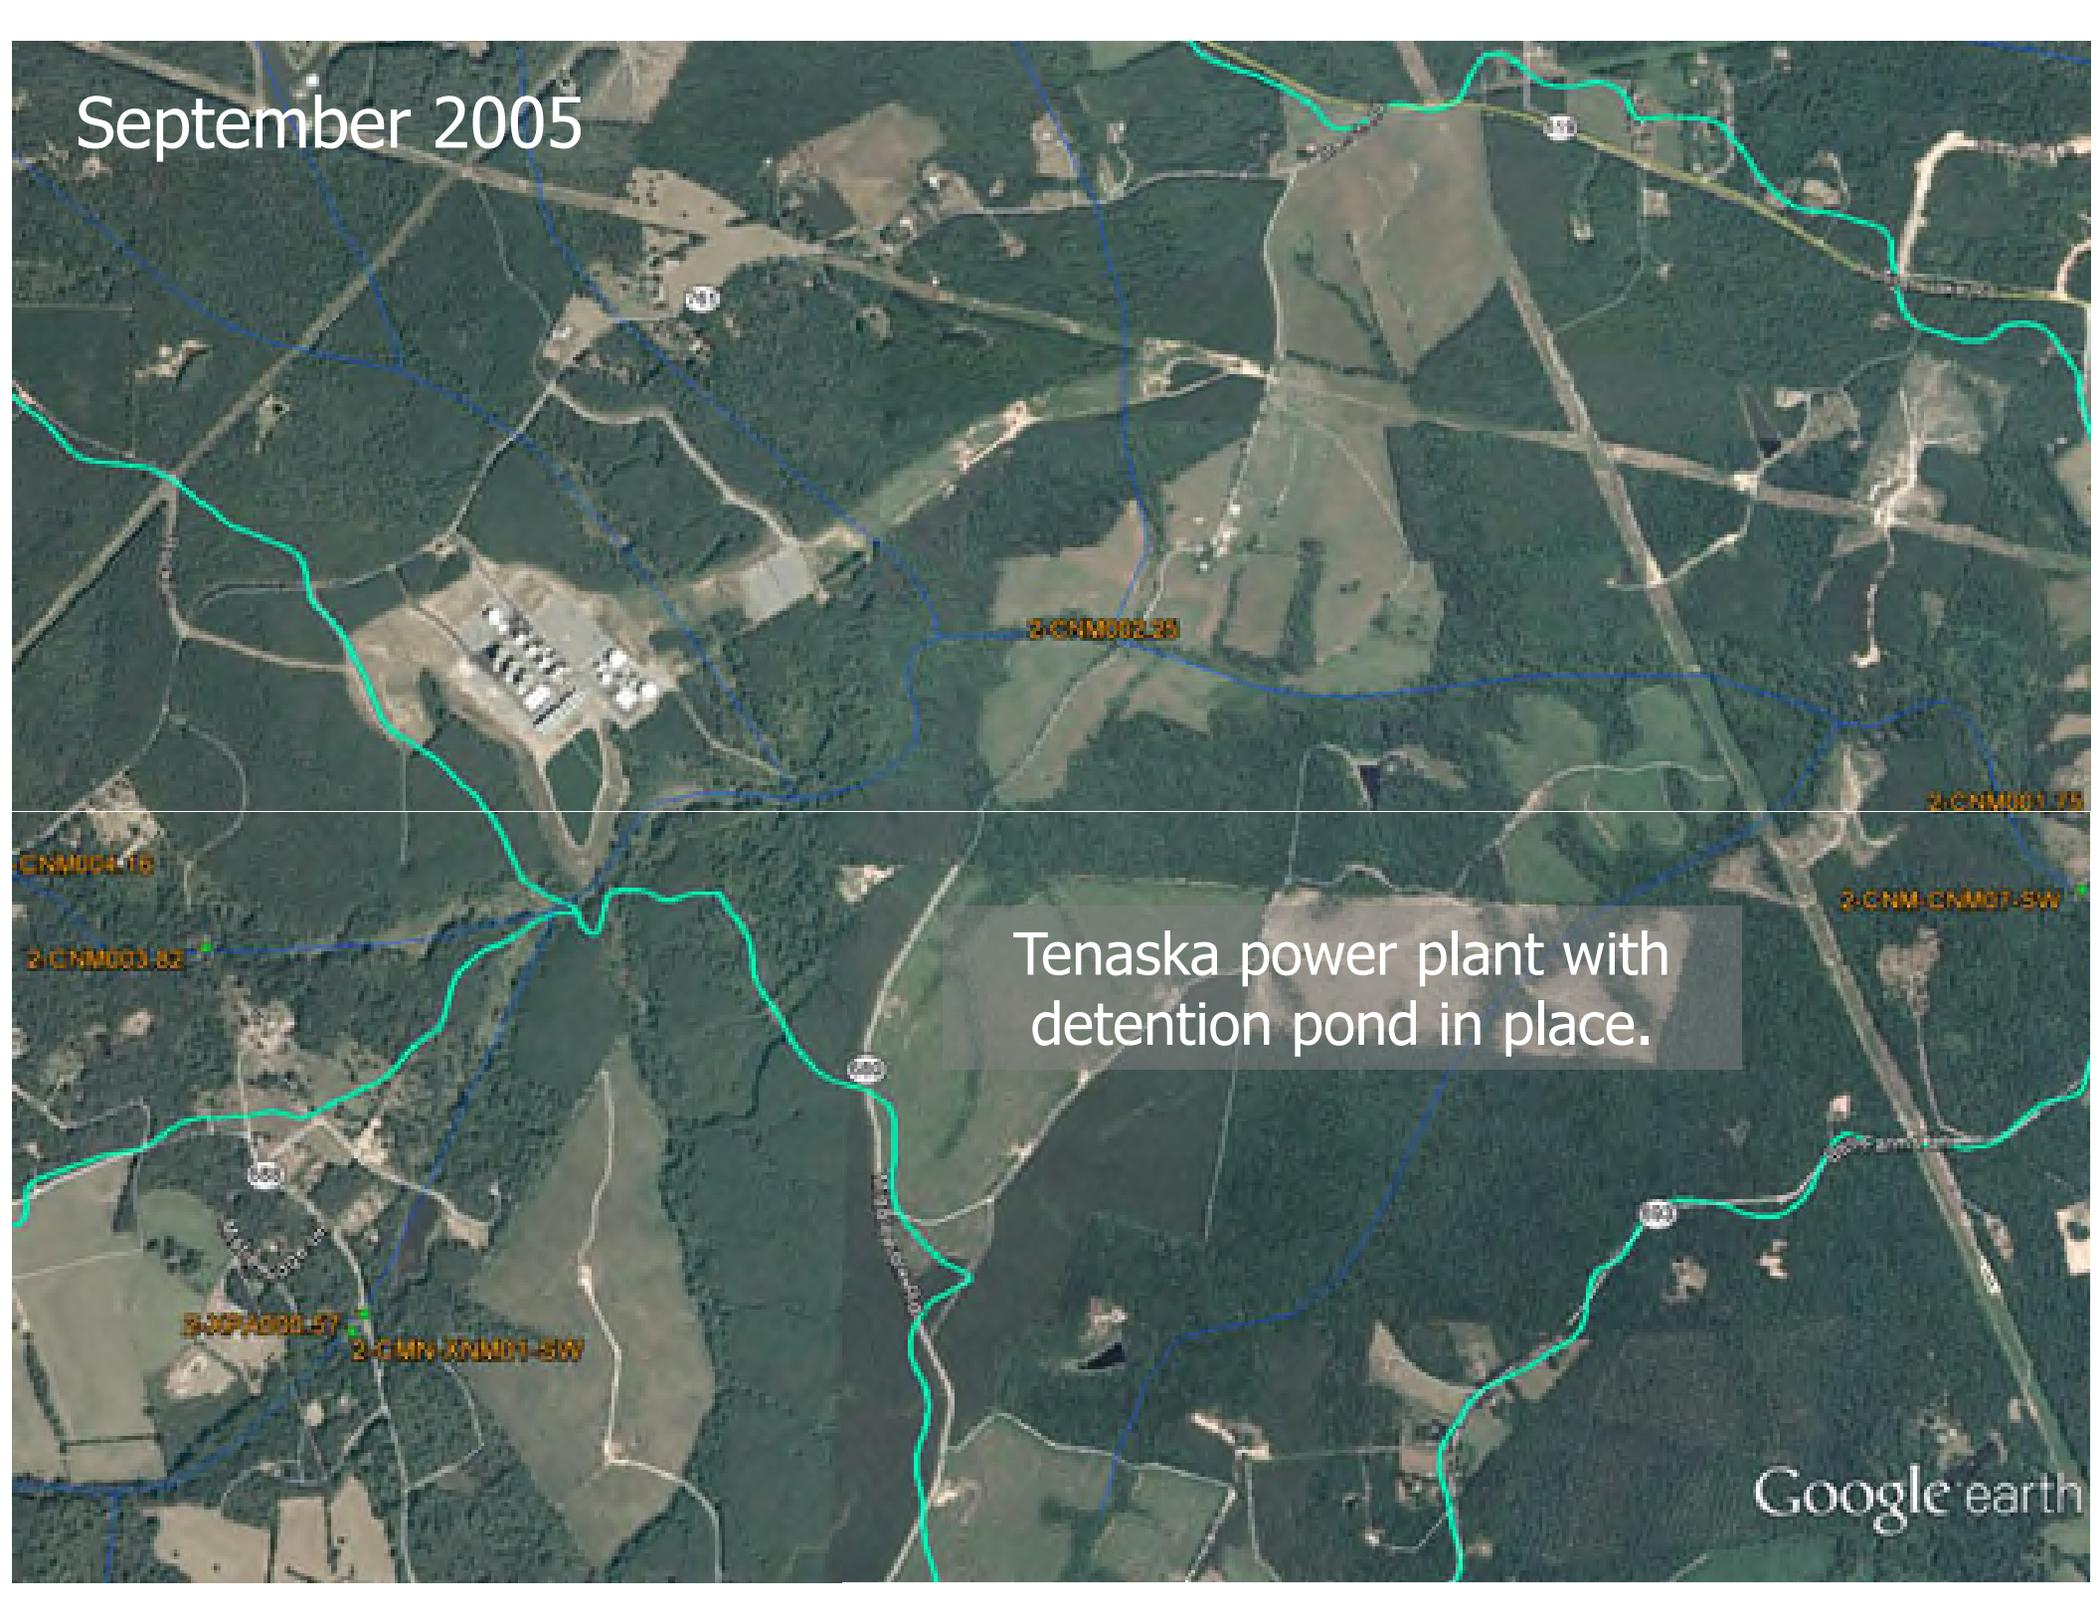
Heavy livestock use and possible stream access, possibly through 2008, prior to current owners of Middle Fork Farm.

Tenaska power plant being built, upstream of 2-CNM002.25, also a connector ROW crossing 3 tributary streams to MF.

Tenaska power plant with
detention pond in place.
