**Natural Conditions
Assessment for Low pH and Low
Dissolved Oxygen,
Nottoway River Tributaries in
Dinwiddie, Prince George, and
Sussex Counties, Virginia**

Virginia Department of Environmental Quality

April 2007

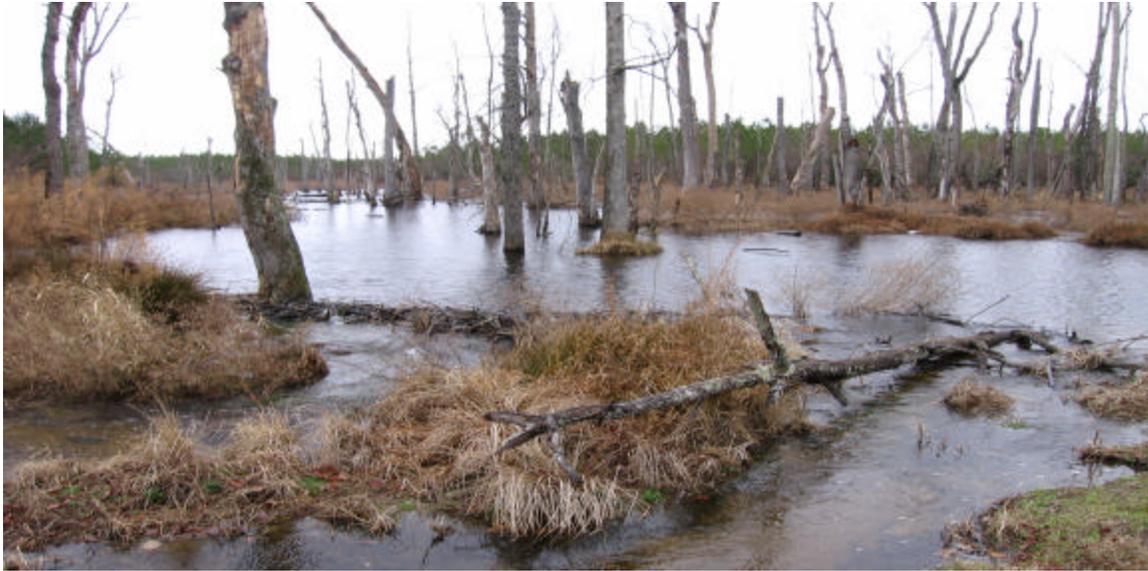
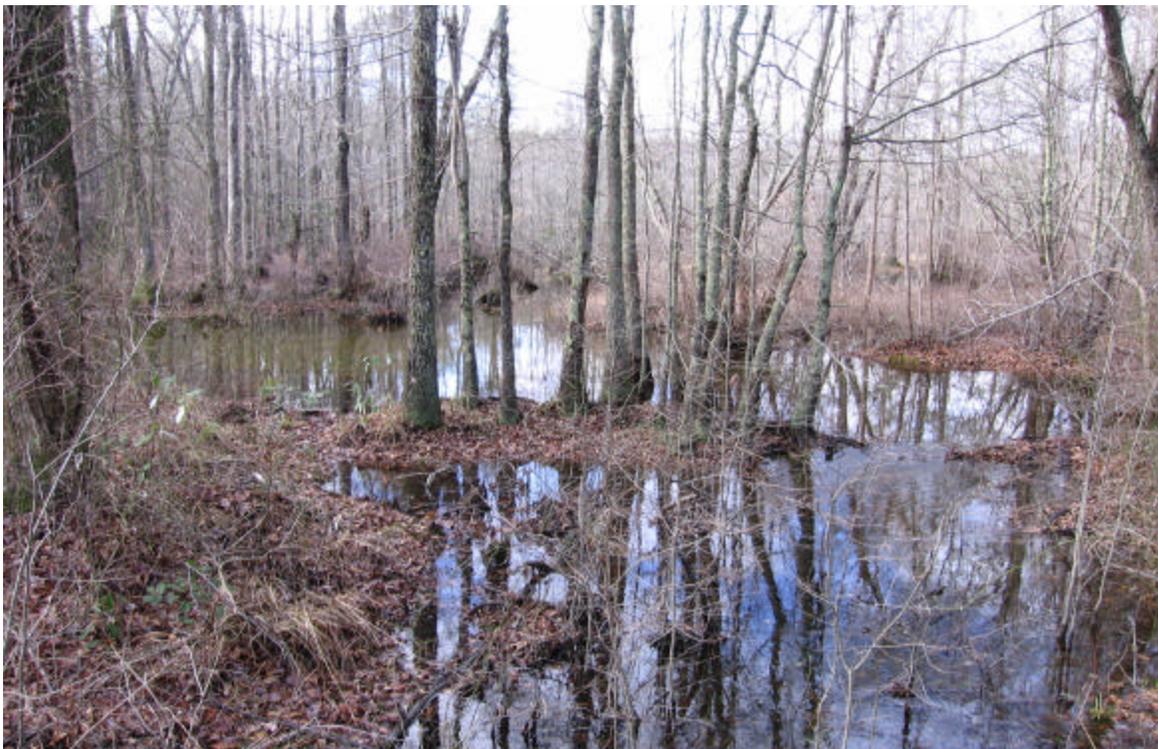
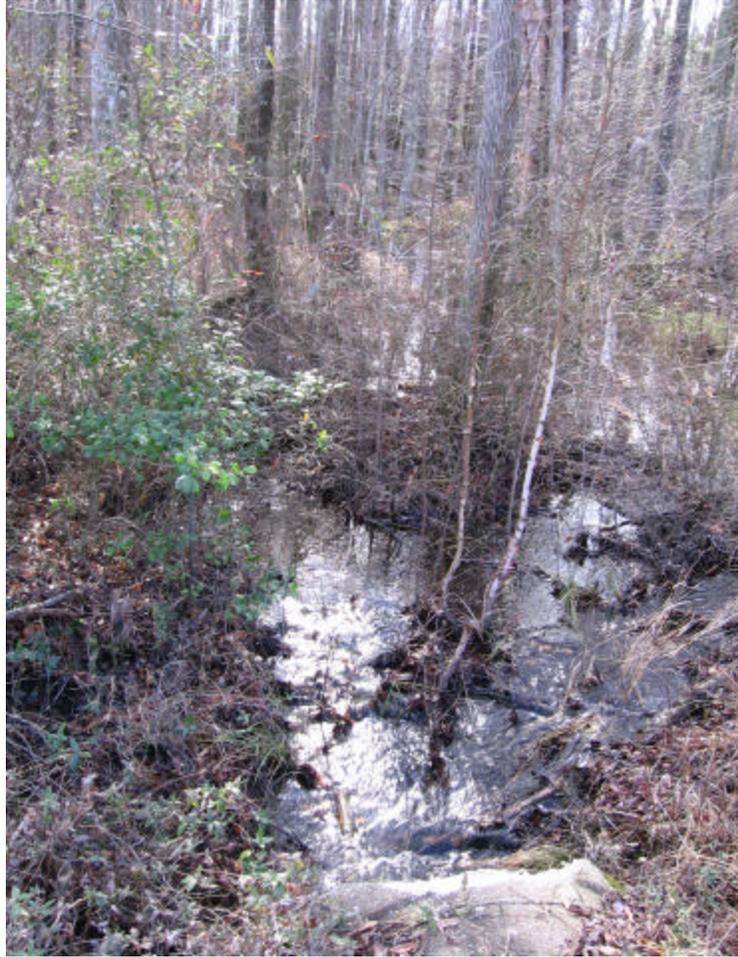
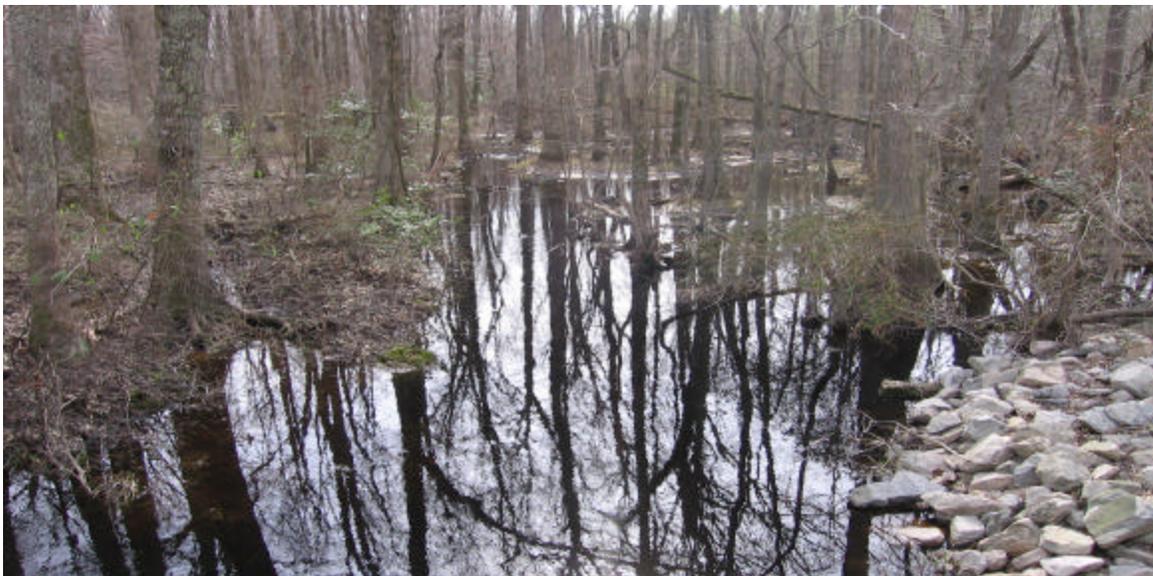
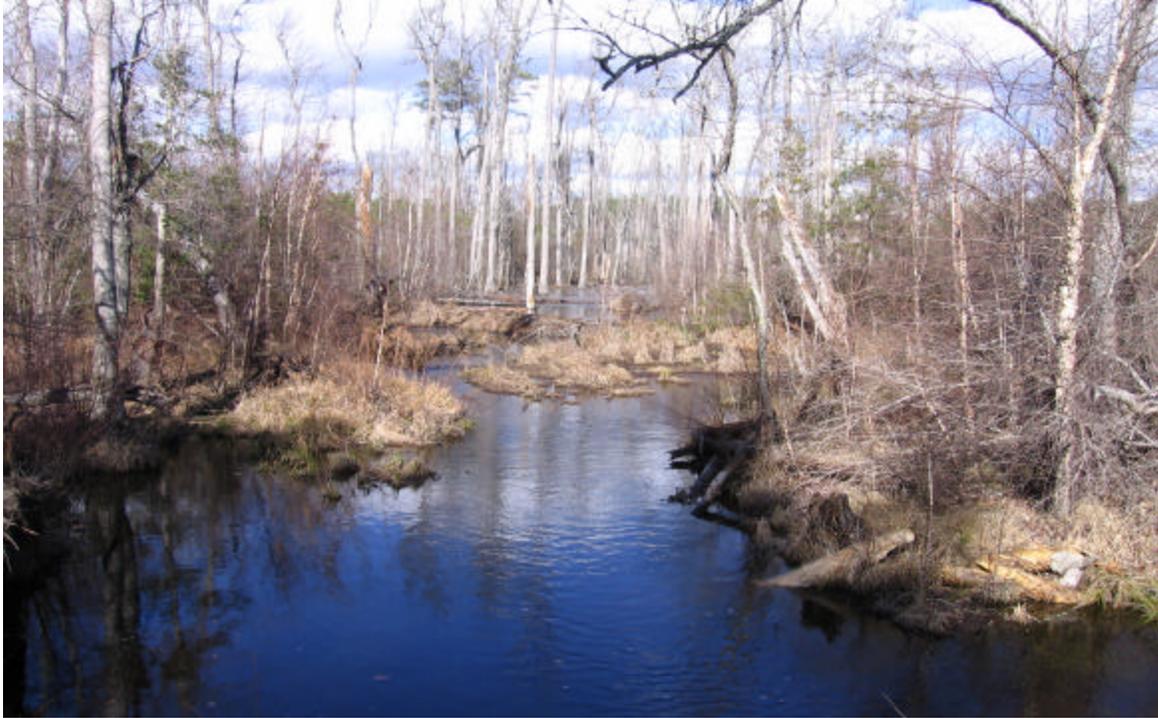
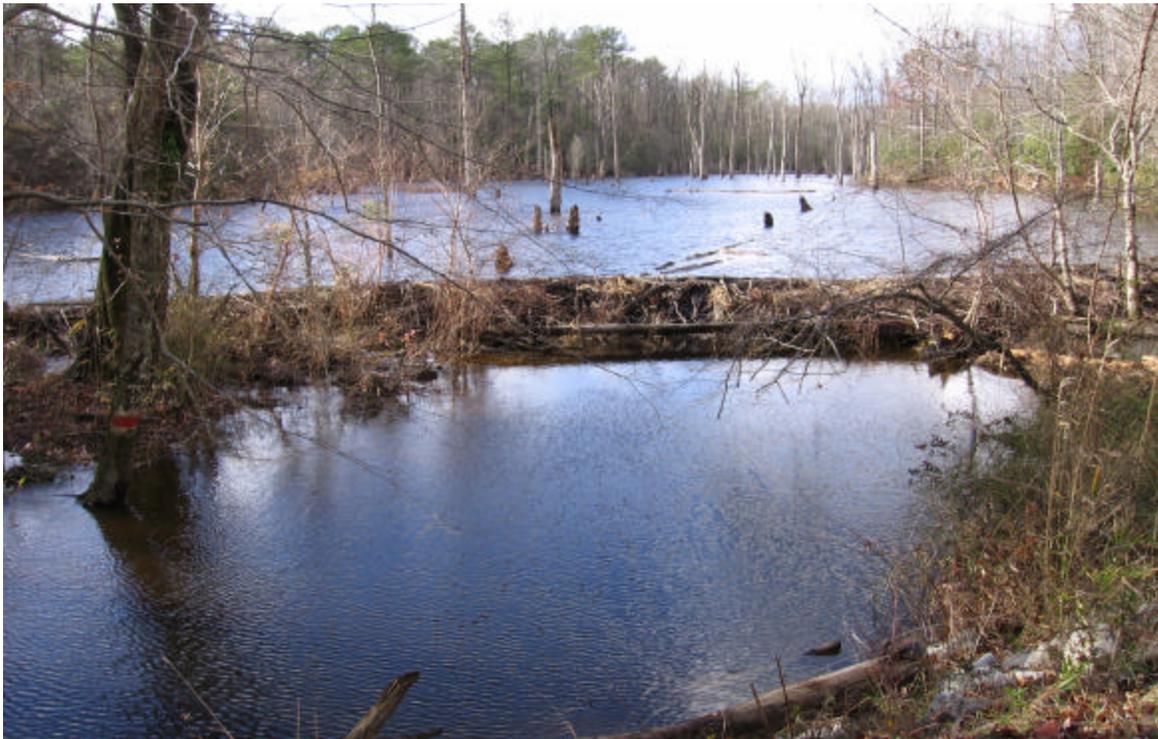
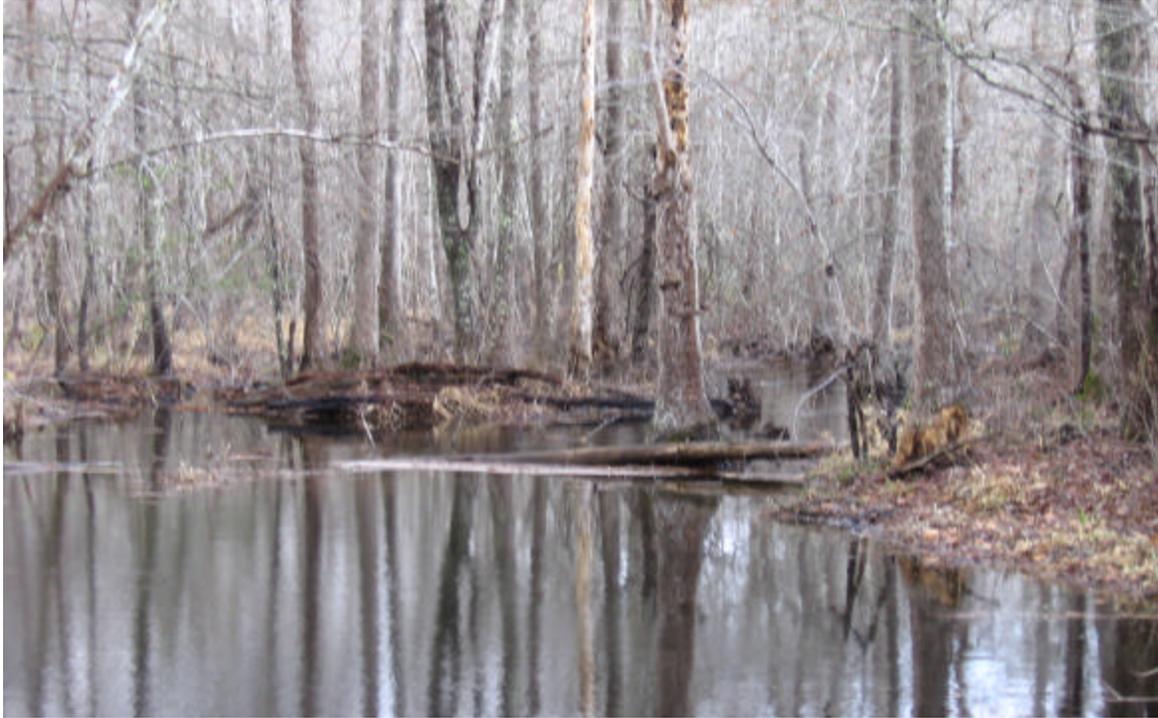
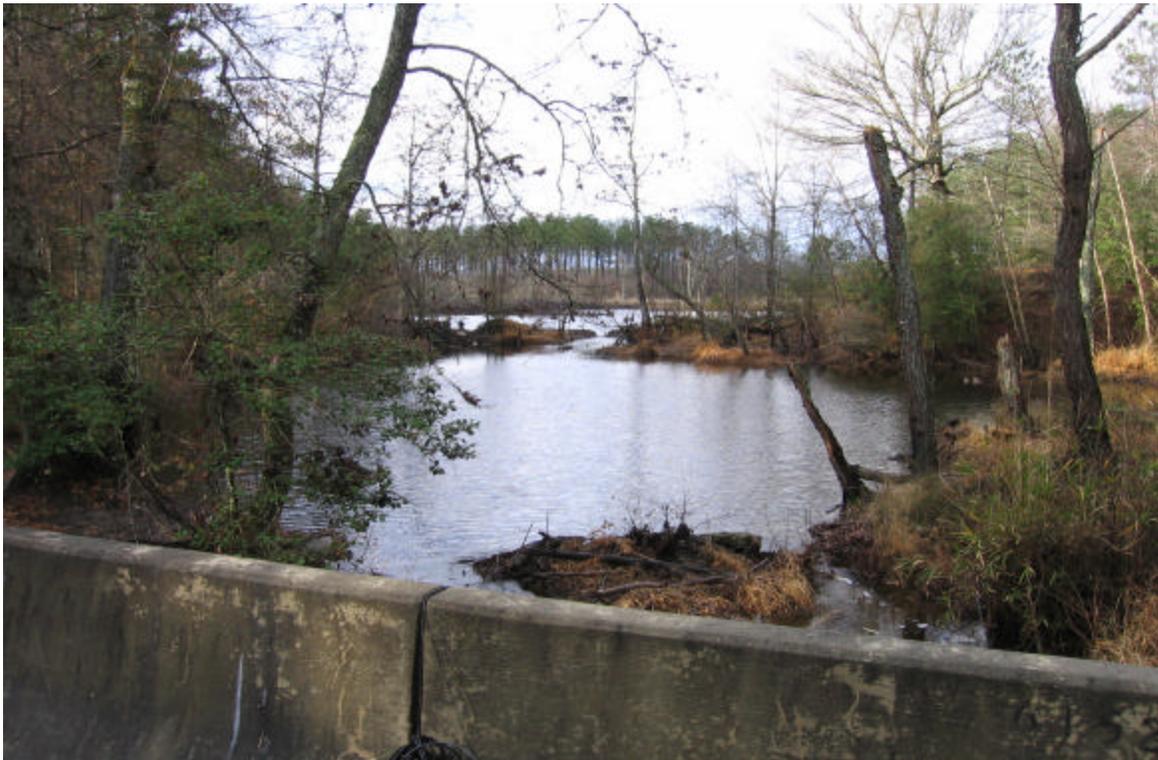
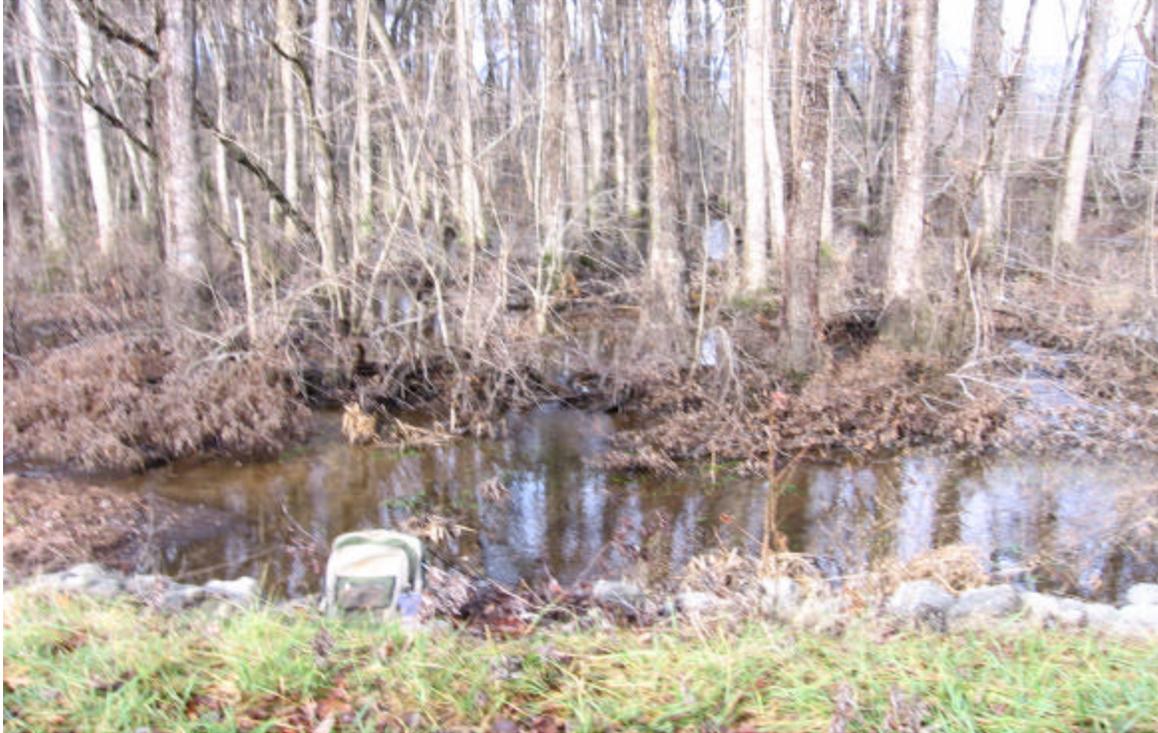
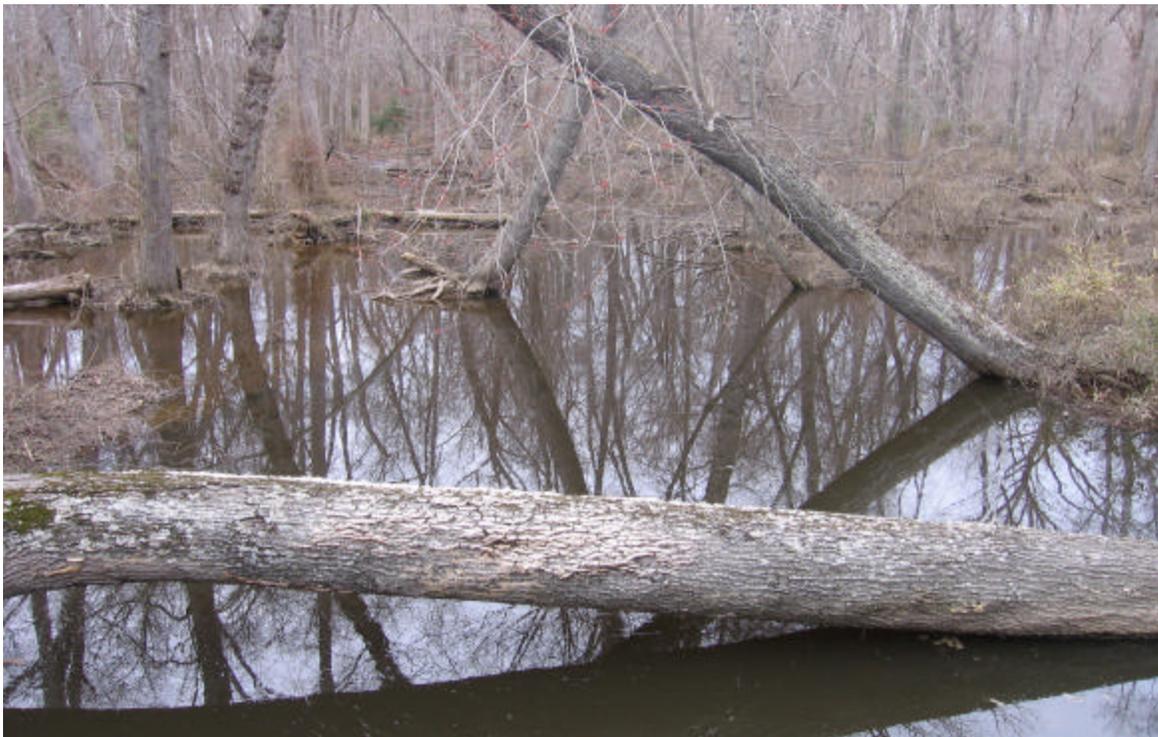
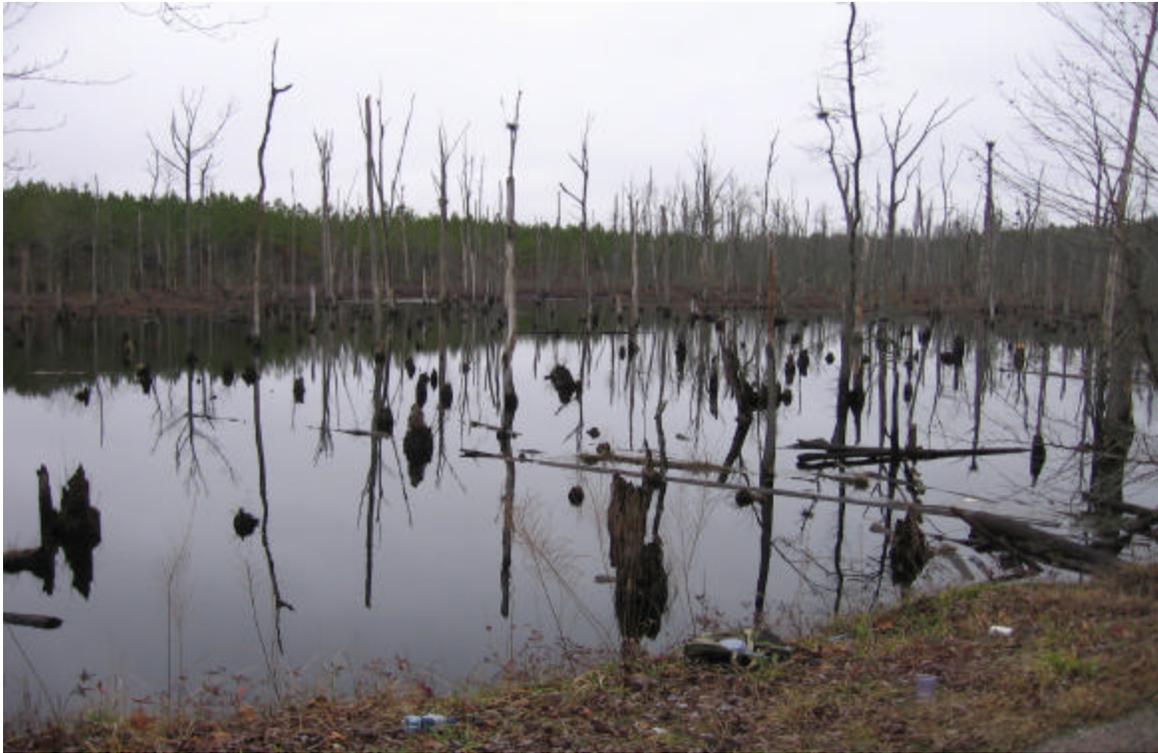
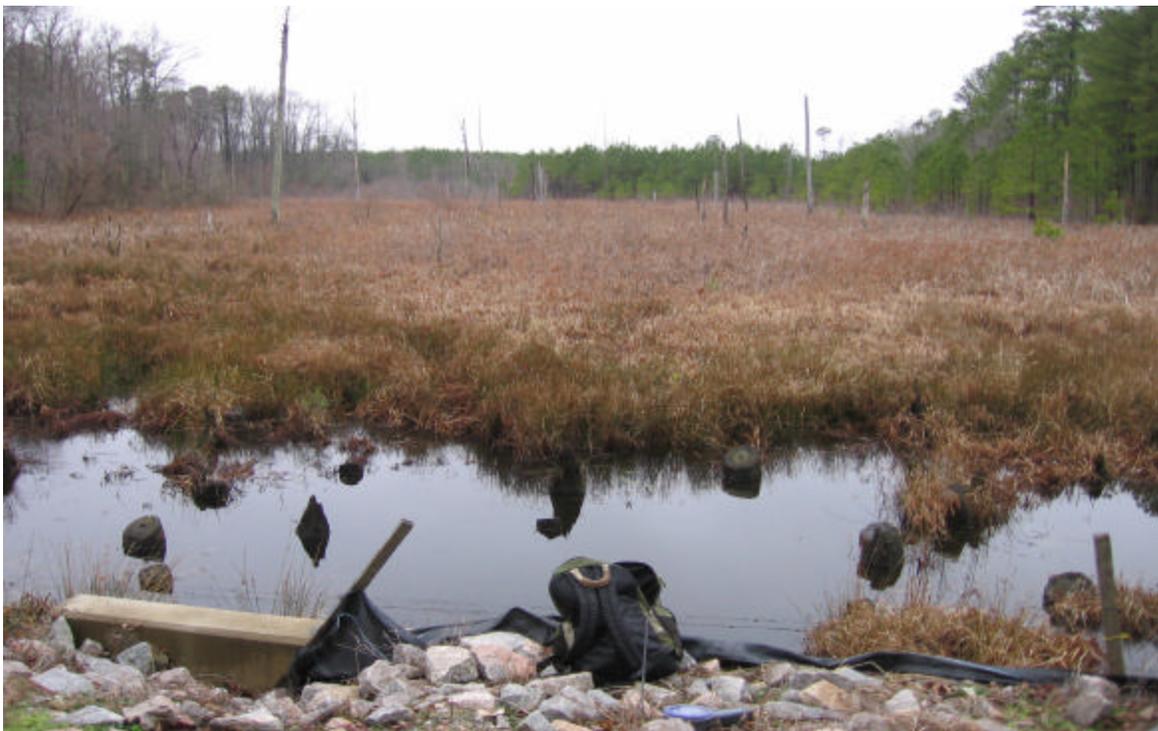
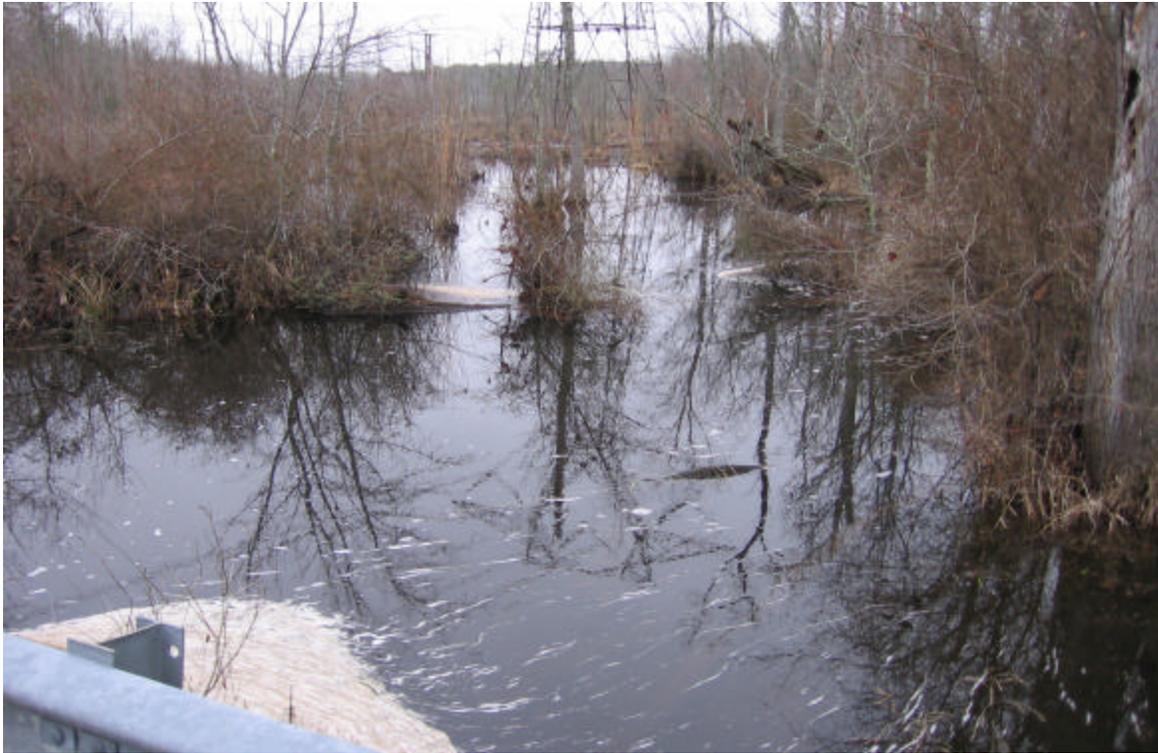
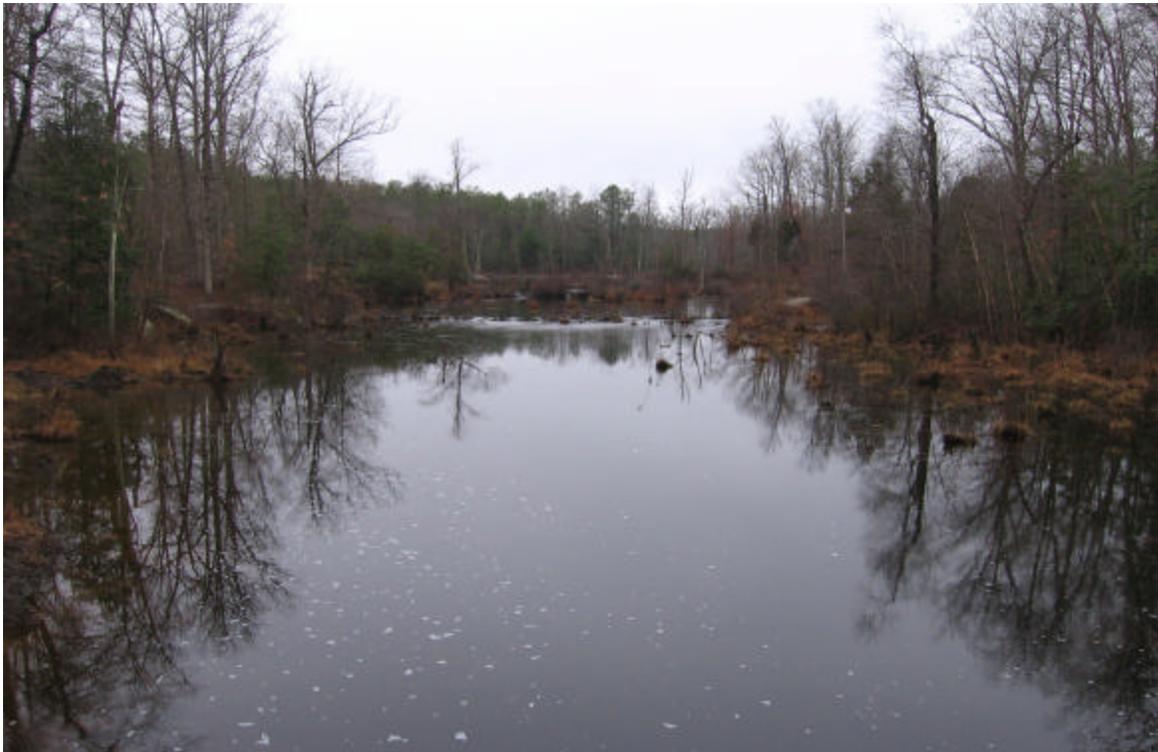
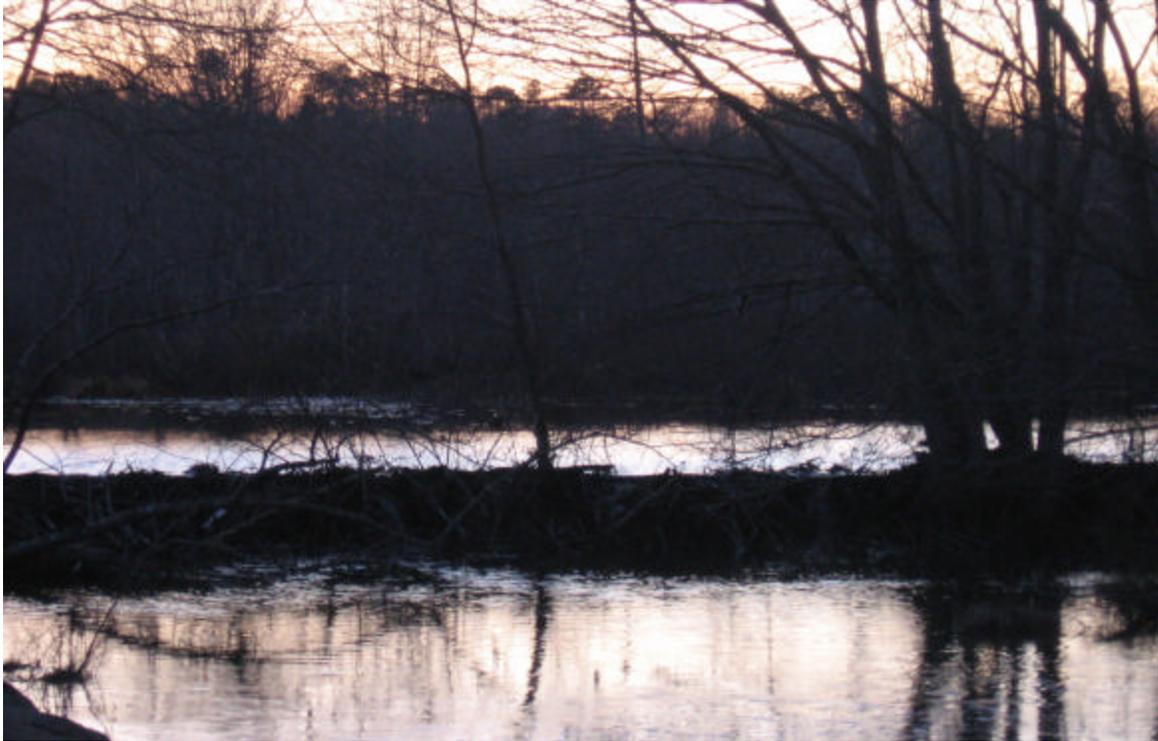
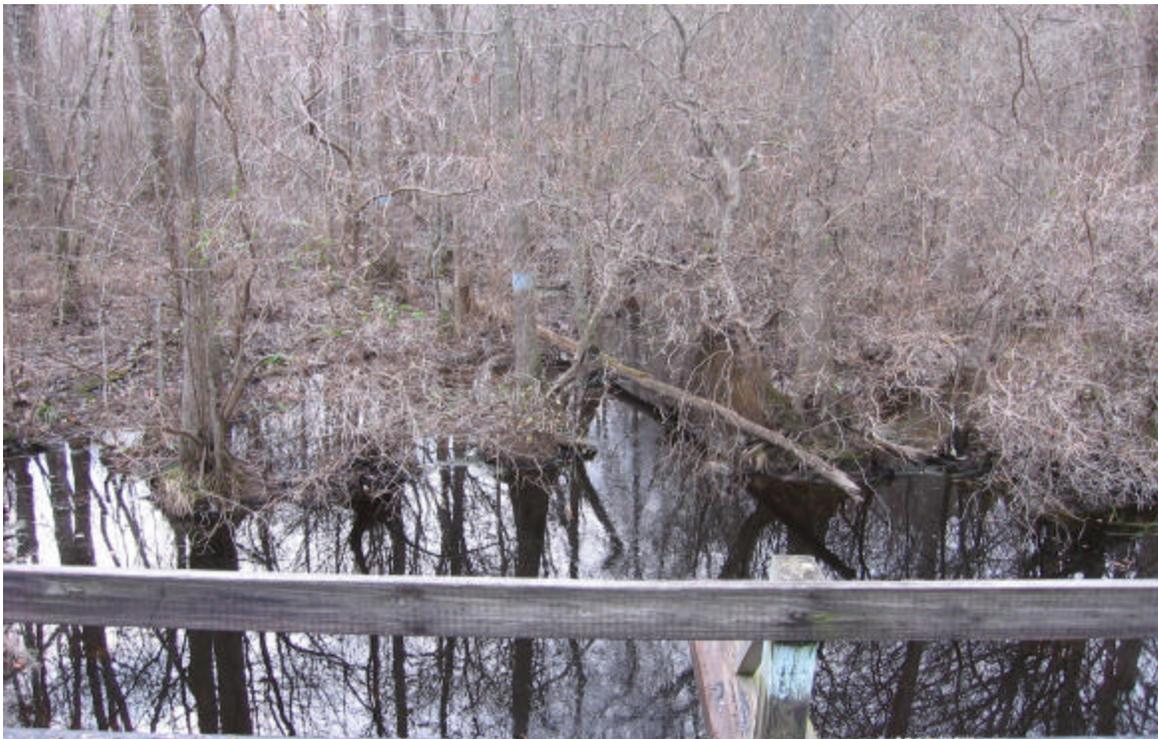
Visual inspections of the 30 Nottoway River tributaries revealed large swamp areas with heavy tree canopy. Decomposition of vegetative matter from large swampy areas lowers DO and pH as decay occurs. (Figures 59-73).
