# Coastal Evolution in Chesapeake Bay

Short and Long Term Impacts to  
The Edge

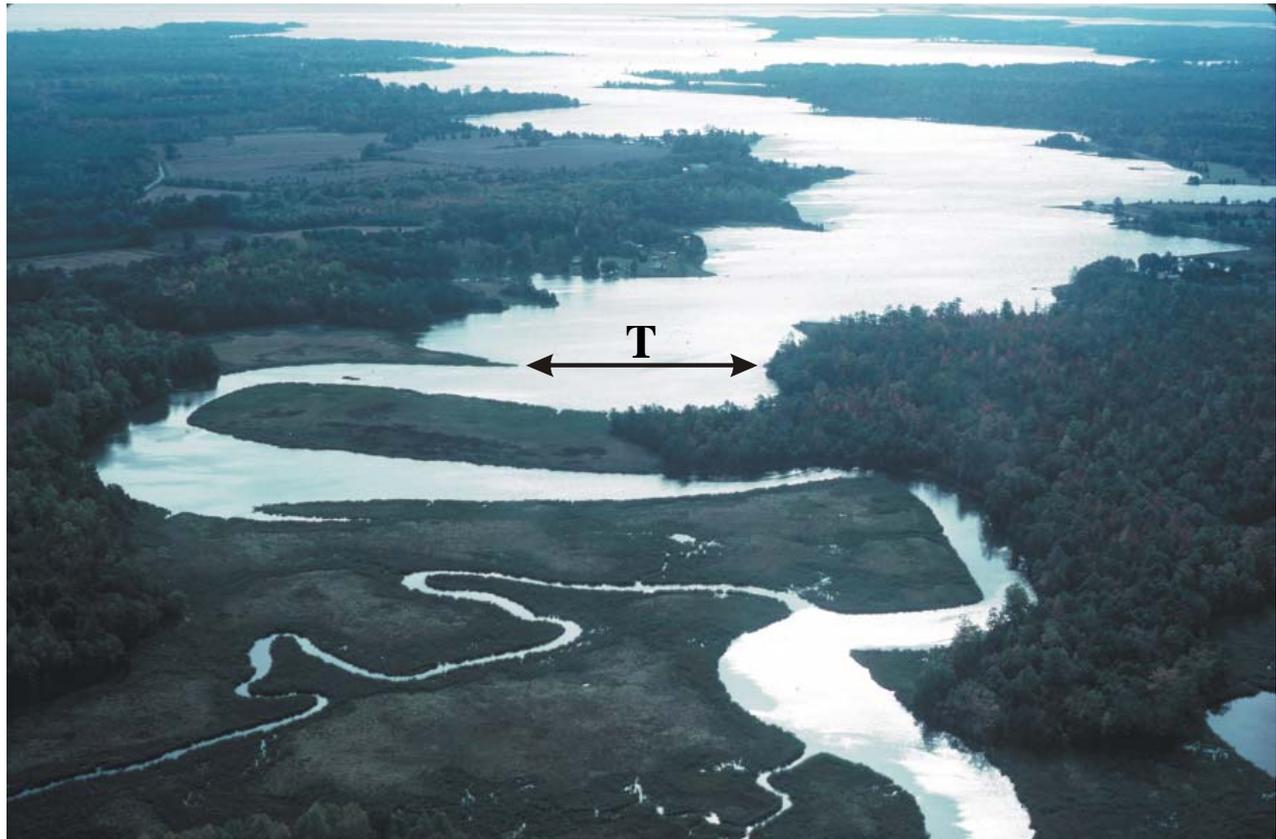
Broad marshes in foreground give way to fringing marshes downstream where there is greater fetch exposure. At the transition point (T), shoreline processes go from tidally dominated to wave dominated (Ware River, Virginia).

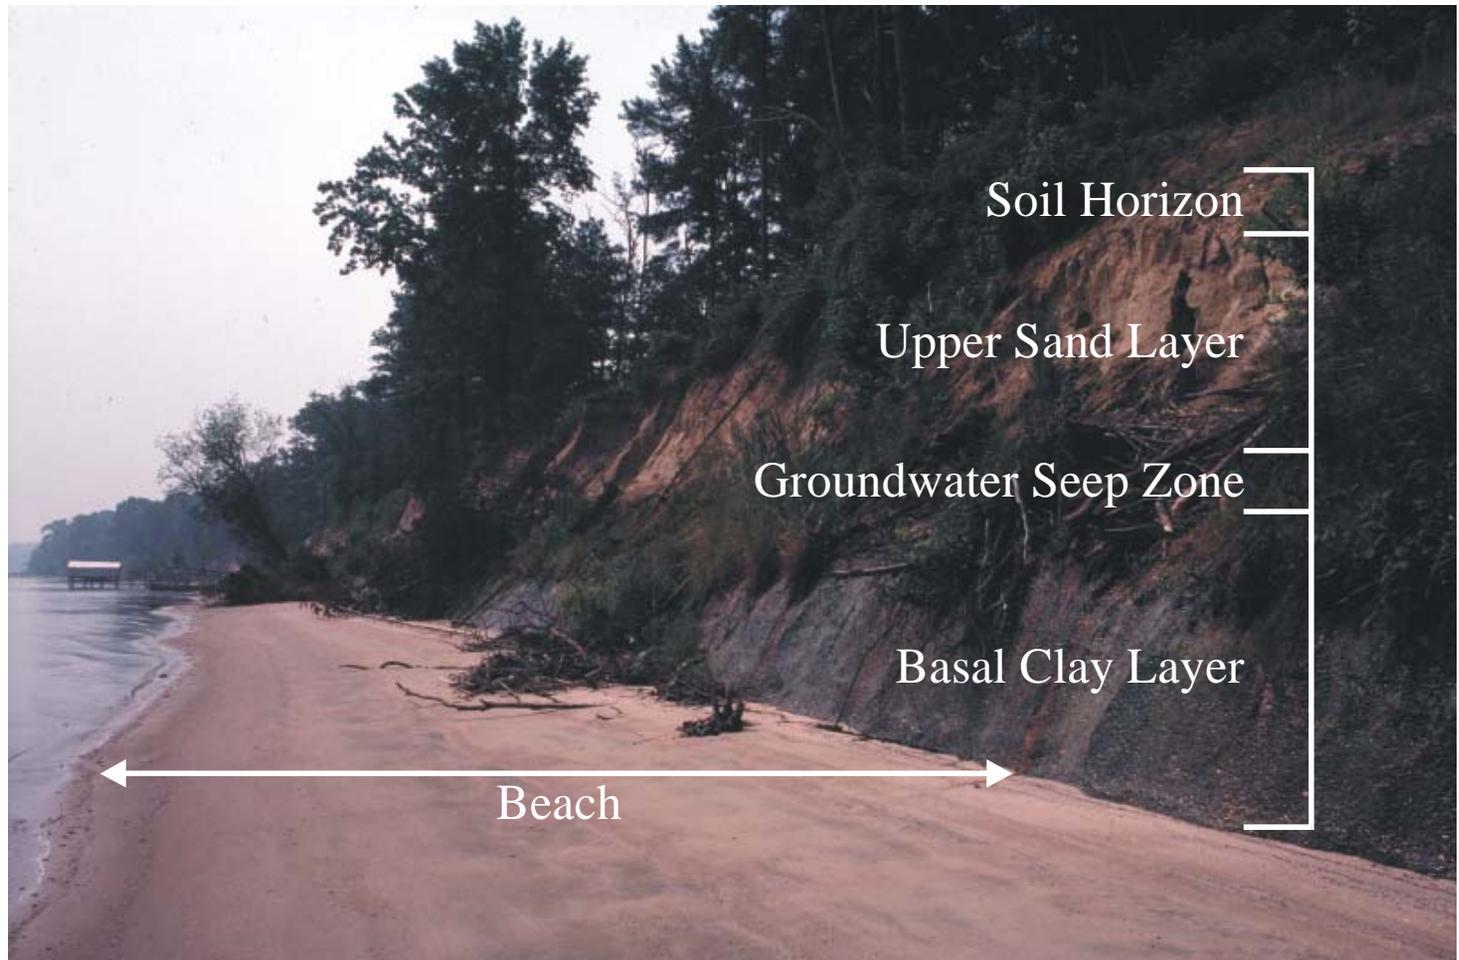
Exposed and eroding upland banks along the Rappahannock River, Virginia. Note: Basal clay acts as a groundwater perch causing the upper layer of sand to slump.

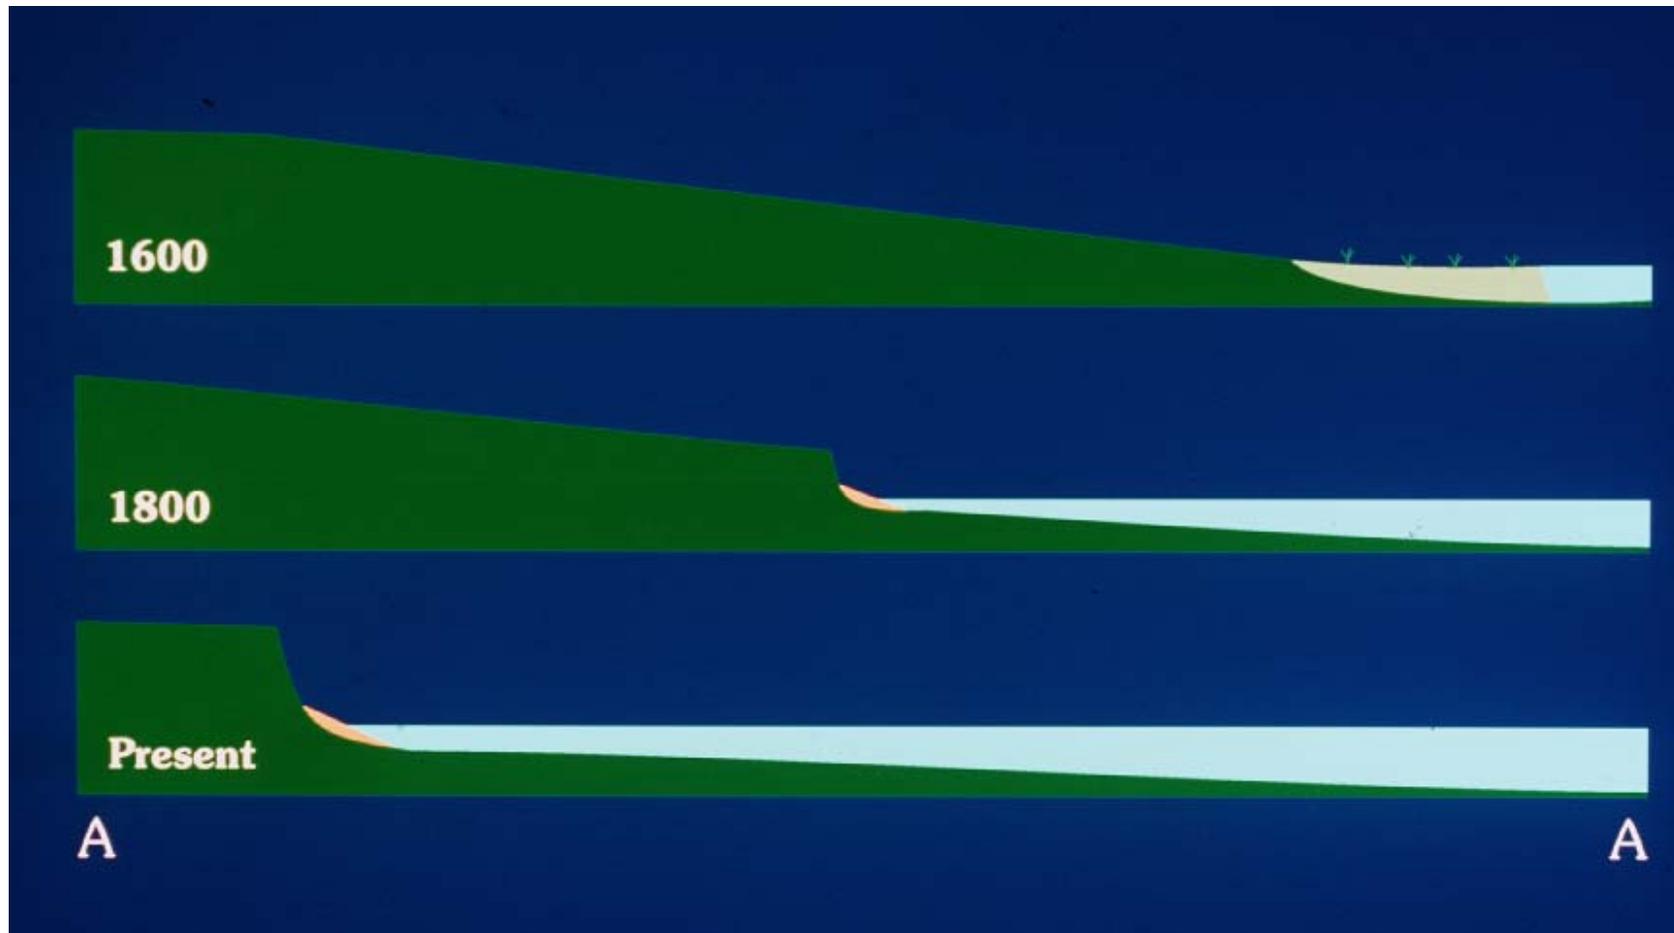
Cross-sectional change in shoreline morphology due to erosive or accretive processes and sea level change.

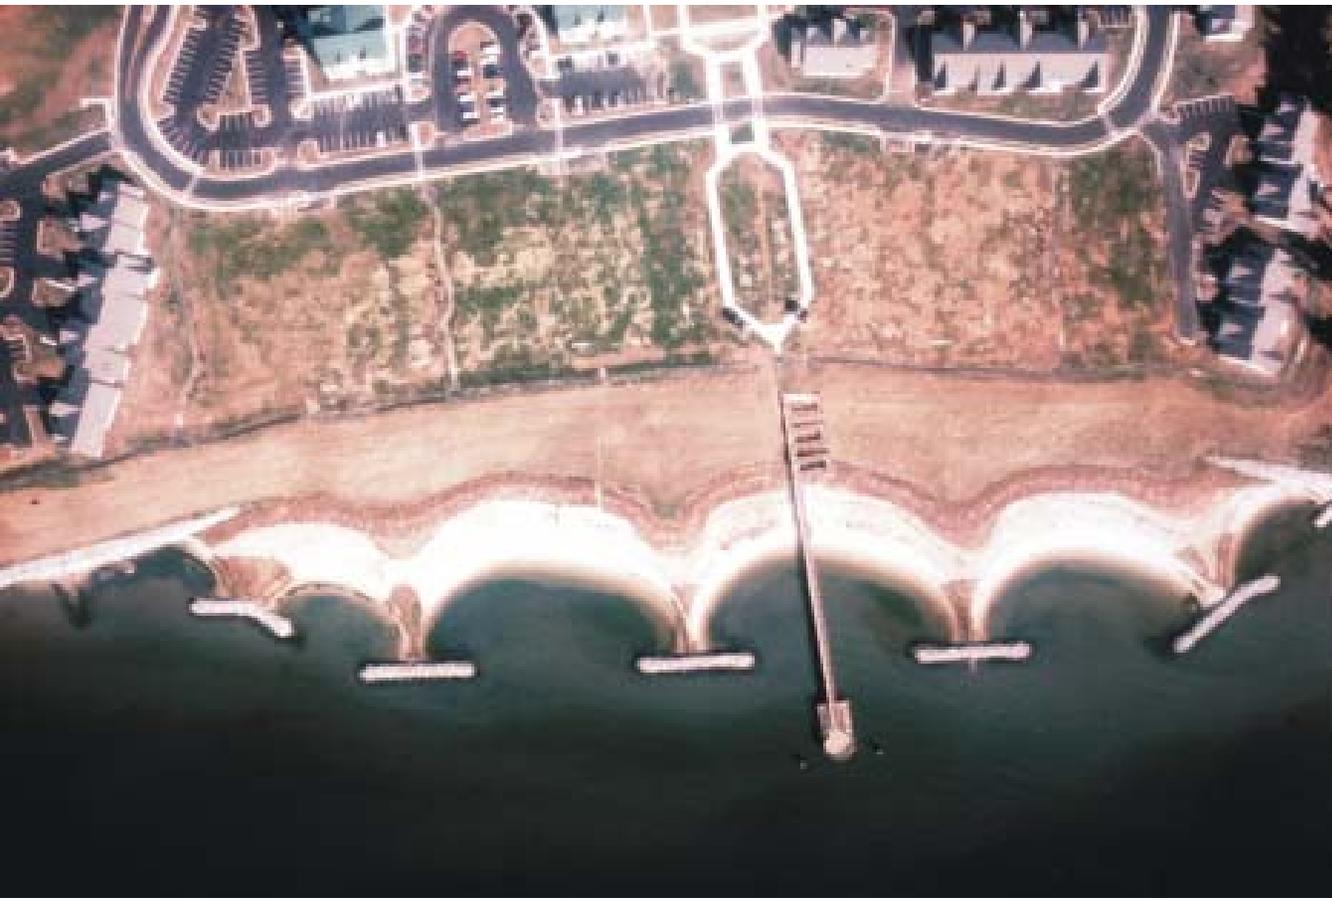
Breakwater system on Patuxent River in Calvert County, MD

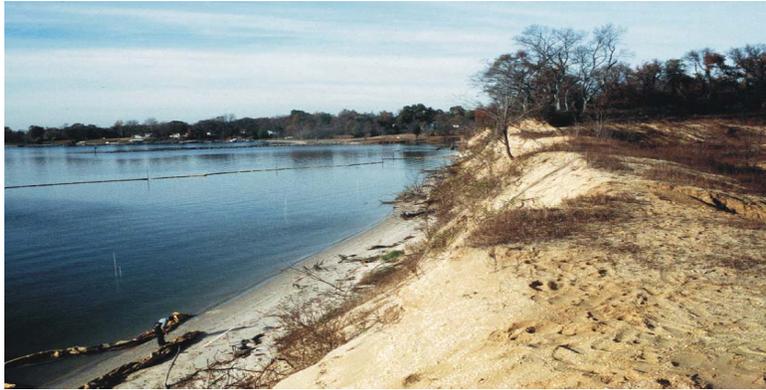
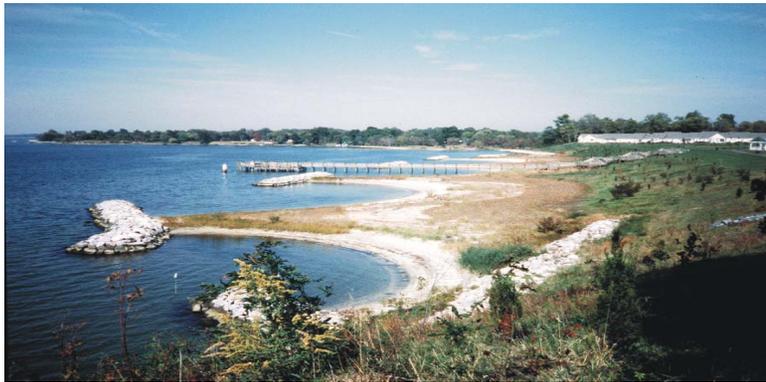
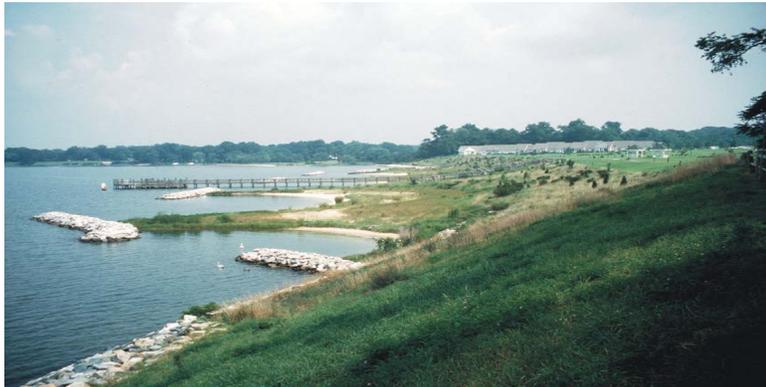
Asbury site before the project (November 1994), after the project (October 1998), and in August 2000.

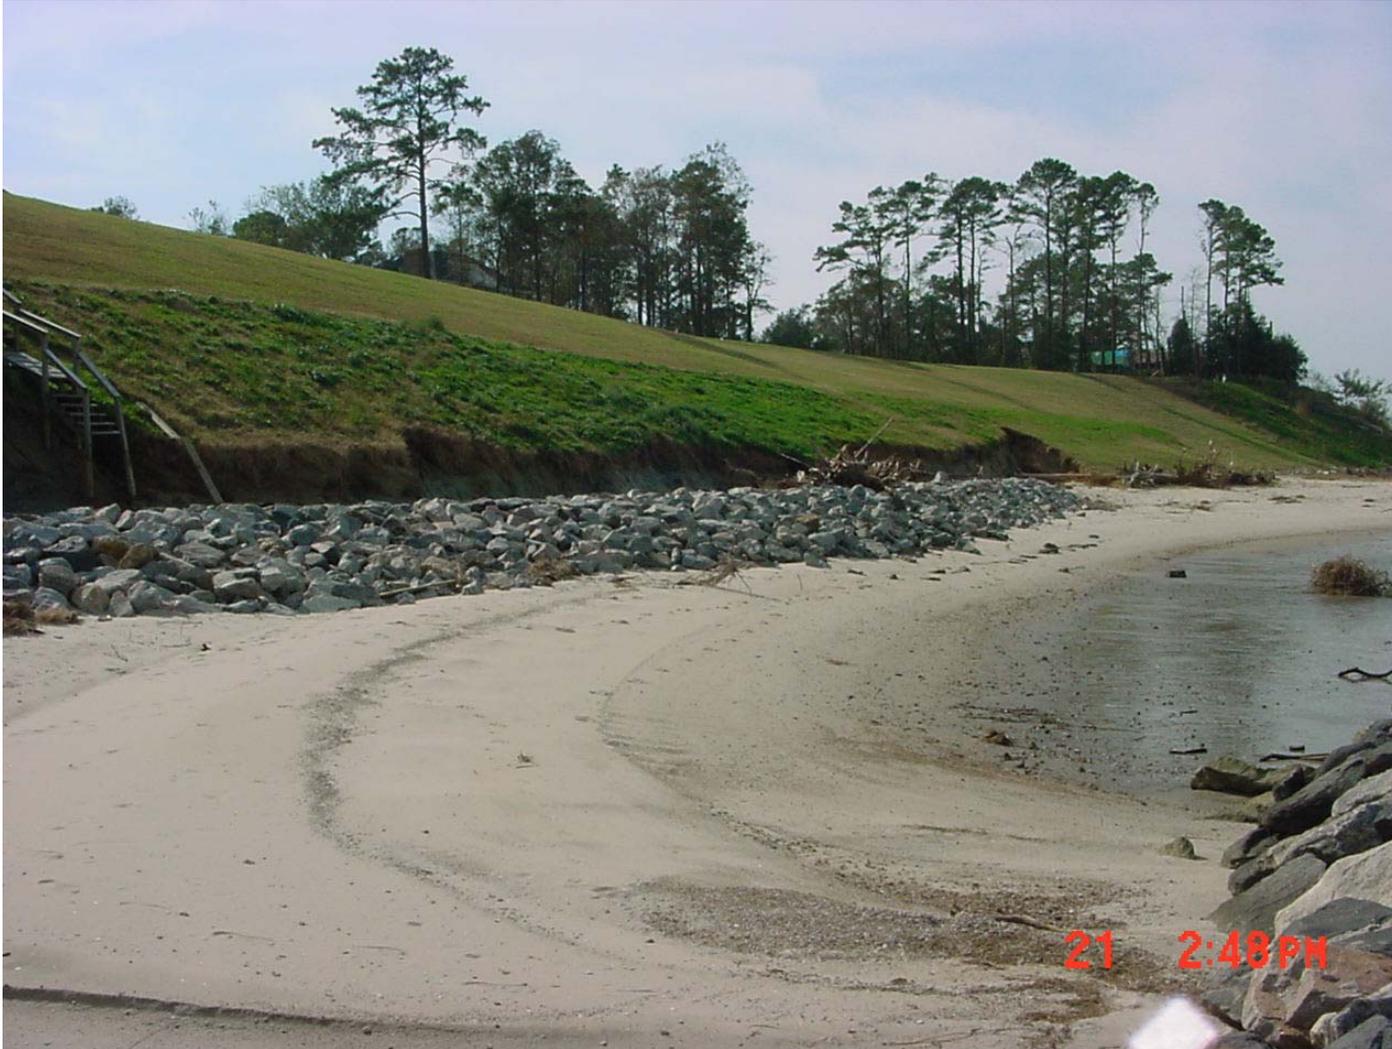
Post Isabel  
21 Oct 2003

The revetment at the east end of the site was overtopped by the storm surge and waves.

Note: no erosion of graded bank and beach is wide behind a headland breakwater.

Note: revetment crest elevation is +8 ft MLLW

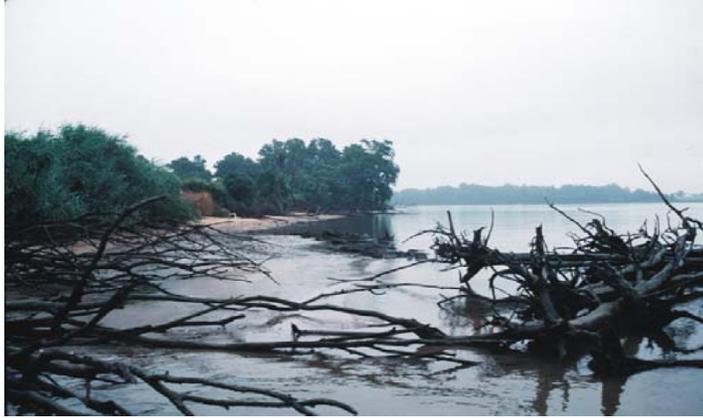
Drum Point before a  
breakwater project  
(August 11, 1989),

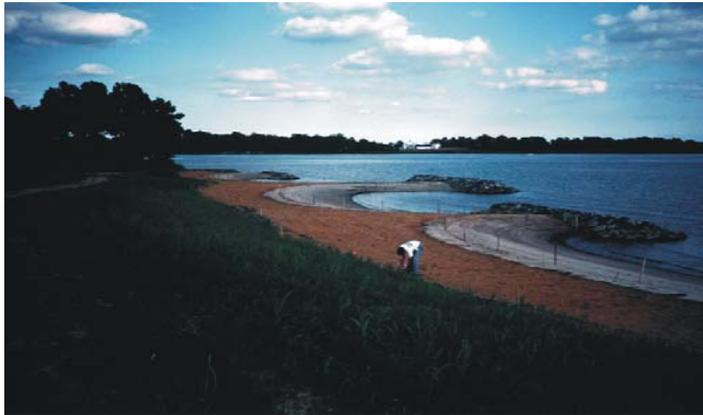
after a project (September  
7, 1990)

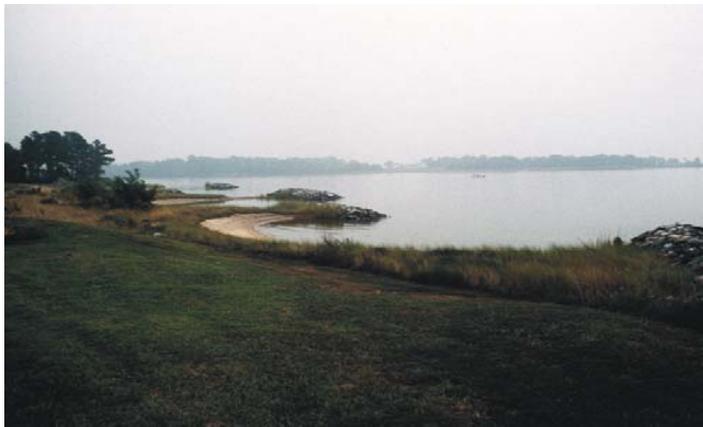
and in September 1994.
