FIELD INSPECTION

Project Name:	Mountain Valley Pipeline	Inspector:	Matthew Grant
Inspection Date:	Wednesday, October 10, 2018	Project Contact:	Brian Clauto
Spread: Giles County Access Rd G-I 234	Spread G	Weather (Wet/Dry/Rain):	Wet

FIELD INSPECTION PHOTO LOG

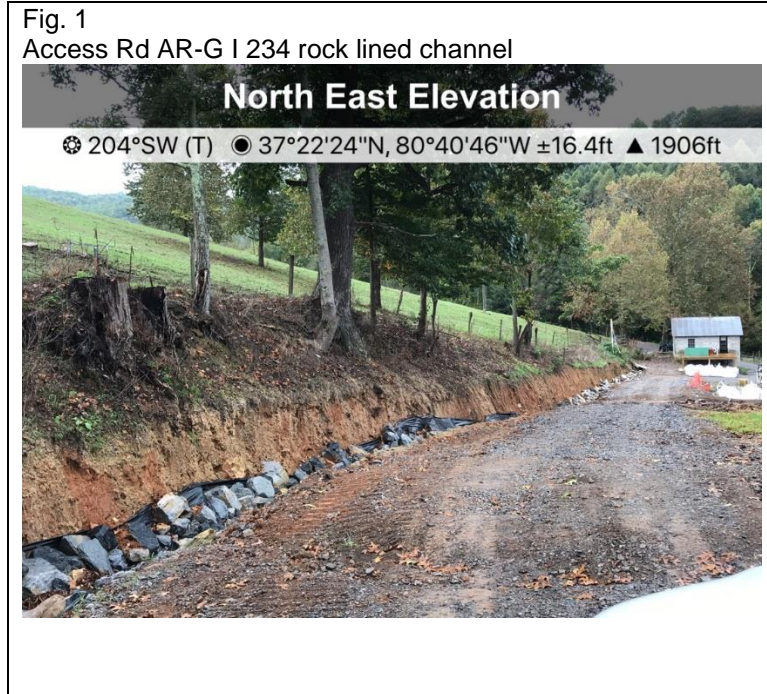
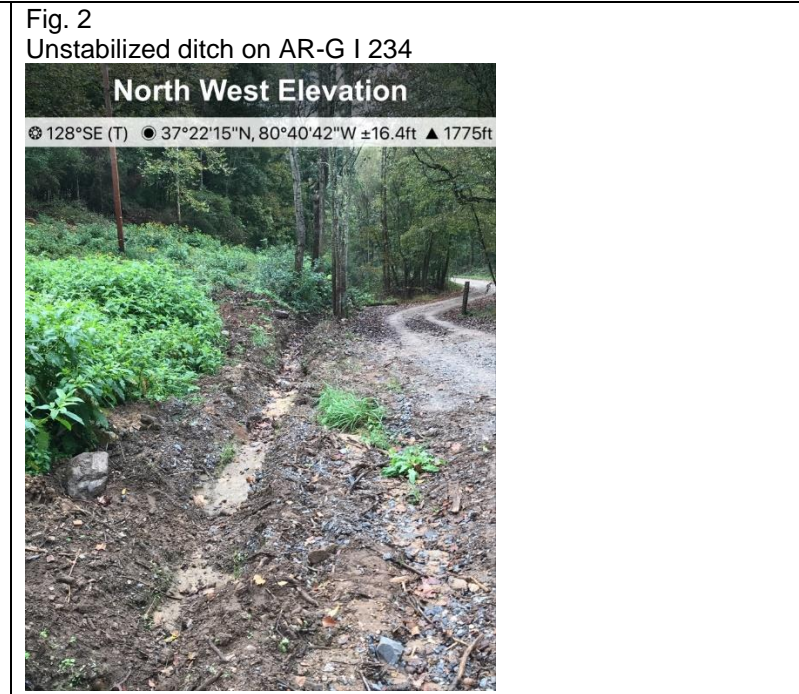
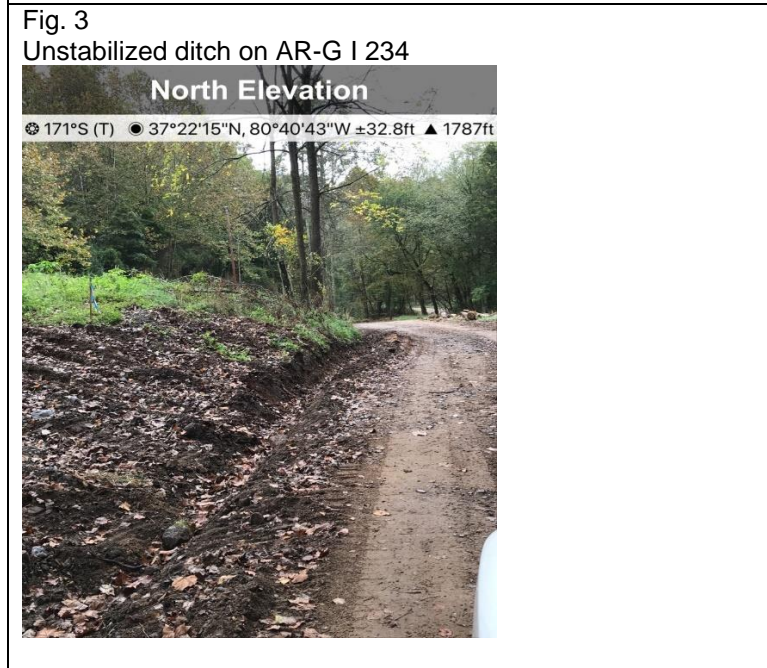
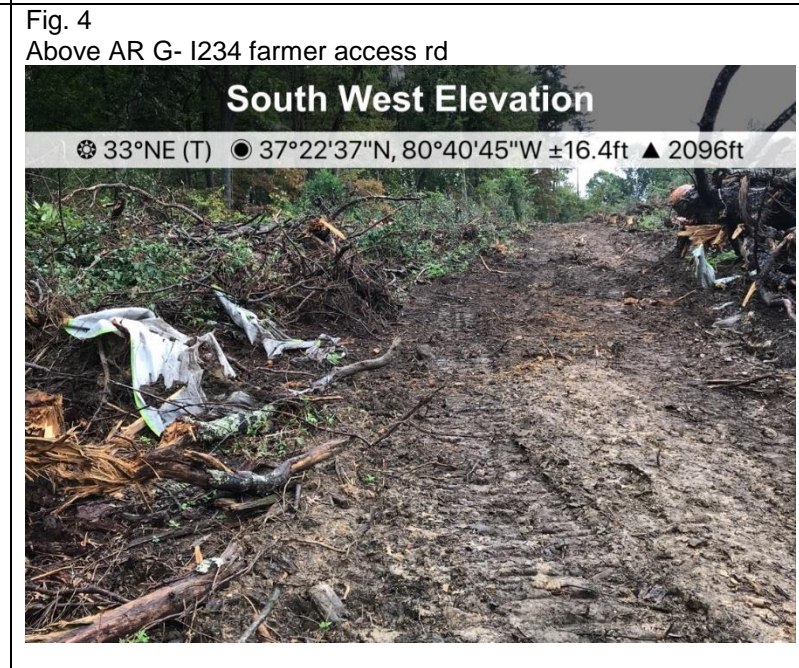
- **Area 1** –Access Road G-I 234, rock lined channel has been constructed. Additional work has been conducted not associated with the MVP including a farmer’s access road in an area that FERC has stopped work and an unstabilized ditch leading to designated stream S-Q14.

Recommended Corrective Action: Install ECD on farmer’s access road leading to the ROW in the No Activity Area per the FERC.

Deadline: Within 24hr notification
