City of Fredericksburg, Virginia Shoreline Inventory Report Methods and Guidelines

**Comprehensive Coastal Inventory Program
Center for Coastal Resources Management
Virginia Institute of Marine Science, College of William and Mary
Gloucester Point, Virginia
September 2017**

Special report in Applied Marine Science and Ocean Engineering No. 458 of the Virginia Institute of Marine Science

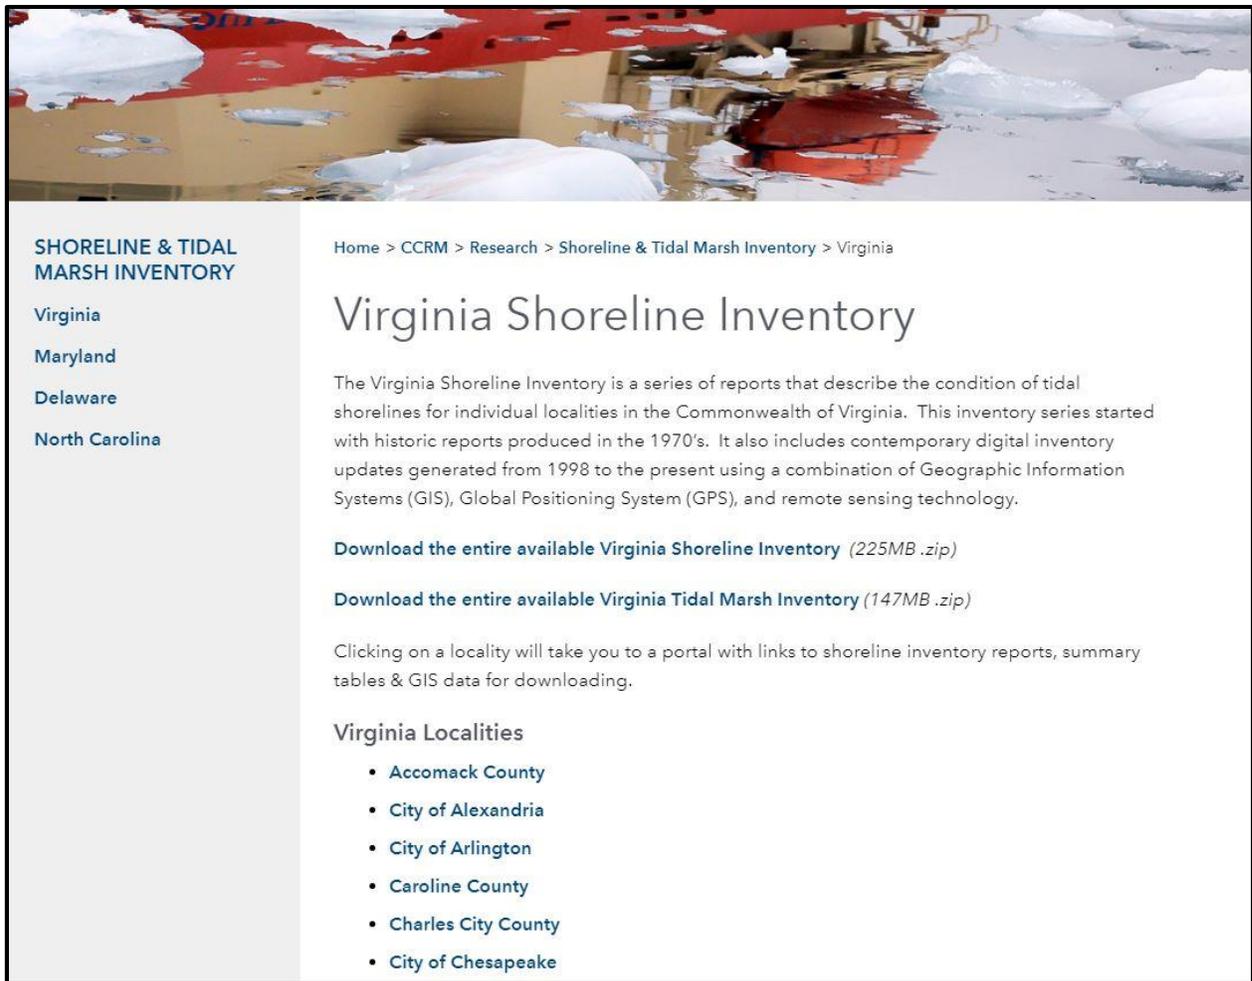
Figure 1. Shoreline Inventory Website

2.4c.) Map Viewer and Summary Tables: The City of Fredericksburg Shoreline Inventory is delivered to the end user through a website; <http://www.vims.edu/ccrm/research/inventory/virginia/index.php> (Figure 1.), by clicking on the City of Fredericksburg in the list of localities. The new format for Shoreline Inventories includes a map viewing tool rather than maps in pdf format. The map viewer allows users to interact with the datasets within a familiar “google” type map service that was developed with Javascript. Here they can view data of their choice and customize map products for printing themselves. Access to the GIS data, summary tables and methods report is also available through this website.

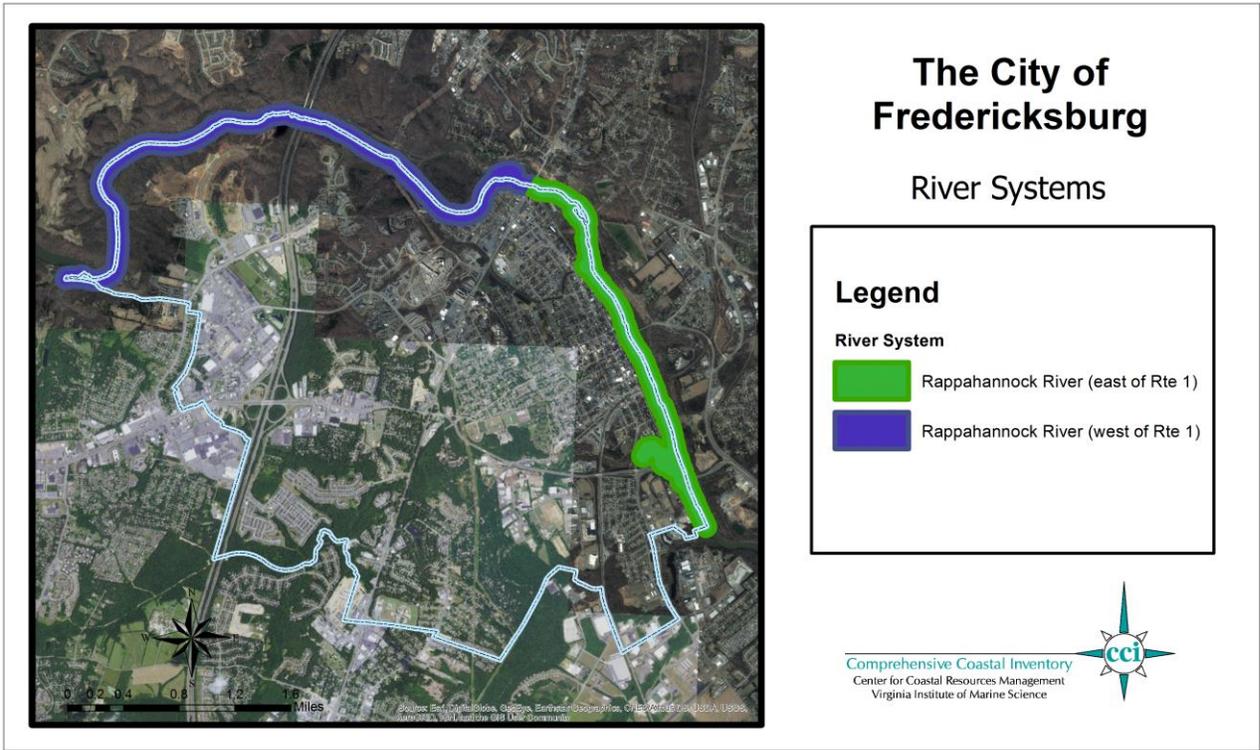
Figure 2. River Systems in the City of Fredericksburg

Summary tables (Tables 4-7) quantify conditions observed on the basis of river systems (Figure 2). Refer to Figure 2 for the location of these rivers systems. Note, river systems do not correspond to watershed boundaries. They were developed for convenience in reporting data.

The top toolbar also includes tabs to access some important status information for the locality. By clicking on the “River System Pie Charts” button, users can obtain a statistical summary distribution of the riparian land use and amount of hardened shoreline for a specific water body selected from the drop down menu in the upper left (Figure 7). More detailed results in table format can be found by clicking the City of Fredericksburg Summary PDF button also in the window. The summary statistics are reported by river systems (Figure 2).

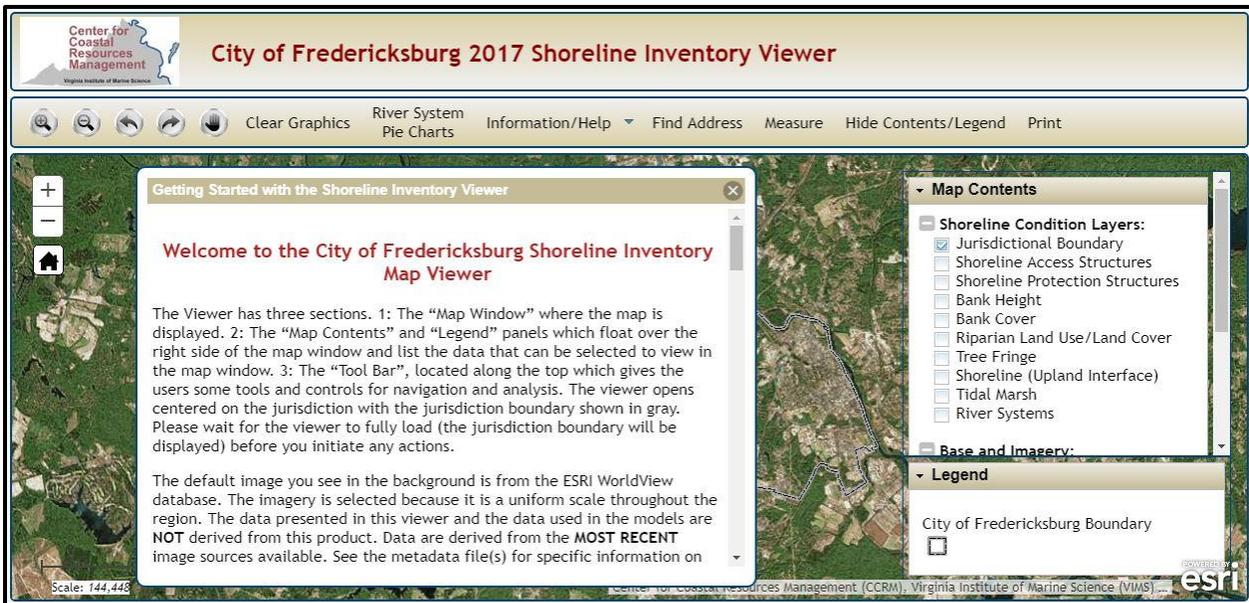
Figure 3. Opening page for the City of Fredericksburg Shoreline Inventory Viewer

The Viewer has two panels: “Map Window”, where the map is displayed and “Map Contents and Legend”, where data that can be selected and viewed in the map window are listed. A tool bar is located along the top of the “Map Window” which gives users some controls for navigation and analysis (Figure 3.).

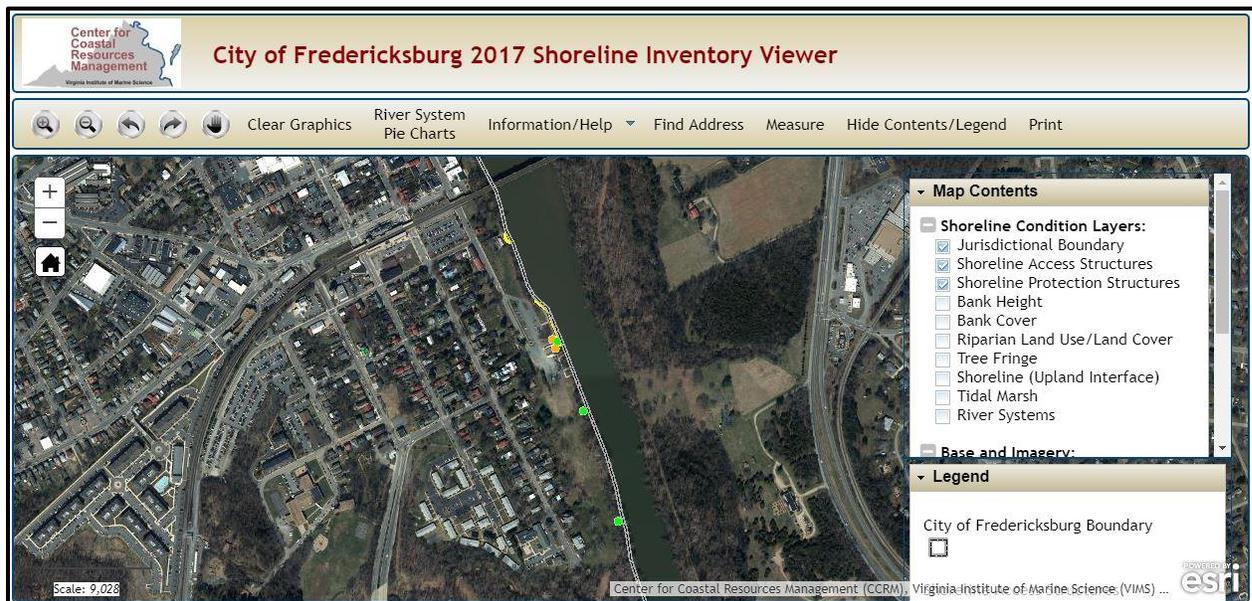
Figure 4. Map Viewer illustrates Shoreline Access and Protection Structures for a section of the City of Fredericksburg.

In Figure 4 Shoreline Access Structures, and Shoreline Protection structures are selected. Shoreline Access structures are point features that includes piers and boat ramps. The actual footprint of these structures is not measured; only their location. Shoreline Protection Structures are line features and are mapped and illustrated in the viewer to show where they occur along the shoreline. Figure 5 illustrates riparian land use in the riparian zone for the same section of the County.

From the “Map Contents” the user may check various attribute layers on or off. The user must use the scroll bar on the far right to see the complete list of layers available. When layers are turned on, the corresponding legend appears in the “Legend” panel, and the data are displayed in the “Map Window” (Figure 4).

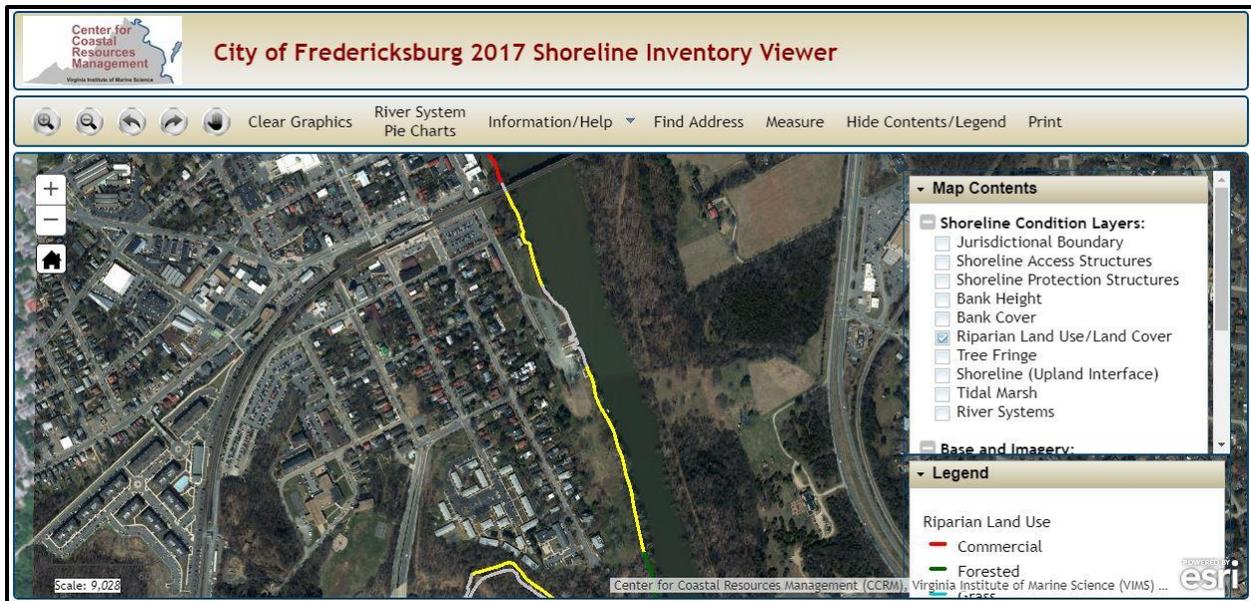
Figure 5. Distribution of land use in the riparian zone is displayed for this region of the City of Fredericksburg.

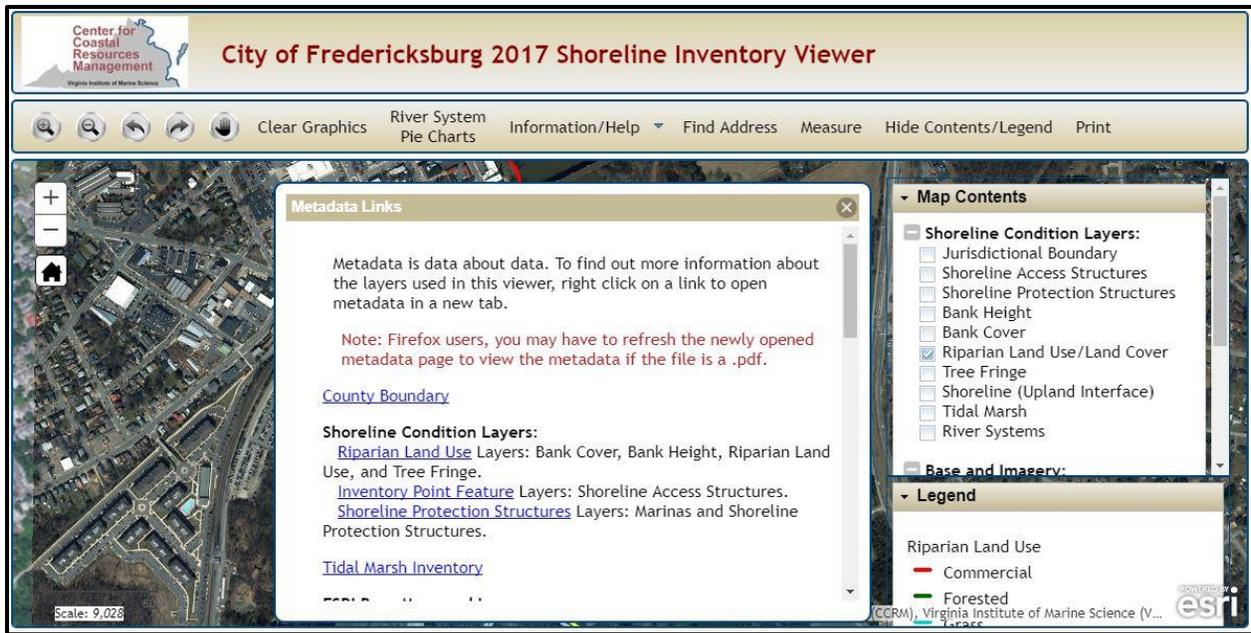
Figure 6. Link to Metadata records has been selected from the top Information tab in the toolbar.

The user can use the zoom and pan tools from the top toolbar or the slide bar on the left side of the map window to change their map extent. If the map resolution is exceeded the window will become illegible. Detailed information can be obtained about the data by selecting the “Information/Help” tab at the top of the map viewer. From here the inventory glossary and metadata records can be easily accessed. In Figure 6 the selection for metadata has been made and 5 possible records can be retrieved.

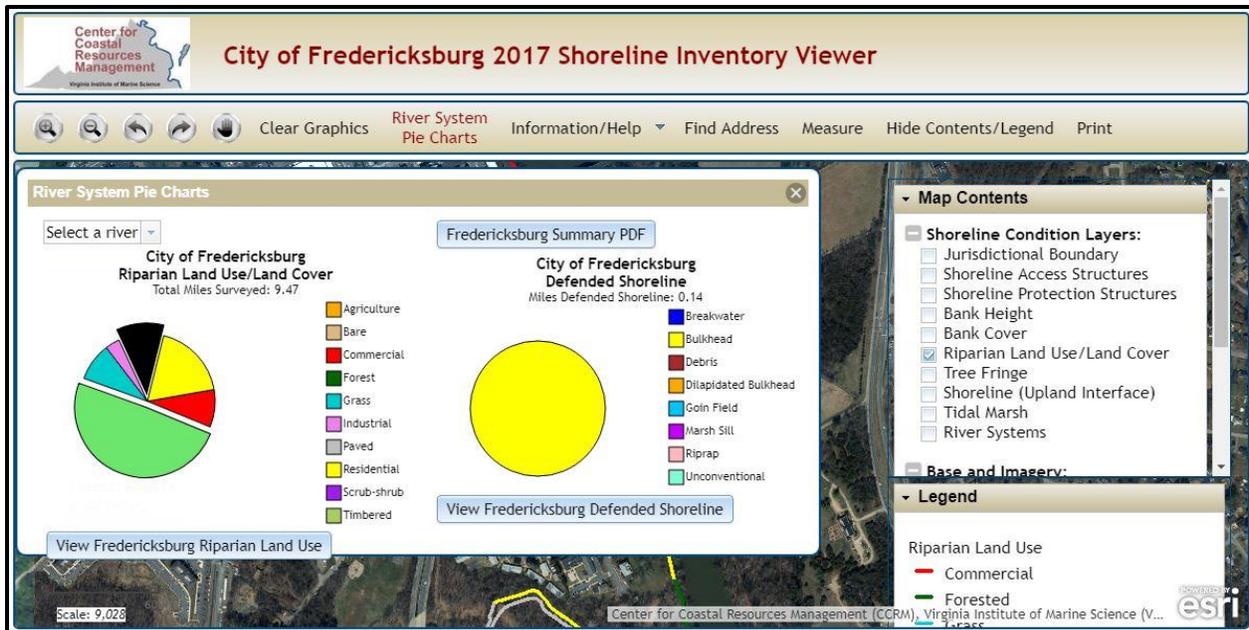
Figure 7. Pie charts display land use and shoreline hardening statistics for each tributary.

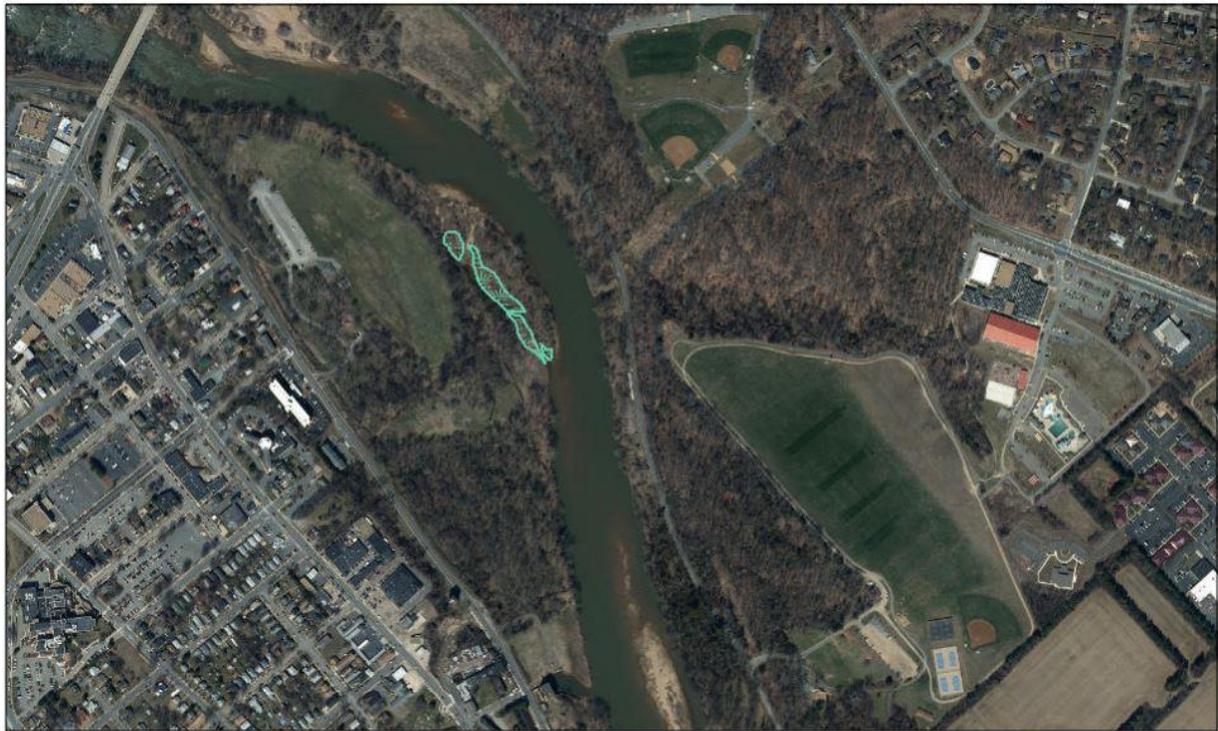
Tidal Marsh - Section of Rappahannock River

Tidal Marsh
Community Type

Undetermined
