Charles City County, Virginia Shoreline Inventory Report Methods and Guidelines

**Comprehensive Coastal Inventory Program
Center for Coastal Resources Management
Virginia Institute of Marine Science, College of William and Mary
Gloucester Point, Virginia
October, 2013**

Special report in Applied Marine Science and Ocean Engineering No. 436 of the Virginia Institute of Marine Science

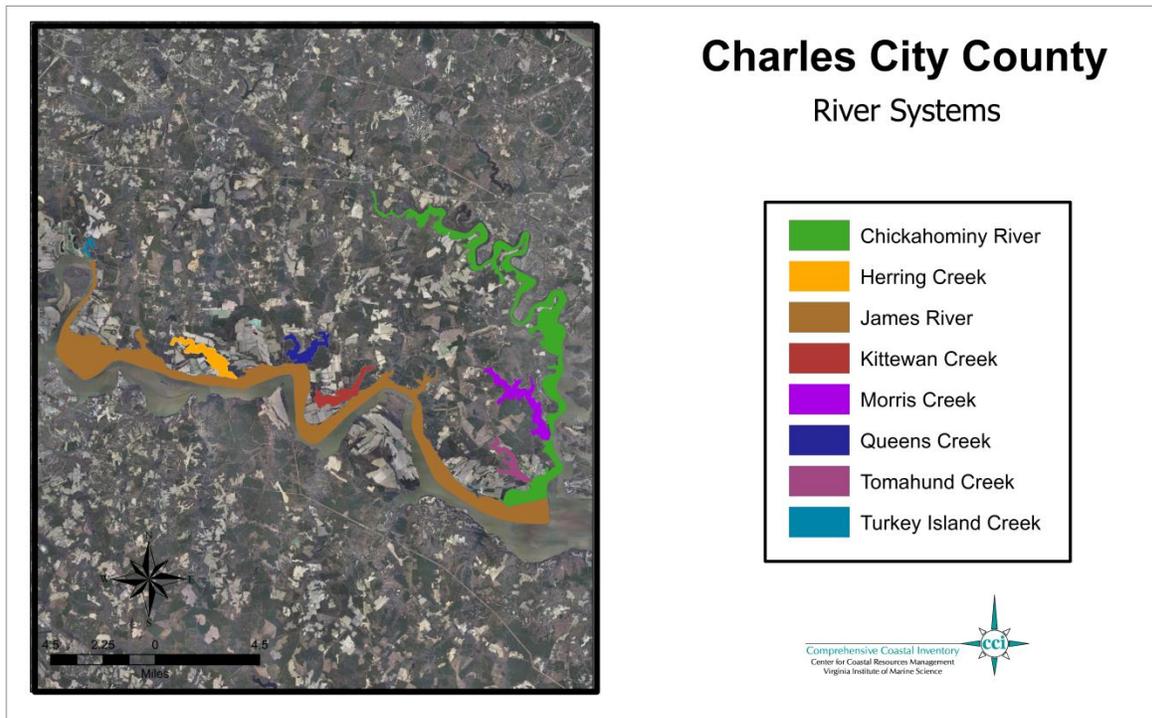
Figure 2. River Systems in Charles City County

Summary tables quantify conditions observed on the basis of river systems (Figure 2). The total miles surveyed in the field and using remote sensing techniques is reported in Table 4.

The top toolbar also includes tabs to access some important status information for the locality. By clicking on the “River System Pie Charts” button, users can obtain a statistical summary distribution of the riparian land use and amount of hardened shoreline for a specific water body which is selected from the drop down menu in the upper left (Figure 8). More detailed results in table format can be found by clicking the Charles City County Summary PDF button also in the window. The summary statistics are reported by river systems (Figure 2).

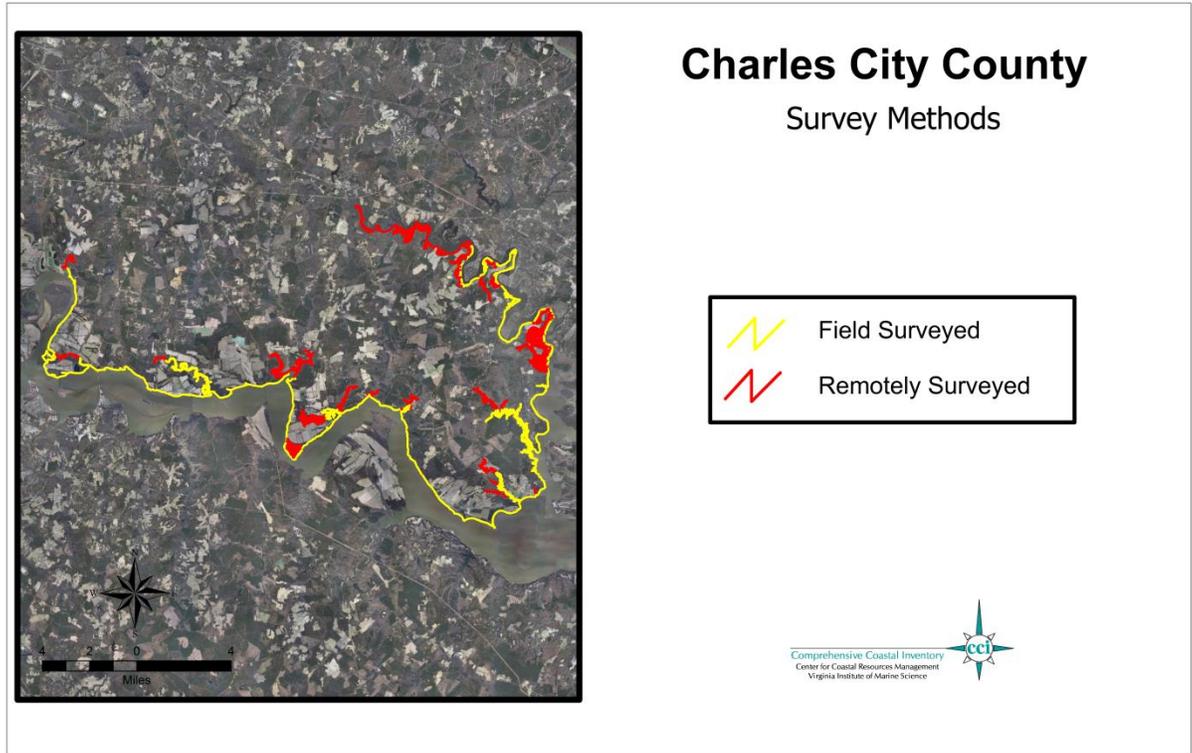
Figure 3. Survey Methodology in Charles City County

In the Charles City County, nearly 127.71 miles of shoreline were surveyed in the field. Just over 160 miles of shoreline were surveyed remotely. Remotely sensed areas comprised mainly the upper reach of the Chickahominy River as well the headwaters of the other tributaries (Figure 3). All these areas are noted in Table 4 along with either survey dates and/or the image year class used for remote coding.

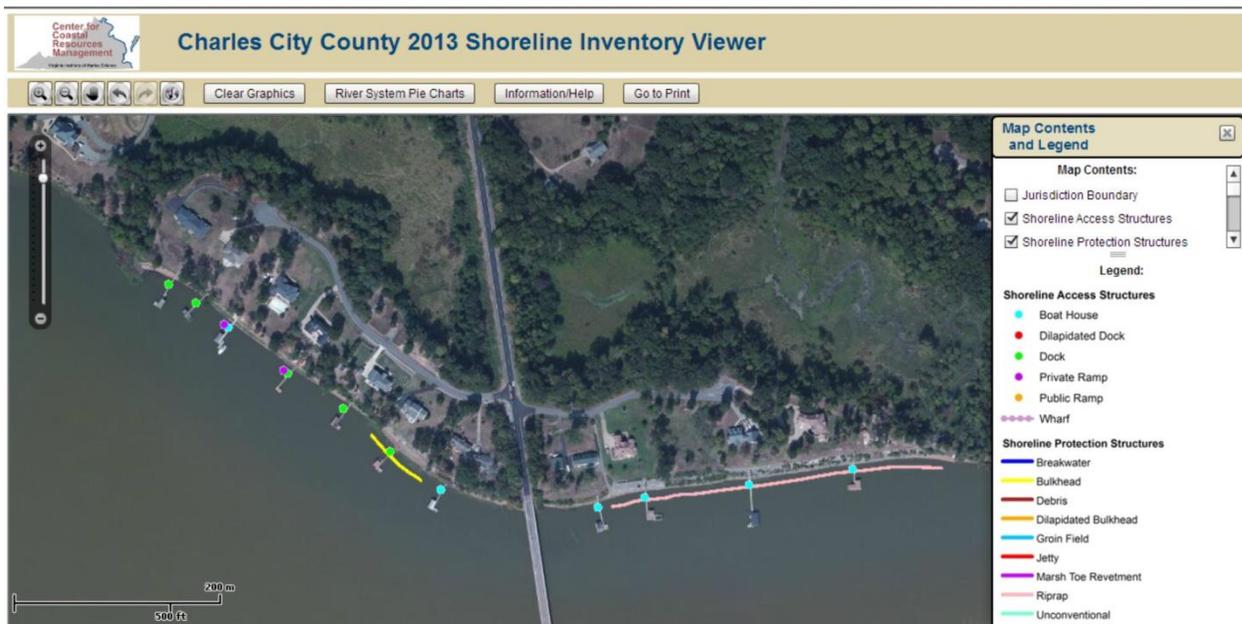
Figure 5. Map Viewer illustrates Shoreline Access and Protection Structures.

In Figure 5 Shoreline Access Structures, and Shoreline Protection structures have been selected along with the boundary. Shoreline Access structures are point features that includes piers and boat ramps. The actual footprint of these structures is not measured; only their location. Shoreline Protection Structures are line features and are mapped and illustrated in the viewer to show where they occur along the shoreline. Figure 6 illustrates riparian land use.
