James City County and City of Williamsburg, Virginia Shoreline Inventory Report Methods and Guidelines

**Comprehensive Coastal Inventory Program
Center for Coastal Resources Management
Virginia Institute of Marine Science, College of William and Mary
Gloucester Point, Virginia
December, 2014**

Special report in Applied Marine Science and Ocean Engineering No. 440 of the Virginia Institute of Marine Science

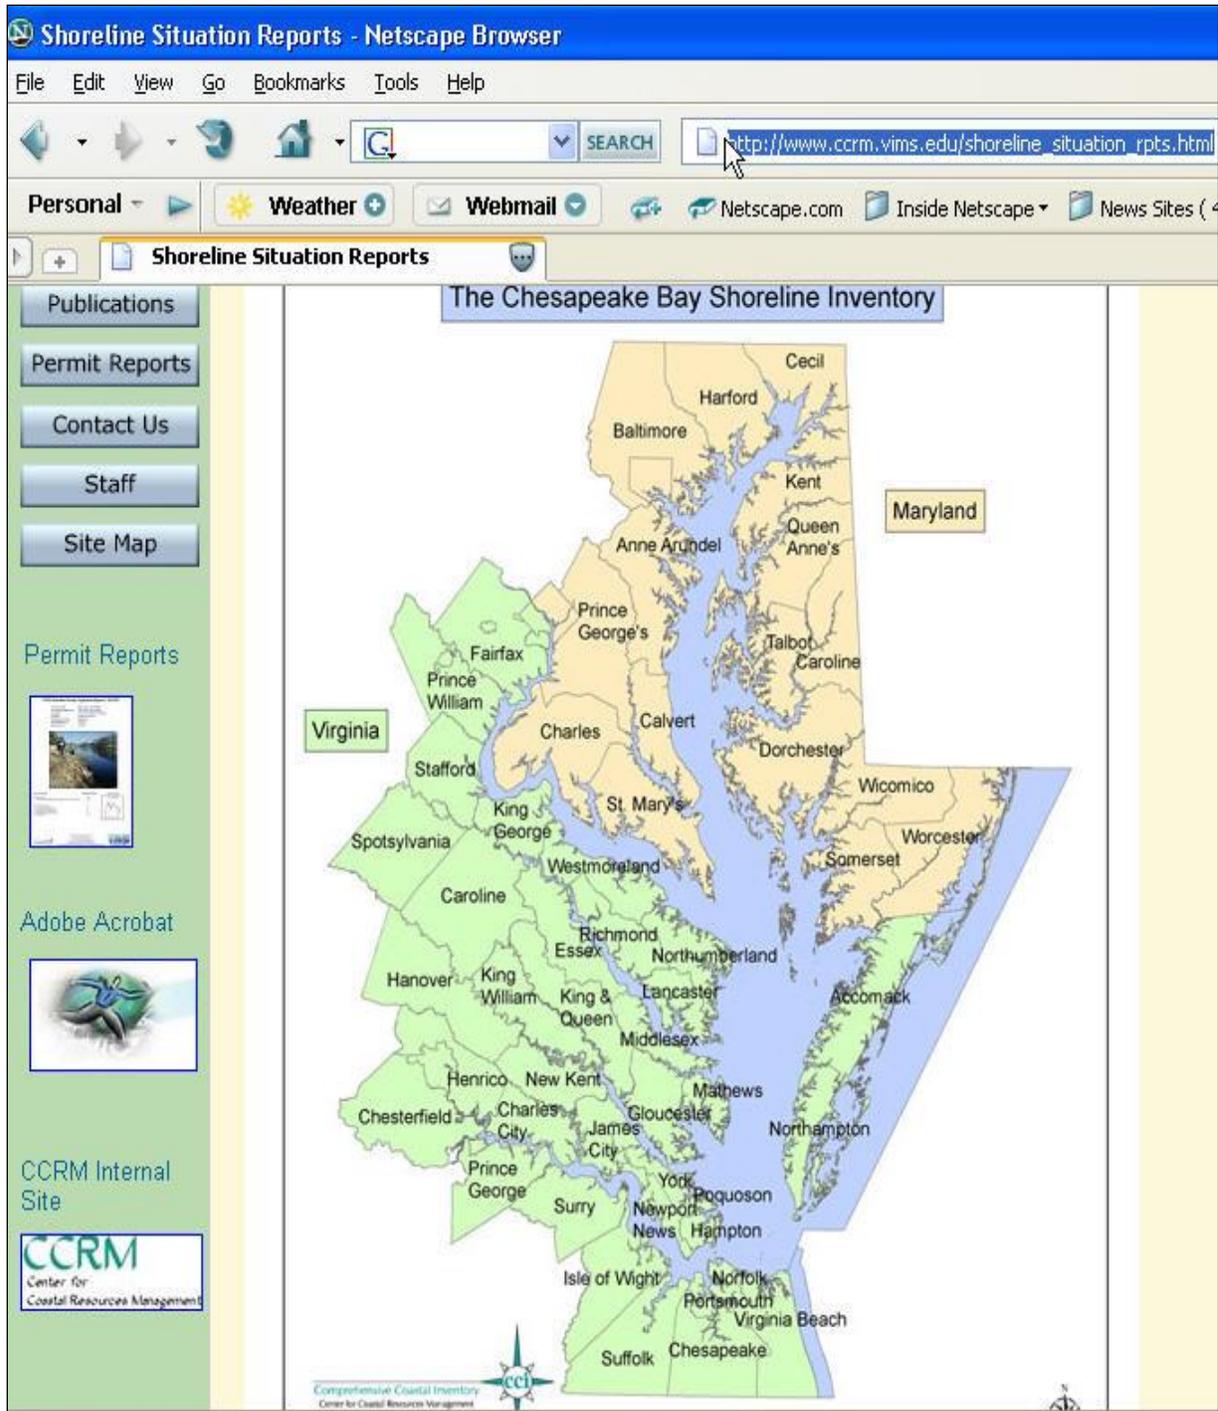
Figure 1. Shoreline Inventory Website

2.4c.) Map Viewer and Summary Tables: The James City County and City of Williamsburg Shoreline Inventory is delivered to the end user through a website; http://ccrm.vims.edu/gis_data_maps/shoreline_inventories/index.html (Figure 1.), by clicking on James City County and City of Williamsburg in the map or list of localities. The format for this inventory includes a map viewing tool rather than individual maps as in previous inventories. The map viewer allows users to interact with the datasets within a familiar “google” type map service that was developed in a Flex/Flash framework. Here they can view data of their choice and customize map products for printing themselves. Access to the GIS data, summary tables and methods report is also available through this website.

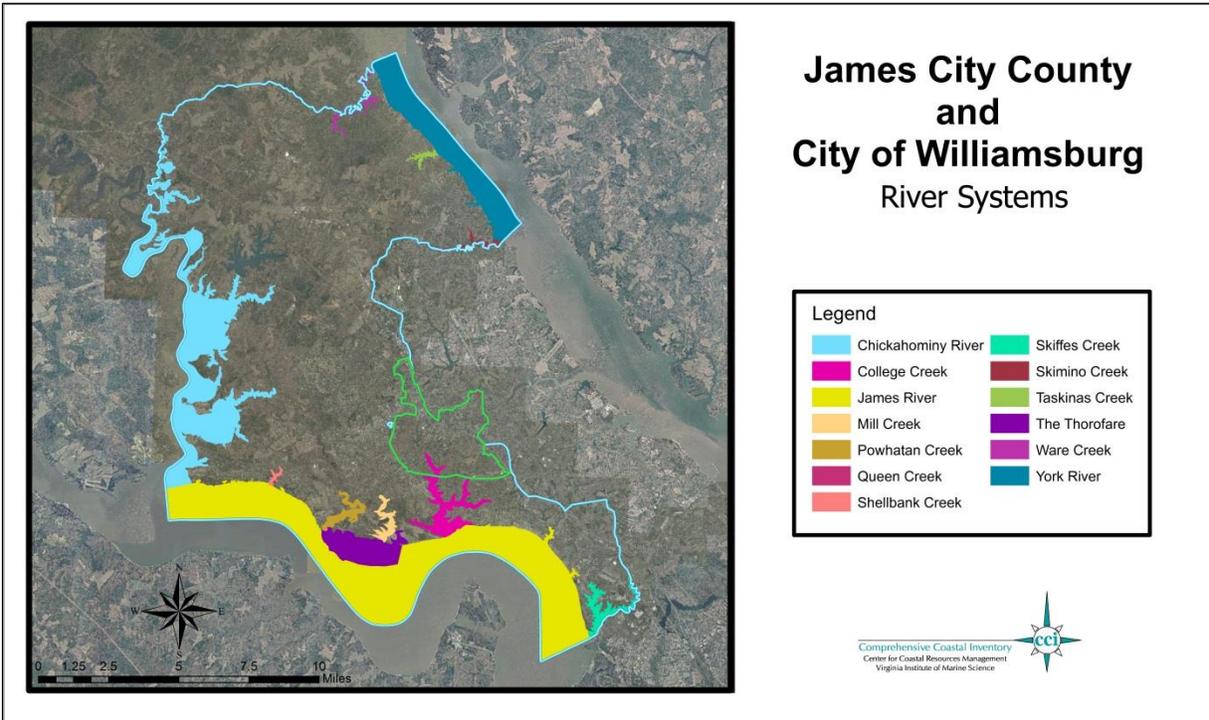
Figure 2. River Systems in James City County and City of Williamsburg

Summary tables (Tables 4-7) quantify conditions observed on the basis of river systems (Figure 2). Refer to Figure 2 for the location of these rivers systems. In James City County, 410 miles of shoreline were remotely surveyed and a total of 5 miles were remotely surveyed for the City of Williamsburg. All these areas are noted in Table 4.

The top toolbar also includes tabs to access some important status information for the locality. By clicking on the “River System Pie Charts” button, users can obtain a statistical summary distribution of the riparian land use and amount of hardened shoreline for a specific water body selected from the drop down menu in the upper left (Figure 7). More detailed results in table format can be found by clicking the James City County or City of Williamsburg Summary PDF button also in the window. The summary statistics are reported by river systems (Figure 2).

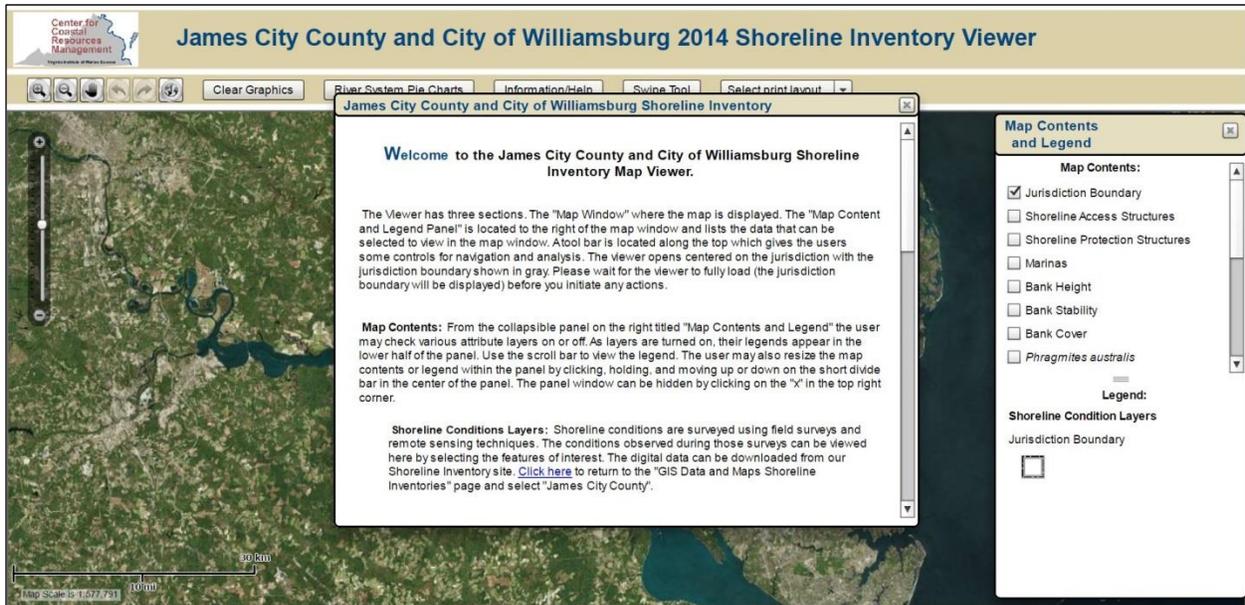
Figure 3. Opening page for the James City County and City of Williamsburg Shoreline Inventory Viewer

The Viewer has two panels: “Map Window”, where the map is displayed and “Map Contents and Legend”, where data that can be selected and viewed in the map window are listed. A tool bar is located along the top of the “Map Window” which gives users some controls for navigation and analysis (Figure 3.).

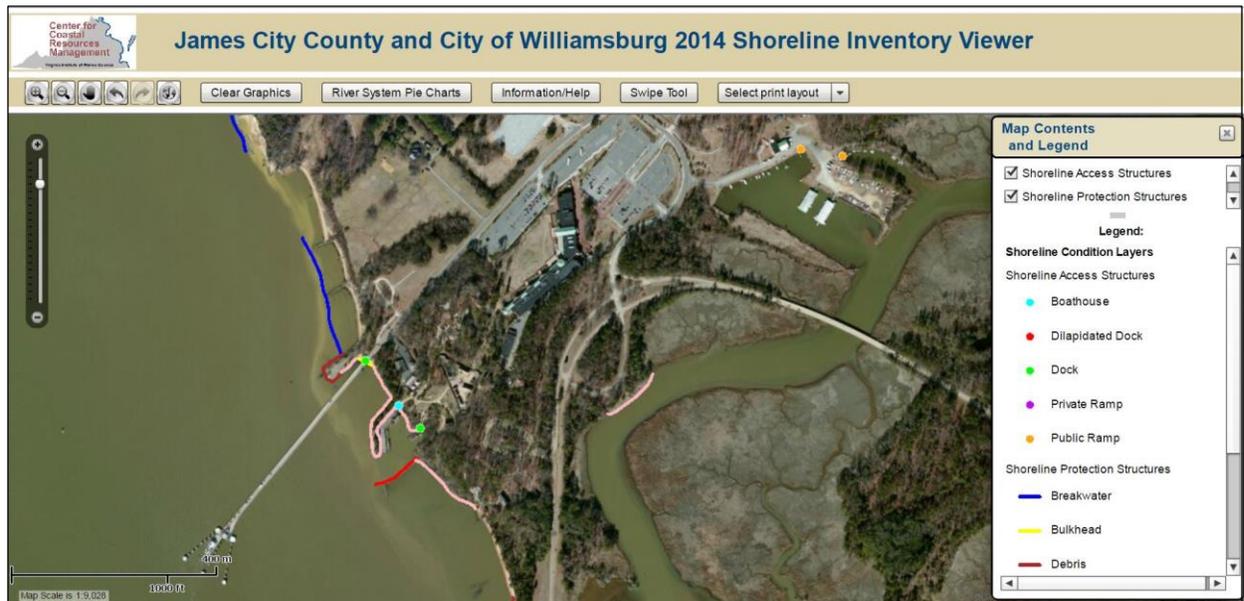
Figure 4. Map Viewer illustrates Shoreline Access and Protection Structures for a section of the County.

In Figure 4 Shoreline Access Structures, and Shoreline Protection structures are selected. Shoreline Access structures are point features that includes piers and boat ramps. The actual footprint of these structures is not measured; only their location. Shoreline Protection Structures are line features and are mapped and illustrated in the viewer to show where they occur along the shoreline. Figure 5 illustrates riparian land use in the riparian zone for the same section of the County.

From the "Map Contents and Legend" the user may check various attribute layers on or off. The user must use the scroll bar on the far right to see the complete list of attributes available. When layers are turned on, the corresponding legend appears in the lower half of the panel, and the data are displayed in the "Map Window" (Figure 4).

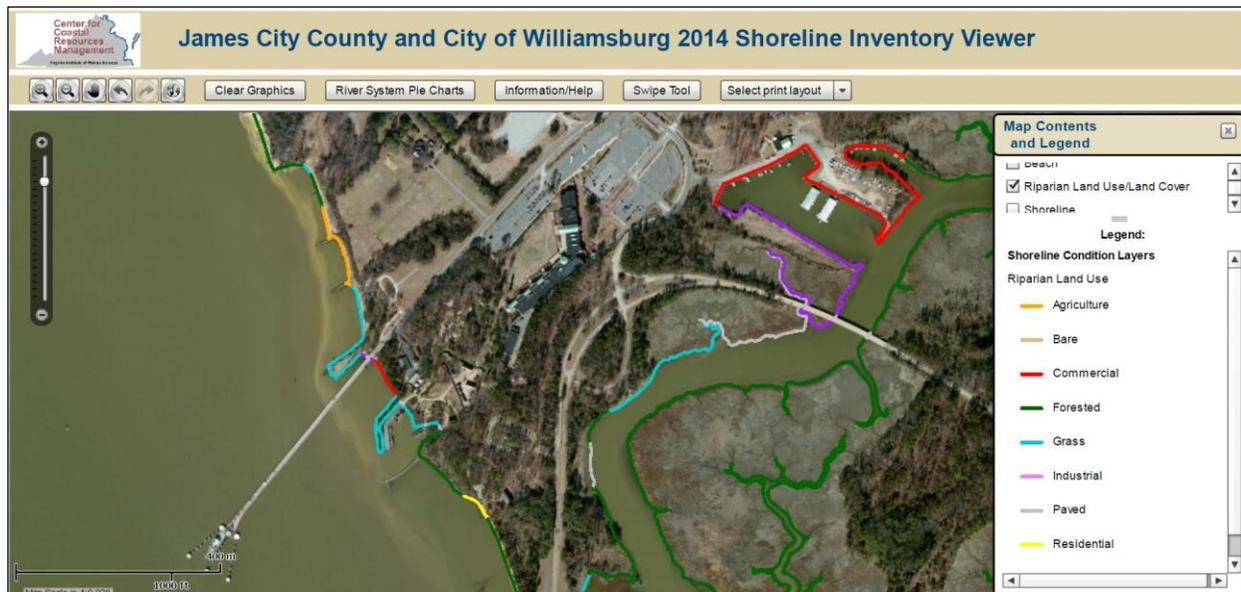
Figure 5. Distribution of land use in the riparian zone is displayed for this region of the County.

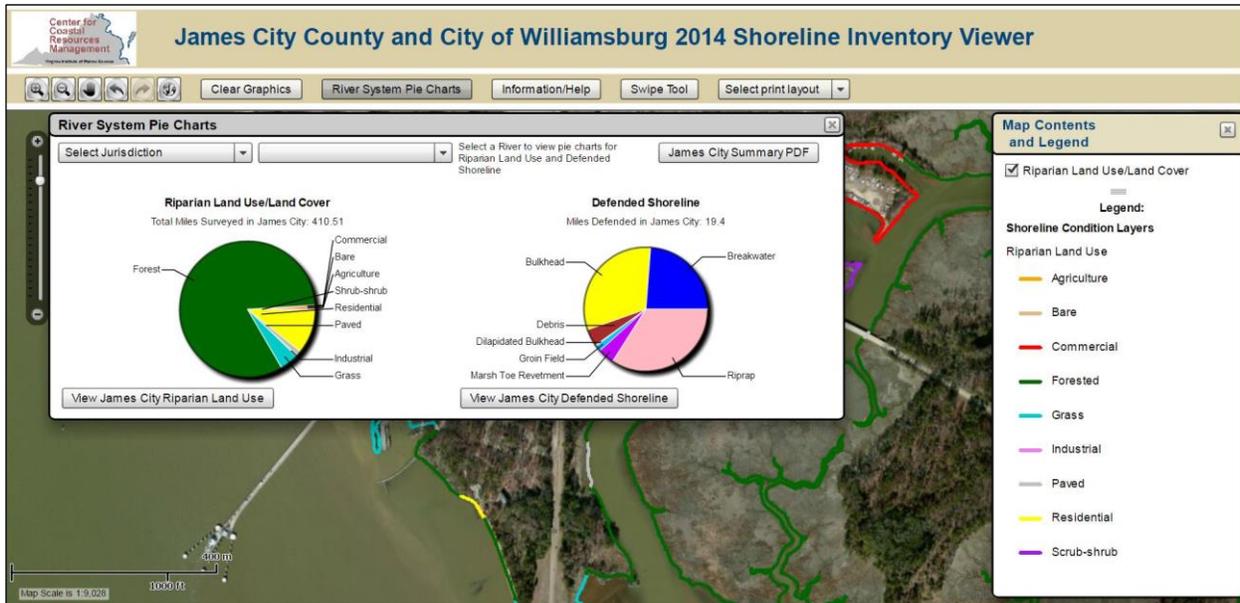
Figure 7. Pie charts display land use and shoreline hardening statistics for each tributary.

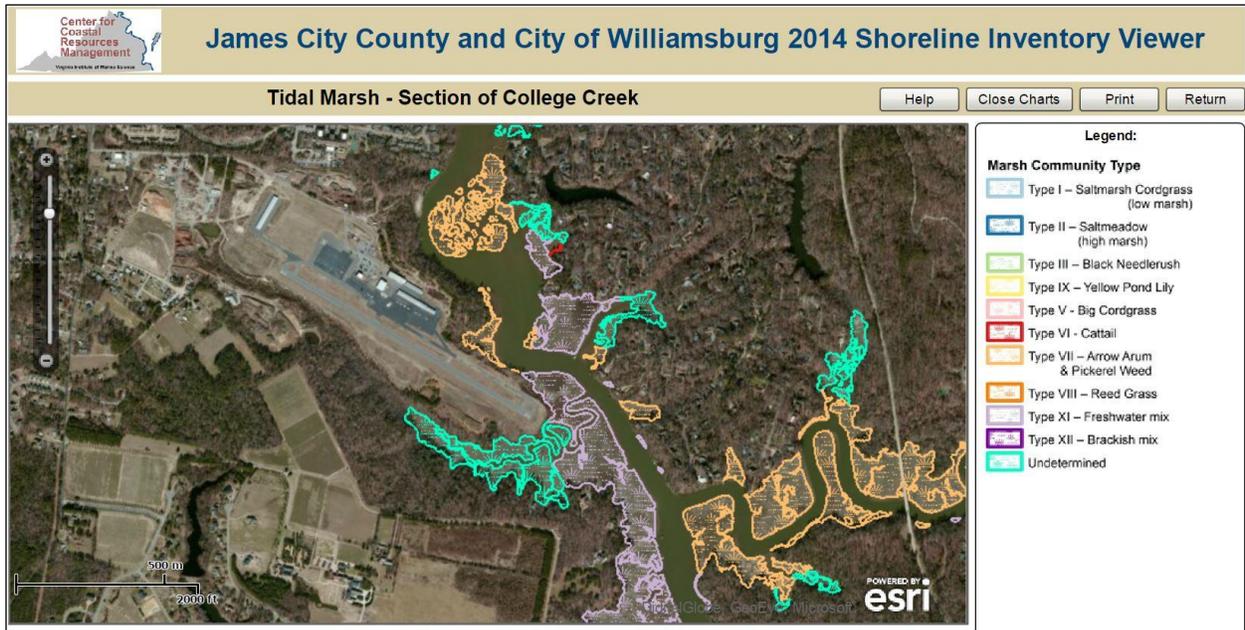
Finally, users have the option to personalize their own maps (i.e. map extent, data displayed, map title, etc.) and print them by clicking “Go to Print” button. The map legend and the charts display below the map. The page can be set up for printing to 8.5 x 11 portrait or landscape style. Figure 8 is an example of a customized map generated for a section of College Creek. Here the tidal marsh communities are displayed, and the community type is reported in the legend beside the illustration.

Figure 8. Customized print window for a section of College Creek.
