Lynnhaven River Shoreline Management Plan

***Prepared for
City of Virginia Beach and
Virginia Coastal Zone Management Program***

**Virginia Institute of Marine Science
College of William & Mary
Gloucester Point, Virginia**

April 2013

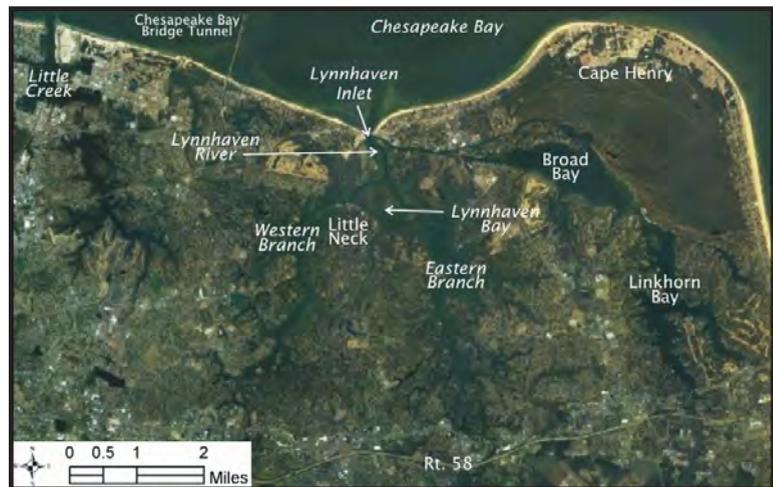
Figure 2-1. Location of features in the vicinity of Lynnhaven River.

The Lynnhaven River lies within the coastal plain of Virginia Beach. It is connected to the Chesapeake Bay via Lynnhaven Inlet where tidal currents run quickly in both ebb and flood directions (Figure 2-1). Lynnhaven Inlet is the only opening to the Lynnhaven River, Broad Creek and Linkhorn Bay watersheds. It lies about 5 miles west of Cape Henry and about 5 miles east of Little Creek. The shorelines, both east and west along the Chesapeake Bay, are sandy beach and dunes with coastal development along much of the coast.

Inside the Inlet, the Lynnhaven River diverges both southwest and southeast into the Western and Eastern Branches (Figure 2-1). Lynnhaven Bay also connects to Broad Bay through Long Creek. The Western Branch and Eastern Branch are separated by Little Neck. The drainage area of the Western Branch is about 8.21 square miles and about 6.53 square miles of drainage area for the Eastern Branch (City of Virginia Beach, 2009). The Eastern Branch narrows southward to about 150 feet at approximately where Route 58 (Virginia Beach Blvd.) crosses the River. The tidal creek continues southward as London Bridge Creek, a narrow channel with minimal branches. The Western Branch of the Lynnhaven River narrows near Route 58 but terminates just beyond as a very narrow, meandering channel bordered by marsh.

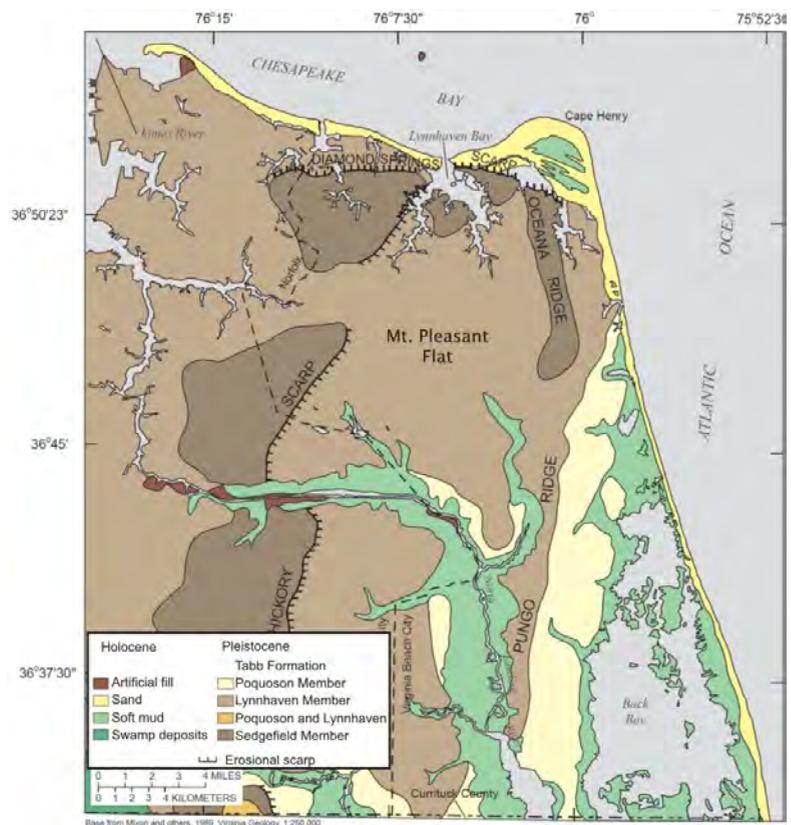
Figure 2-2. Surficial geology and geomorphic features at Virginia Beach, Virginia. (From Smith and Harlow, Jr., 2002)

The Lynnhaven River watershed is formed by the Tabb Formation (Figure 2-2) of upper Pleistocene age. It was likely deposited during the last major high stand of sea level that extended from approximately 135,000 to 75,000 years ago. The Tabb Formation has been divided from youngest to oldest into the Poquoson, Lynnhaven and Sedgefield Members (Mixon *et al.*, 1989) that are likely the result of small scale variations in sea level with peaks occurring about 80,000, 105,000, and 125,000 years ago (Toscano, 1992). The Poquoson Member forms the east side of Pungo Ridge from sea level to about 11 ft

above sea level. It is a gray, medium to coarse, pebbly sand grading upward into a clayey, fine sand and silt. The Poquoson and Lynnhaven Members are undifferentiated along Virginia Beach's coast.

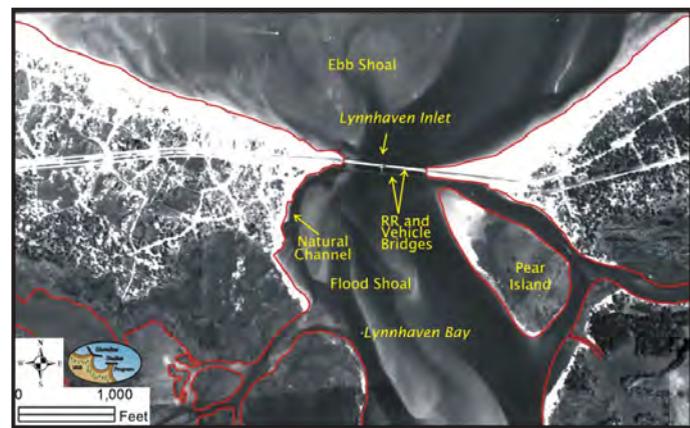
Figure 2-4. Orthorectified image of Lynnhaven Inlet and vicinity in 1937. The 1937 shoreline is shown in red. From Milligan et al. (2012).

Aerial imagery in 1937 shows both a vehicle bridge and railroad bridge spanning the inlet (Figure 2-4). A pear-shaped marsh/sand island (named Pear Island for this report) occurs just inside Lynnhaven Bay. This and other marsh/sand islands occur in Lynnhaven Bay as part of a vegetated supratidal flood shoal system. The Inlet occurs as a sinuous channel with wide sandy beaches

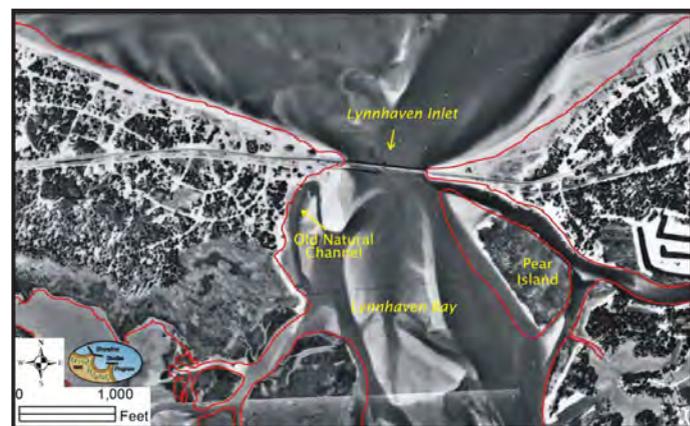
Figure 2-5. Orthorectified image of Lynnhaven Inlet and vicinity in 1954. The 1937 shoreline is shown in red. From Milligan et al. (2012).

along the Bay shore. In 1954, a sand spit can be seen entering Lynnhaven Inlet from the west along with shore advancement on the Bay shore east of the Inlet (Figure 2-5). Pear Island was smaller. Sand movement in and around the inlet is somewhat complex, and as time went on, dredging became necessary to navigate the Inlet as commerce increased.

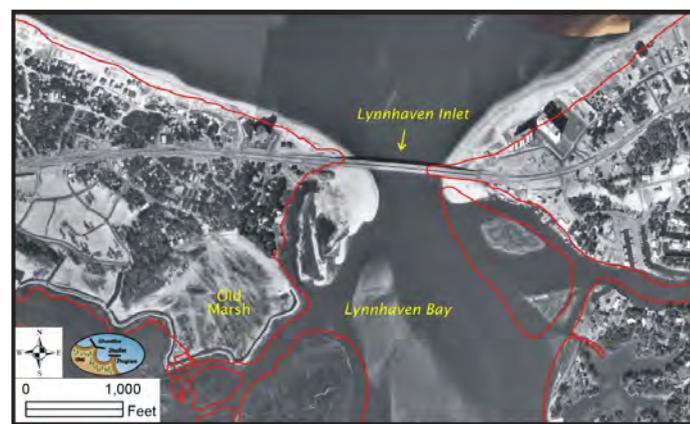
Figure 2-7. Orthorectified image of Lynnhaven Inlet and vicinity in 1976. The 1937 shoreline is shown in red. From Milligan et al. (2012).

The earliest record of inlet dredging was in 1965 with subsequent maintenance dredging in 1968, 1969, 1970 and 1972 (U.S. Army Corps of Engineers, 1980). Dredged material was mostly sand and disposed of along the Ocean Park Bay shoreline just west the inlet and sometimes in Lynnhaven Bay on the west shore just inside the inlet. Aerial imagery in 1970 shows the dredged channel through the ebb shoal (Figure 2-6). It is likely that the dredge material was disposed of along the shoreline as evidenced by the widened beach both east and west of the Inlet as well as inside Lynnhaven Bay. Now a four lane bridge can be seen and "Pear" island has broken into two sections. The 1976 photo indicates that the tidal marsh southwest of the Inlet was a disposal site for some of the dredged material (Figure 2-7).

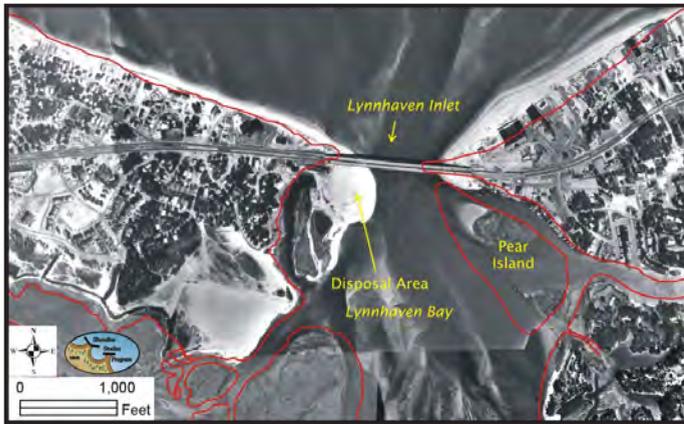
Figure 2-8. Orthorectified image of Lynnhaven Inlet and vicinity in 1980. The 1937 shoreline is shown in red. From Milligan et al. (2012).

By 1980, inlet dredging and subsequent disposal continued with more material stacked in Lynnhaven Bay thus "growing" the area in height and planform (Figure 2-8). An infilling of the channel from the west can also be seen as a wide spit feature. Pear Island was smaller. In 1987, aerial imagery by VIMS shows a dredge plant operating just inside the inlet in Lynnhaven Bay with the dredge pipe extending up into the newly constructed disposal basin (Figure 2-9).

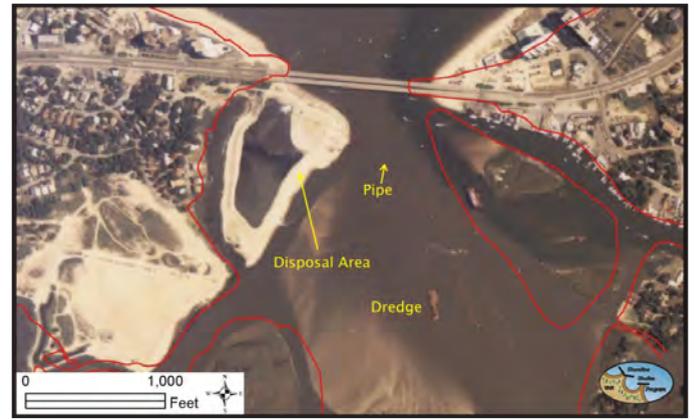
Figure 2-9. Orthorectified image of Lynnhaven Inlet and vicinity in 1987. The 1937 shoreline is shown in red. From Milligan et al. (2012).

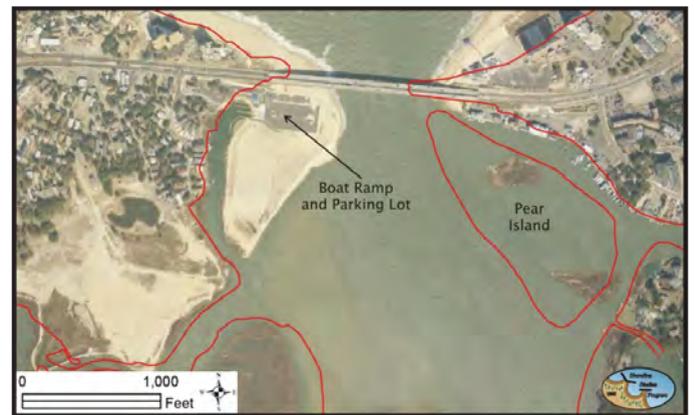
Figure 2-10. Orthorectified image of Lynnhaven Inlet and vicinity in 2002. The 1937 shoreline is shown in red. From Milligan et al. (2012).

By 2002, the inlet disposal area has a parking lot and boat ramp facility in place, and the southwest disposal area has a small pond that is becoming more vegetated (Figure 2-10). Pear Island is almost non-existent. In fact, most of the shoreline in Lynn Haven Bay is eroding. In 2011, channel dredging can be seen along the Lynn Haven Bay edge of the Inlet disposal area (Figure 2-11). Today this channel continues to be maintained, but the shore is eroding. Hardaway *et al.* (1993) reported that a reversal in littoral drift occurs approximately 2,000 feet west of Lynnhaven Inlet. The report indicated that in order to minimize infilling of the channel with dredged material, future disposal should be placed west of that area.

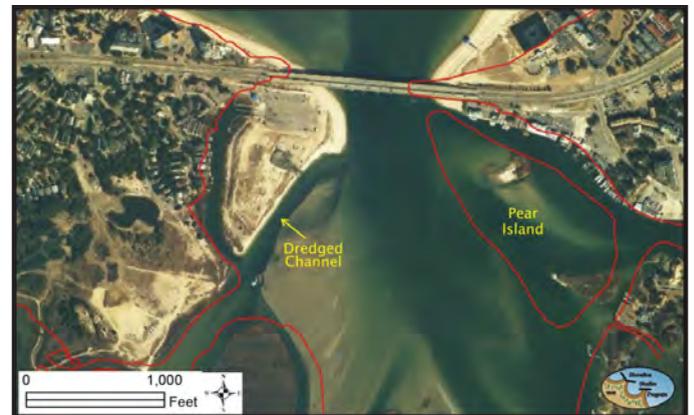
Figure 2-11. Orthorectified image of Lynnhaven Inlet and vicinity in 2011. The 1937 shoreline is shown in red. From Milligan et al. (2012).

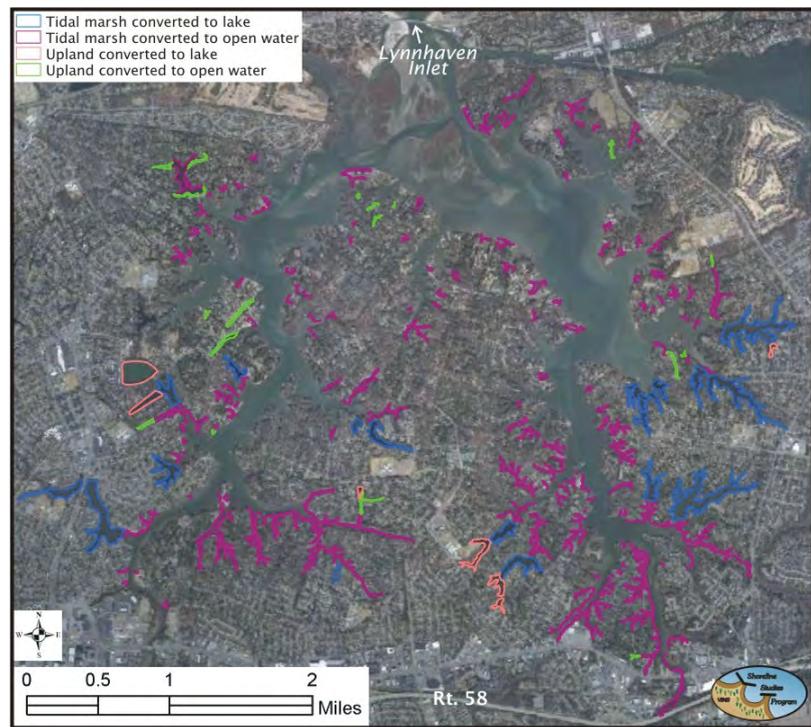
Figure 2-12. Orthorectified image of Lynnhaven River showing the areas where marsh and upland were dredged to create channels and lakes for development.

The shorelines along the Lynnhaven River watershed also have gone through some changes as land development has proceeded. This includes channelizing by dredging as well as damming numerous creeks (Figure 2-12). Starting in about 1970, many of the small tidal marsh tributaries to the Lynnhaven River system were dredged to create accessible waterfront. Between 1937 and 2009 approximately 214 acres of tidal marsh were converted to open water. A similar trend is seen in Broad and Linkhorn Bays.

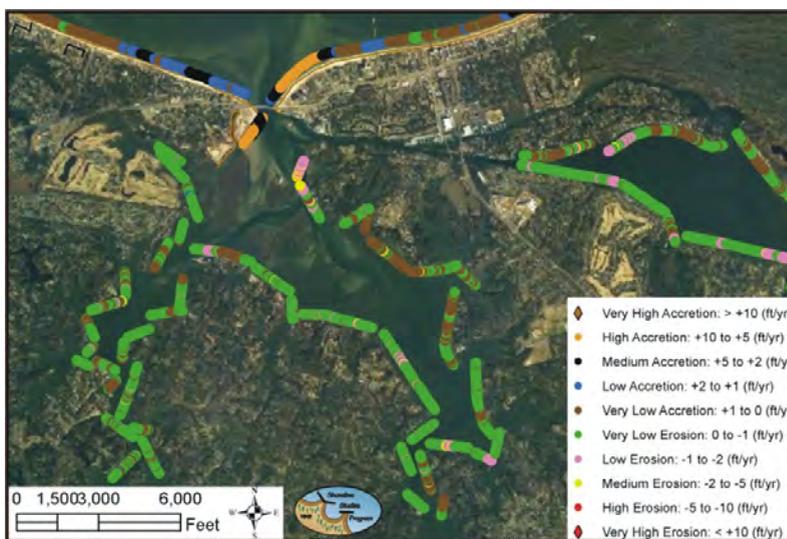
Figure 2-14. End point rates of shoreline change between 1937 and 2009 for segments of the Lynnhaven River (Milligan *et al.*, 2012).

Shoreline erosion results from the combined impacts of waves, sea level rise, tidal currents and, in some cases, shoreline hardening. Since the shorelines are low energy and an extensive amount of shoreline hardening has occurred (Berman *et al.*, 2012), the average end point rate of shoreline change for Lynnhaven River is only -0.1 ft/yr (1937-2009). The shoreline rates of change for various areas of the River are shown in Figure 2-14.

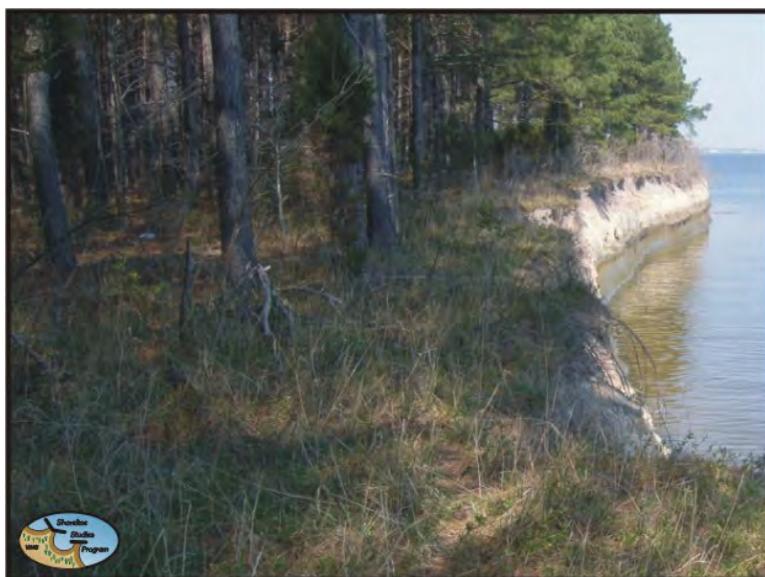
Figure 3-1. One example of forest management. The edge of the bank is kept free of tree and shrub growth to reduce bank loss from tree fall.

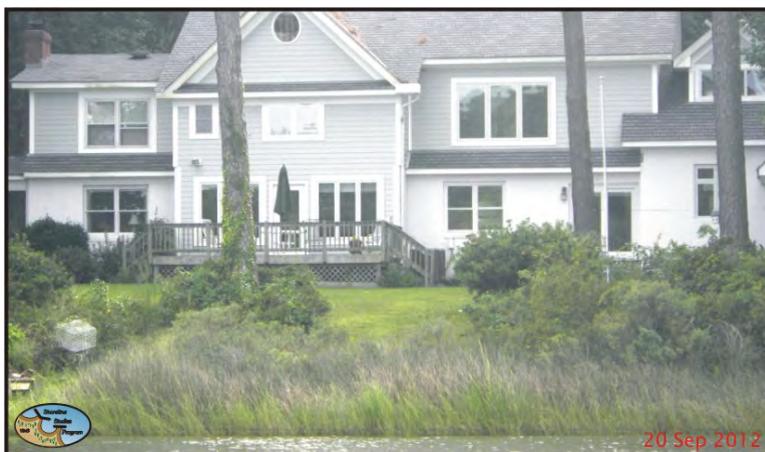
Figure 3-2. Maintaining and enhancing the riparian and marsh buffers can maintain a stable coastal slope.

Enhancement of both riparian and existing marsh buffers together can be an effective practice to stabilize the coastal slope (Figure 3-2) from the intertidal area to the upland by allowing plants to occupy suitable elevations in dynamic fashion to respond to seasonal fluctuations, shifts in precipitation or gradual storm recovery. At the upland end of the slope, forest buffer restoration and the planting of ornamental grasses, native shrubs and small trees is recommended. Enhancement of the marsh could include marsh plantings, the use of sand fill necessary to plant marsh vegetation, and/or the need for fiber logs to stabilize the bank toe and newly established marsh vegetation.

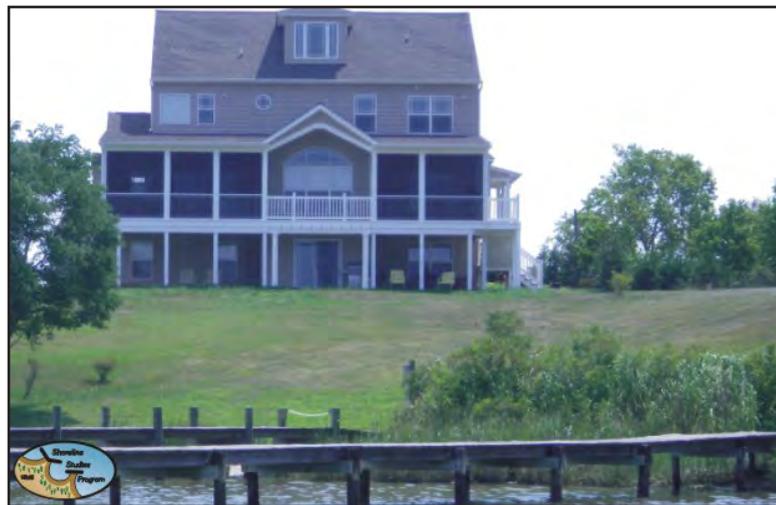
Figure 3-3. Bank grading reduces steepness and will improve growing conditions for vegetation stabilization.

In cases where the bank is unstable, medium or high in elevation, and very steep, bank grading may be necessary to reduce the steepness of bank slopes for wave run-up and to improve growing conditions for vegetation stabilization (Figure 3-3). The ability to grade a bank may be limited by upland structures, existing defense structures, adjacent property conditions, and/or dense vegetation providing desirable ecosystem services.

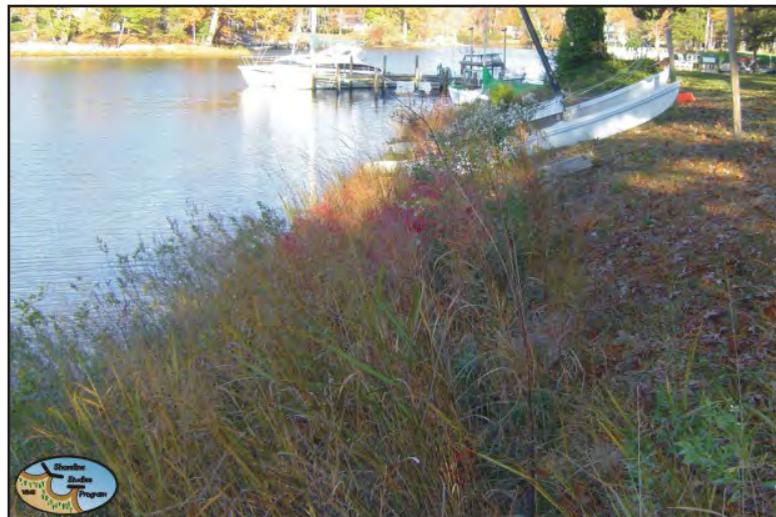
Figure 3-4. This low-energy site had minor bank grading, sand added, and *Spartina alterniflora* planted. This photo shows the site after 24 years.

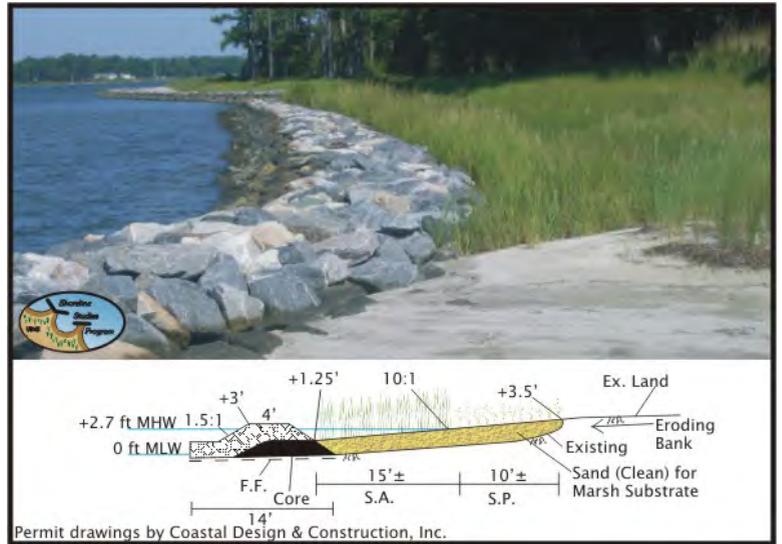
Figure 3-5. Sand fill with stone sills and marsh plantings at Poplar Grove, Mathews County, Virginia after six years and the cross-section used for construction (From Hardaway et al., 2010b).

Hardaway and Byrne (1999) indicate that in low wave energy environments, a sill should be placed at or near MLW with sand fill extending from about mean tide level on a 10:1 to the base of an eroding bank. The height of the rock sill should be at least equal to mean high water to provide adequate backshore protection. Armor stone should be VA Class I. Much of the shoreline in Lynnhaven River has already been hardened. However, in cases where a structure is failing or the landowner wants a more environmental edge, a sill can be placed in front of an existing structure (Figure 3-6).

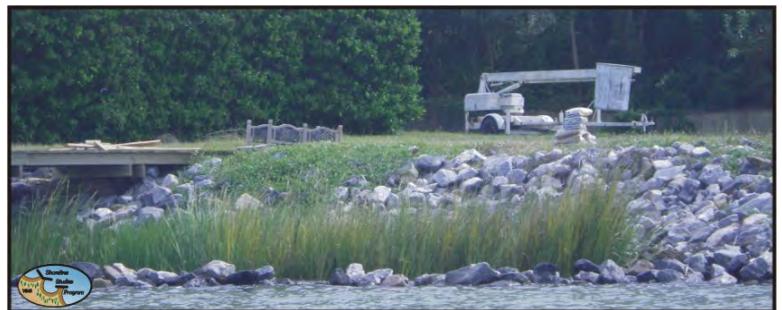
Figure 3-6. Low marsh sill built in front of a rock revetment in Lynnhaven Bay.

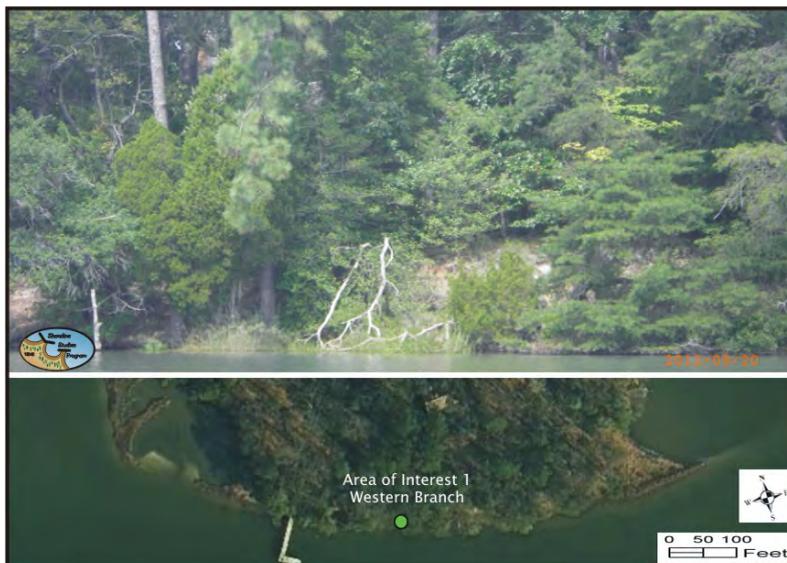
Figure 5-5. Ground photo showing existing conditions of Area of Interest 1 and its approximate location on the Western Branch of Lynnhaven River on the 2011 VBMP image.

The proposed alternative is for a small sill system along the length of the upland section of the project coast as illustrated in Appendix 3, Figure 1. In this case, bank grading should not be considered due to the already wooded nature of the riparian buffer. Continued bank erosion will provide some sediment to the proposed sill system, and, with time, the bank face will slowly stabilize. Similar sites occur within the Lynnhaven River watershed where upland bank instability is evidenced by a vertically-exposed bank face.

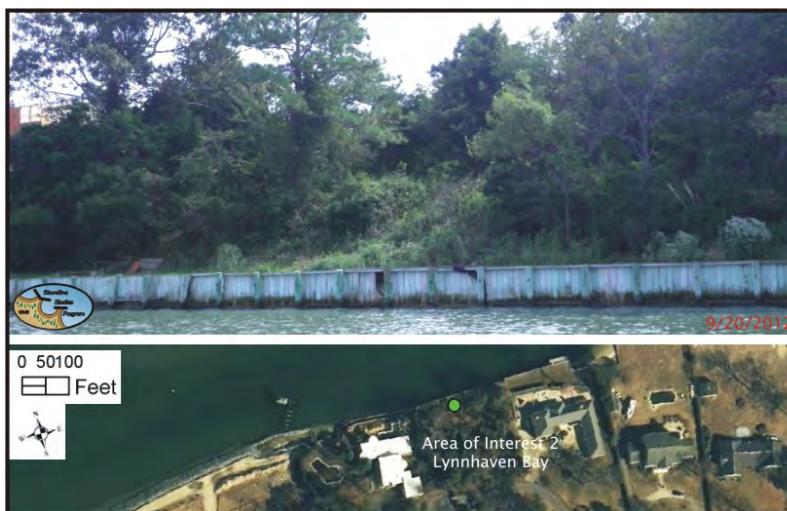
The shoreline currently has a wood bulkhead that is in poor condition and an even earlier bulkhead may have existed at the site (Figure 5-6). Some backfill appears

Figure 5-6. Ground photo showing existing conditions of Area of Interest 2 and its approximate location on Lynnhaven Bay on the 2011 VBMP image.

to be lost through gaps in the structure. Ample beach existed along this shore segment in 1970, and a bulkhead appears in 1980 imagery (Milligan *et al.*, 2012). The beach diminished in width over time and was gone by 1994. Today no beach exists, and a small channel runs along the nearshore. Further offshore sand shoals rise up and are part of the flood shoal complex that becomes vegetated wetland islands about 1,500 feet out.

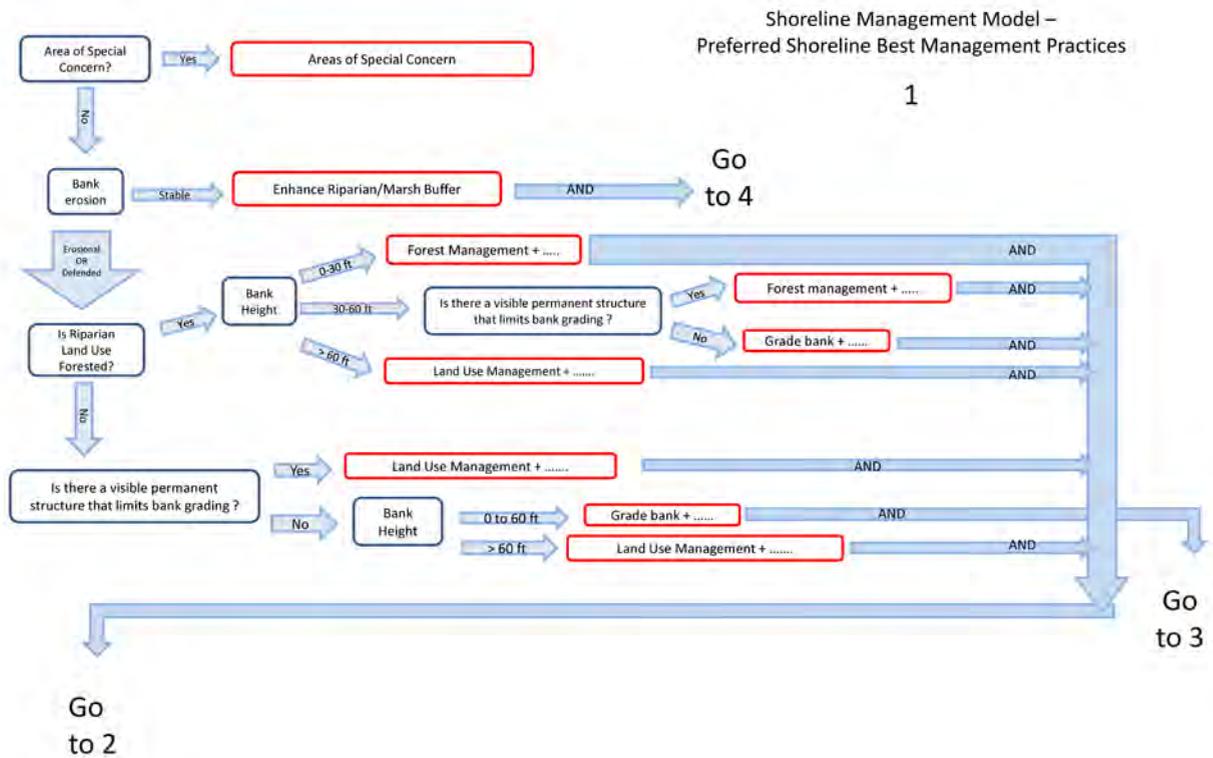
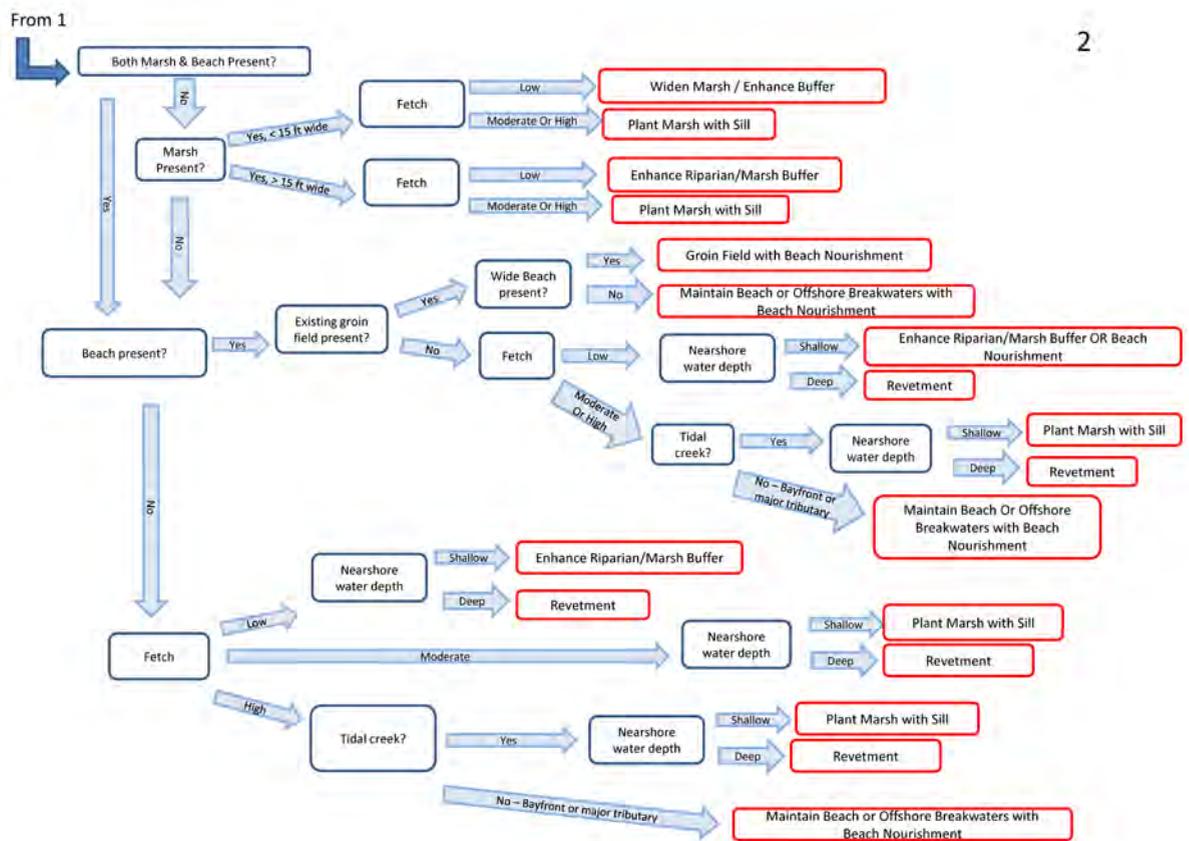
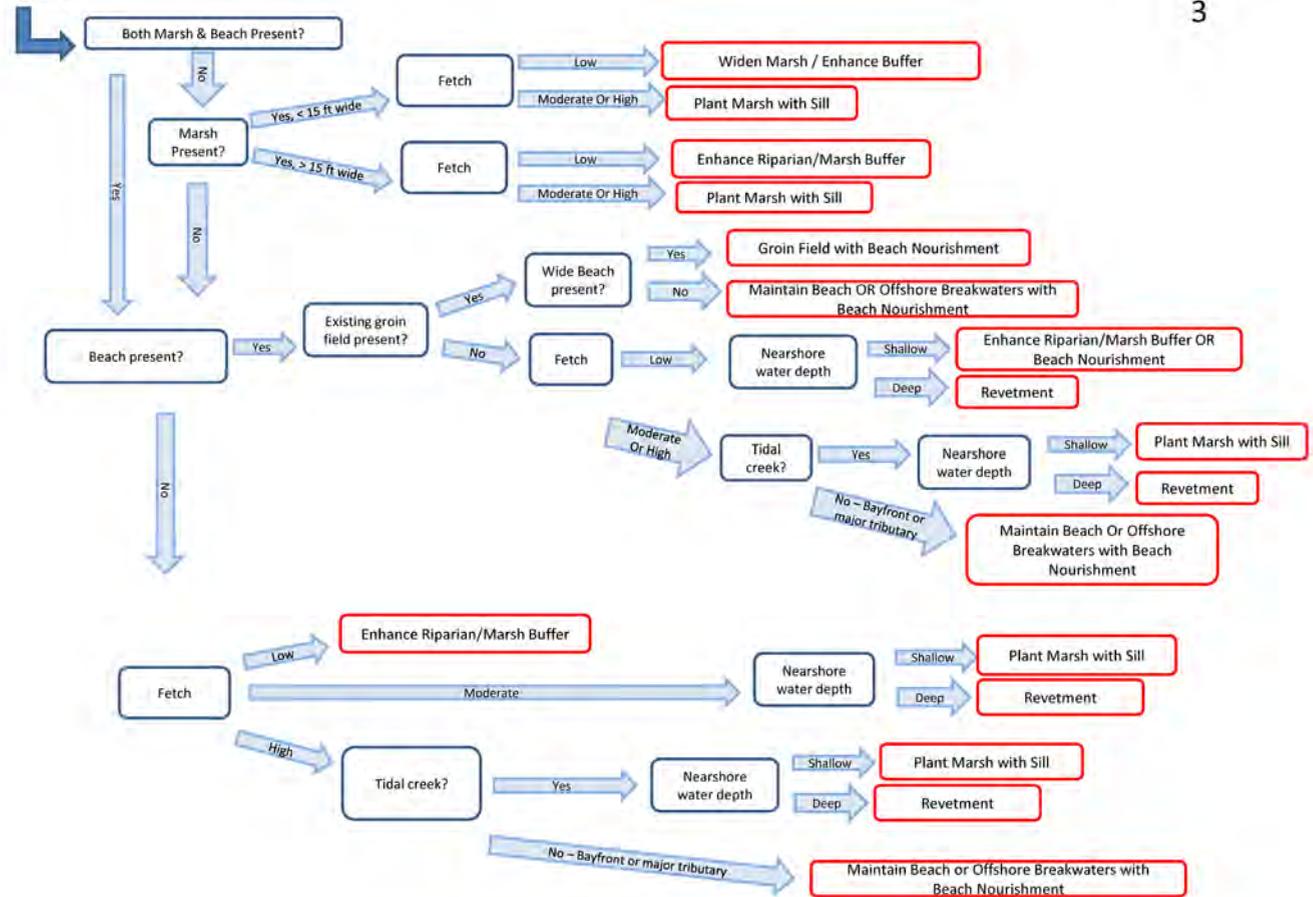
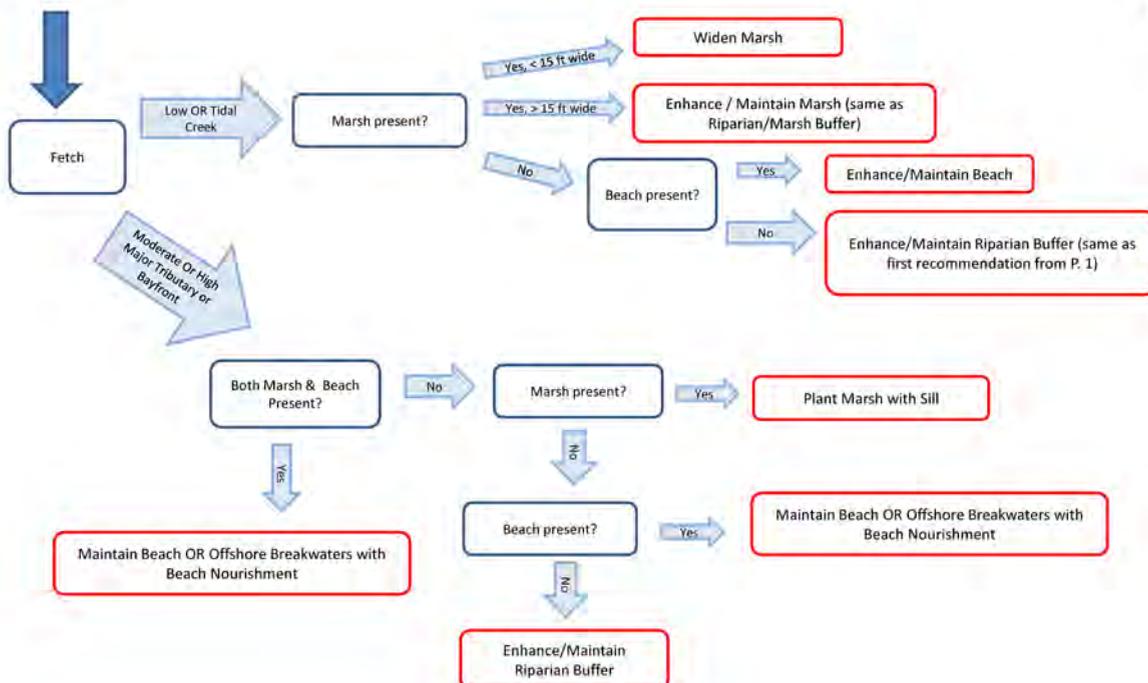
Shoreline Management Model Flow Diagram

The model is constructed using multiple decision-tree pathways that lead the user to a final recommended strategy or strategies in some cases. There are four major pathways levels. The pathways are determined based on responses to questions that determine onsite conditions. Along the upland and the bank, the model queries a site for bank stability, bank height, presence of existing infrastructure, land use, and whether the bank is defended to arrive at an upland management strategy. At the shore the model queries a site for presence and condition of beaches, marshes, the fetch, nearshore water depth, presence of specific types of erosion control structures, and creek setting to drive the shore recommendations. Appendix 1 illustrates the logic model structure.

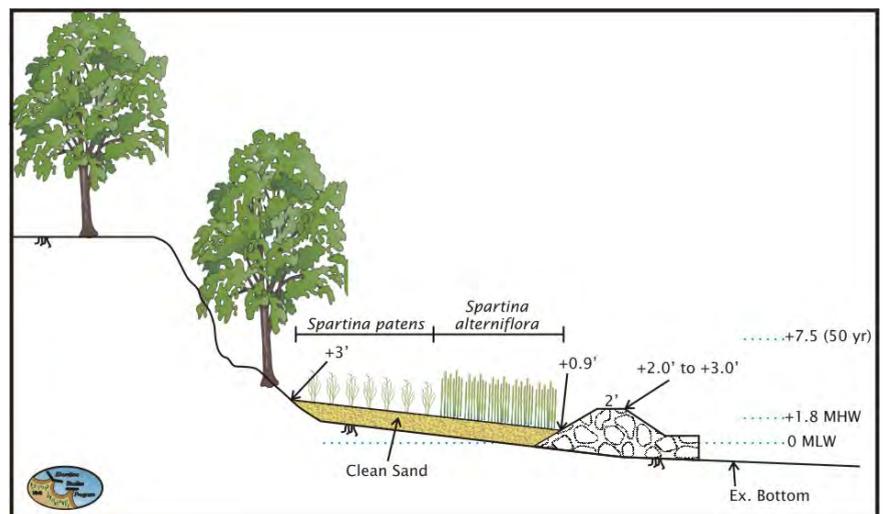
Figure 1. Typical cross-section for a low sill that is appropriate for low energy shorelines of Lynnhaven River. The project utilizes clean sand on a 10:1 (H:V) slope, and the bank can be graded to a (minimum) 2:1 slope, if appropriate.

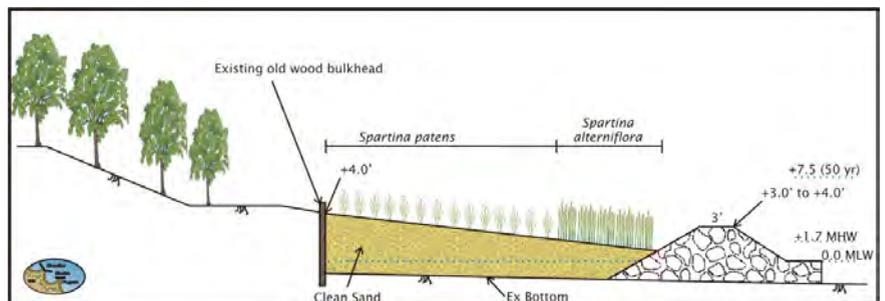
Figure 2. Typical cross-section for a slightly higher sill that is appropriate for the shorelines of Lynnhaven Bay in an effort to replace or protect a failing bulkhead. The project utilizes clean sand on a 10:1 (H:V) slope, and the bank can be graded to a (minimum) 2:1 slope, if appropriate.
