TMDL Project Closeout Report

GUEST RIVER—

Wise, Dickenson and Scott Counties

Virginia Nonpoint Source MANAGEMENT PROGRAM

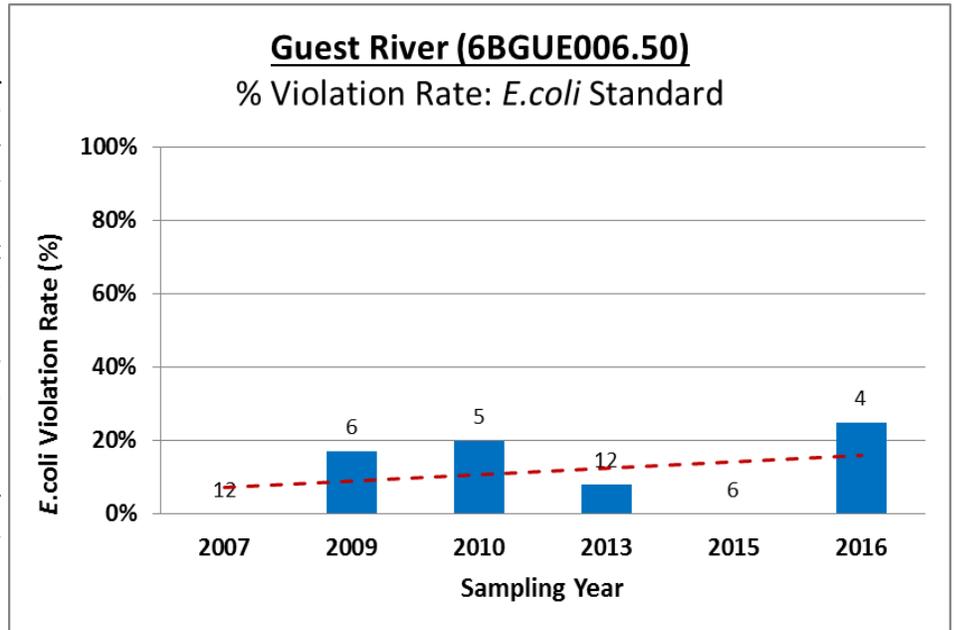
Graph 1: Bacteria Water Quality Data for Guest River :2007-2016 (Station 6BGUE006.50)

Water quality data collected by VADEQ for the period of 2007 through 2016 were analyzed to determine *E. coli* violation rates in the project area for the water quality standard of 235 cfu/100 mL. The bar graph below shows the percent violation rate for samples collected annually at monitoring station 6BGUE006.50, located at Route 74 Bridge #1058. The number of samples collected each sampling year is shown above each bar. The linear regression fitted to the data suggest possible water quality deterioration, but it does not represent a statistically significant trend. Monitoring over a longer period of time is needed to identify water quality changes.

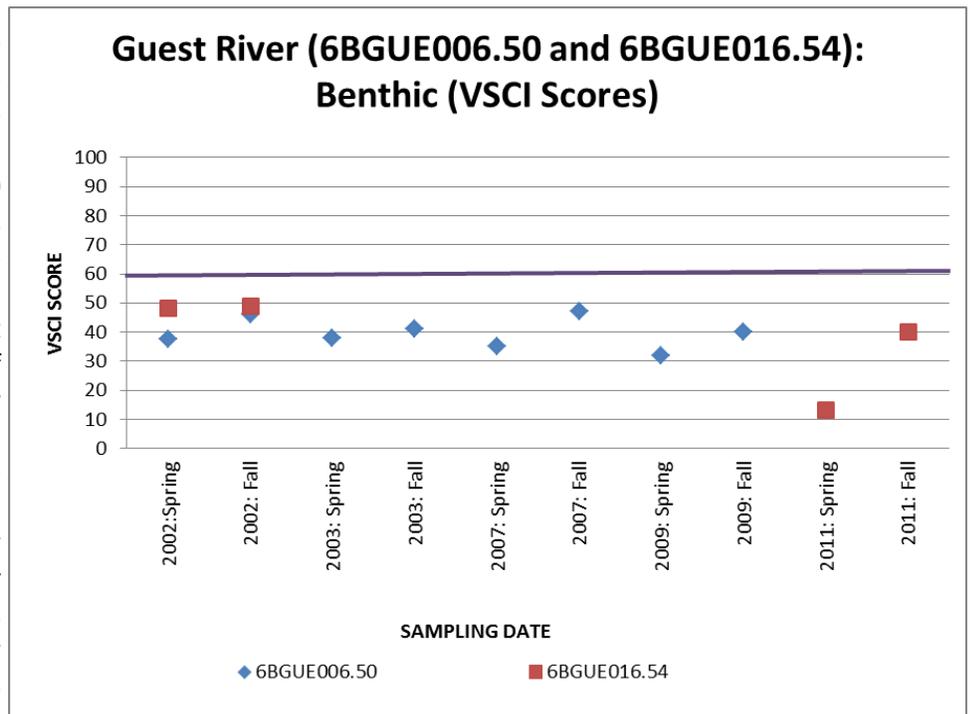
Graph 2: Biological Monitoring Data for Guest River : 2002-2011 (Monitoring Stations 6BGUE006.50 and 6BGUE016.54).

Benthic water quality conditions were also analyzed. The Virginia Stream Condition Index (VSCI) is used to designate biological impairment of a stream. Streams with VSCI scores greater than 60 are considered non-impaired, whereas streams scoring less than 60 are considered impaired. The water quality data from stations 6BGUE006.50 (located at Route 74) and 6BGUE016.54 (located of Alternate Route 58) in the Guest River watershed were analyzed for the period 2002 through 2011; the results are shown in the graph below. Though VSCI scores remain below the water quality standard of 60, monitoring over a longer period of time with consistent trends is needed to corroborate water quality changes. No biological monitoring has been conducted in the watershed since 2011.
