TMDL Project Closeout Report

MAYO RIVER WATERSHED—

Henry and Patrick Counties, Virginia

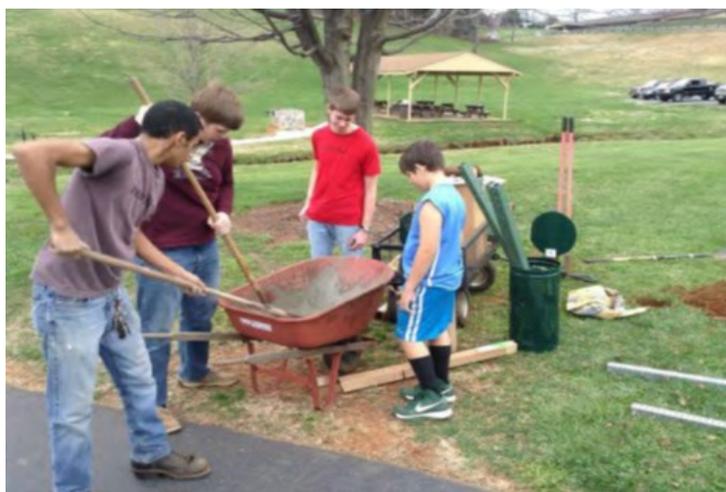
Photo: (Right) Boy Scout Troop #65 of Patrick County working to install a pet waste collection station.

The DRBA worked with local Boy Scout troop #65 of Patrick County, Virginia, to install two pet waste collection stations. The stations were installed at visible common use areas - a town park and another along a river trail. In addition to the pet waste collection stations, the DRBA conducted a pet waste education program to educate the public regarding proper handling of pet waste to minimize entry into local waterways. DRBA also provided pet waste information on post cards and distributed the cards at local businesses and veterinary offices.

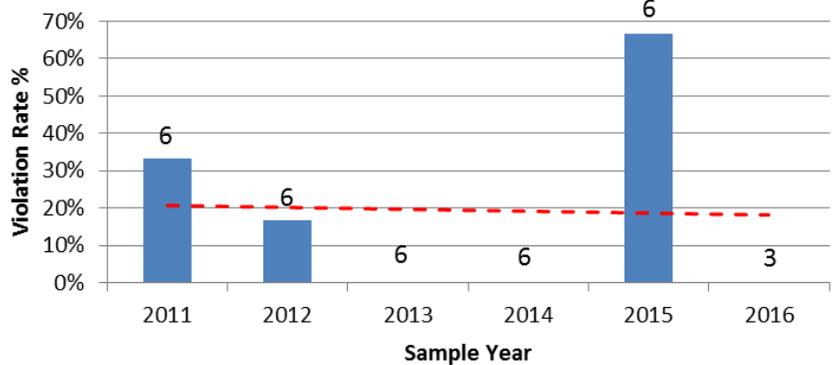
**South Mayo River (4ASMR016.09)
E.coli**

Graphs: DEQ *E. coli* monitoring data from 2011-2016 for (Top Right) South Mayo River (4ASMR016.09) and (Bottom Right) North Mayo River (4ANMR002.60). **Photo:** (Bottom Right) Student participating in Coliscan training.

The VADEQ monitors the water quality in North Mayo and South Mayo Rivers and tributaries through the agency’s ambient monitoring program. The water quality data for the period of 2011 through 2016 in South Mayo and North Mayo Rivers were analyzed to determine *E. coli* violation rate in the project areas for the water quality standards of 235 cfu/100 mL. The bar graphs to the right show the percent violation rate for samples collected annually at monitoring stations 4ASMR016.09 (South Mayo River) and 4ANMR002.60 (North Mayo River). The number of samples collected each year is shown above each bar. The linear trends fitted to the data suggests almost no change in South Mayo River and a water quality decline in North Mayo River. However, neither of these trends are statistically significant. Monitoring over a longer period of time with consistent trends is needed to corroborate water quality changes.

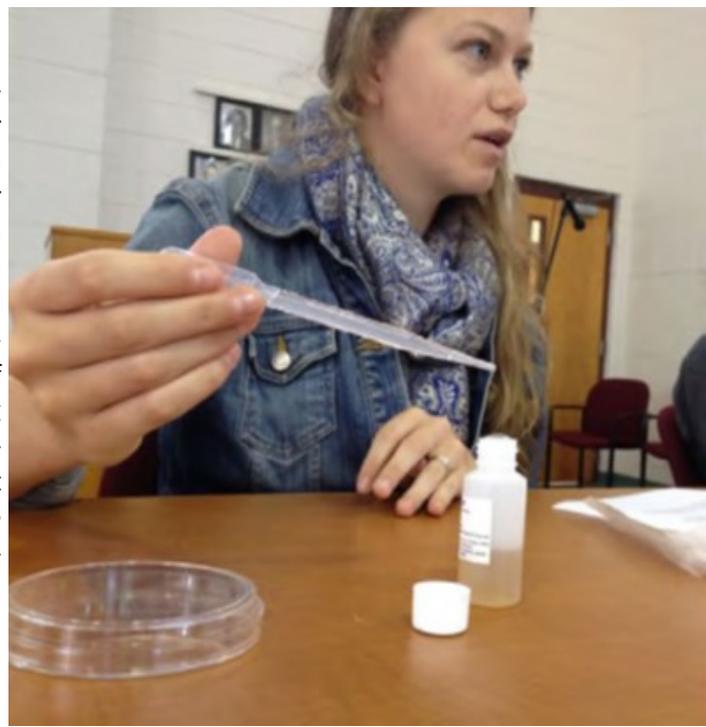
DRBA submitted a Quality Assurance Project Plan (QAPP) to VADEQ, which served as a guideline for the water quality monitoring activities. DRBA conducted monthly water quality monitoring activities for 2 years (2014-2016) at six sites on the North Mayo and Upper South Mayo rivers. Ten additional monitoring sites were added in 2015, for a total of 16 water quality monitoring sites: 10 monitoring sites on the South Mayo River and six on the North Mayo River. Based on input from DRBA, the water quality monitoring activities established a baseline bacteria count. While it was impossible to provide an average bacteria count over the monitoring period because of the lack of consistency of the monitoring stations (six in 2014, then transitioning to 16 in 2015), DRBA indicated that there were no consistent instances where high levels of fecal coliform bacteria appeared to result from point and non-point sources, and data show that most of the time, bacteria levels remained below the VADEQ established threshold of 235 cfu/100 mL, though some spikes were noted.

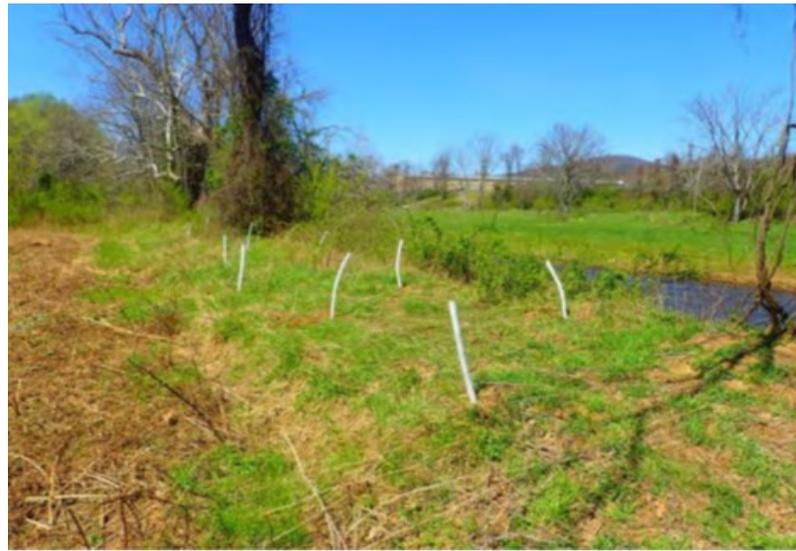
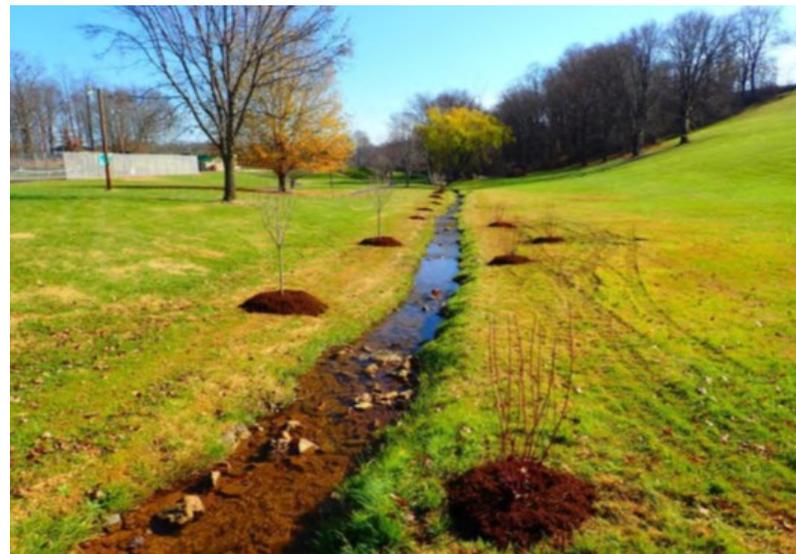
Photo: (Above) Voluntarily installed riparian vegetative buffers

In addition to their pet waste efforts, DRBA planted 2.59 acres of riparian buffer in four locations throughout the Town of Stuart, Virginia. DRBA staff conducted field visits to confirm the presence of streambanks which could benefit from buffer plantings and visited property owners to gauge whether they were interested in having buffers established on their properties. DRBA published a flyer advertising the streambank stabilization component of this project and provided letters, as well as informative door hangers, to property owners having property along the water to encourage them to participate in the program.
