# TMDL Project Closeout Report

## HAYS, MOFFATTS, OTTS & WALKERS CREEKS

# Virginia Nonpoint Source MANAGEMENT PROGRAM

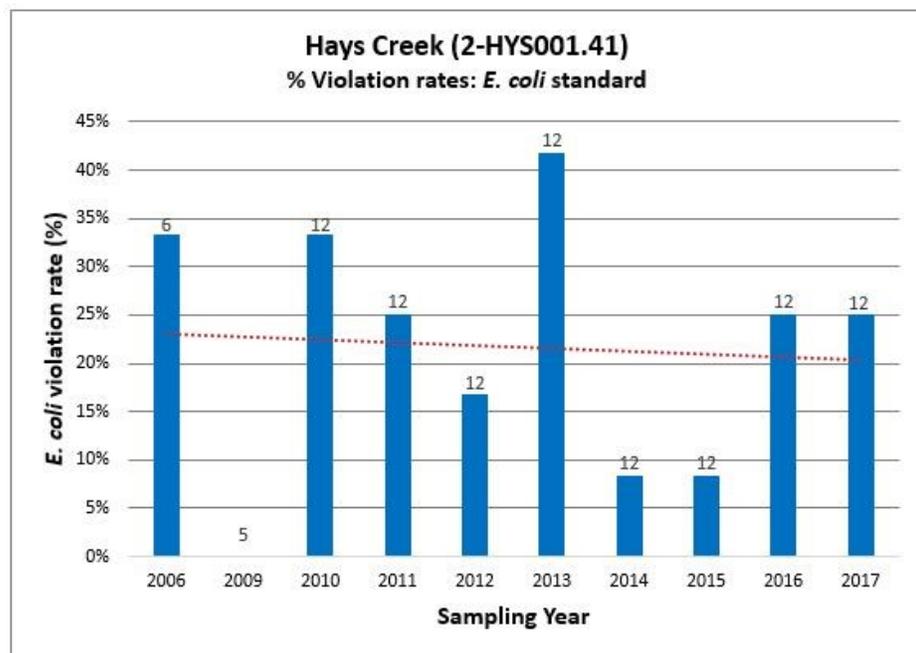
**Graph 1: *E. coli* data for Hays Creek (Station 2-HYS001.41), 2006-2017**

Water quality data collected by DEQ for the period of 2006 through 2017 were analyzed to determine the impact of BMPs implemented in the project area on *E. coli* violation rates and associated long-term trends, if any, in water quality. The graph to the right shows the percent violation rate for samples collected at monitoring station 2-HYS001.41, located near the mouth of Hays Creek, which did not meet the water quality standard of 235 cfu/100 mL. The number of samples collected each year is shown above each bar. The linear regression fitted to the data shows a potentially decreasing trend in violation rates over the sampling period, indicating possible improvements in water quality in Hays Creek.

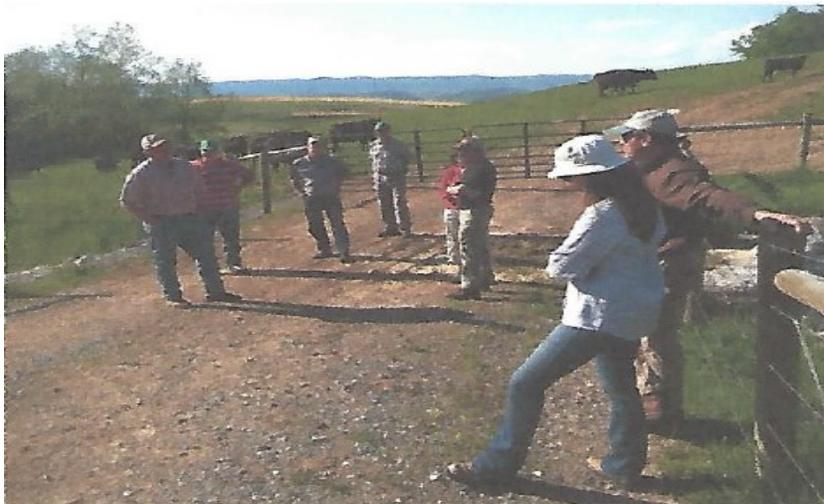
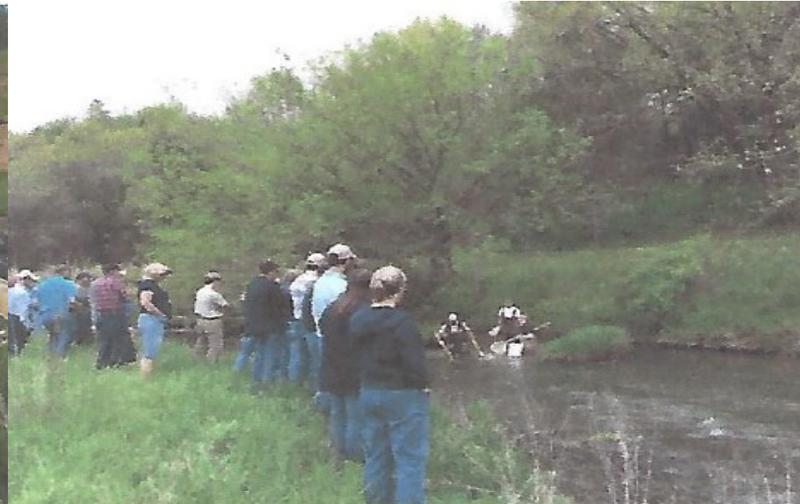
Photo 1 (bottom left): Site tour of stream exclusion practice; Photo 2 (bottom right): Site tour of stream restoration and fish sampling
