Project Location and Background

Implementation Highlights

Closeout Analysis

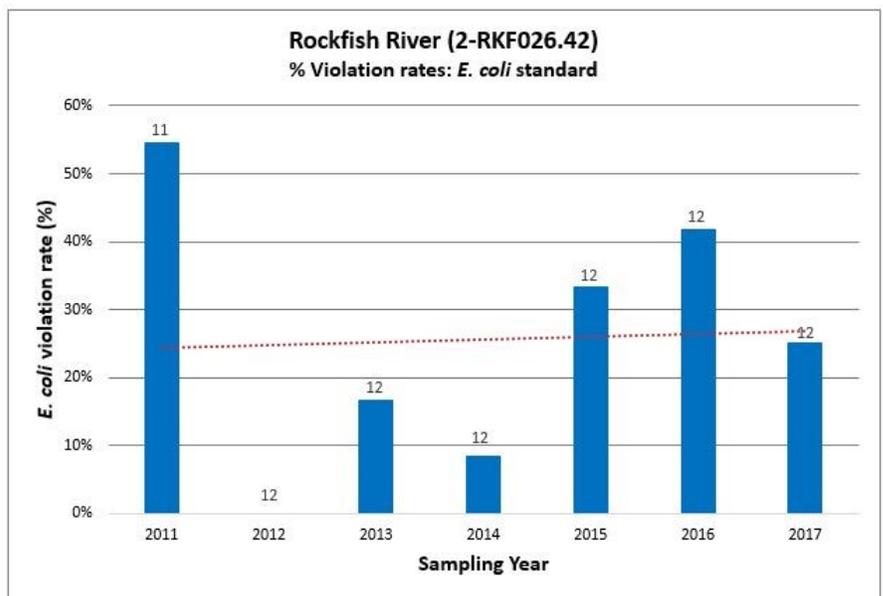
Graph 1: *E. coli* data for Rockfish River (Station 2-RKF026.42), 2011-2017

Water quality data collected by DEQ for the period of 2011 through 2017 were analyzed to determine the impact of BMPs implemented in the project area on *E. coli* violation rates and associated long-term trends, if any, in water quality improvements. The bar graph below shows the percent violation rate for samples collected annually at monitoring station 2-RKF026.42, located downstream of the confluence with the North and South Forks of the Rockfish, which did not meet the water quality standard of 235 cfu/100 mL. The number of samples collected each year is shown above each bar. The linear regression fitted to the data shows a potentially increasing trend in violation rates over the sampling period, largely driven by the number of violations in 2016. Although this increase is slight, it is likely that additional efforts will be needed to meet the bacteria water quality standard in the Rockfish River.

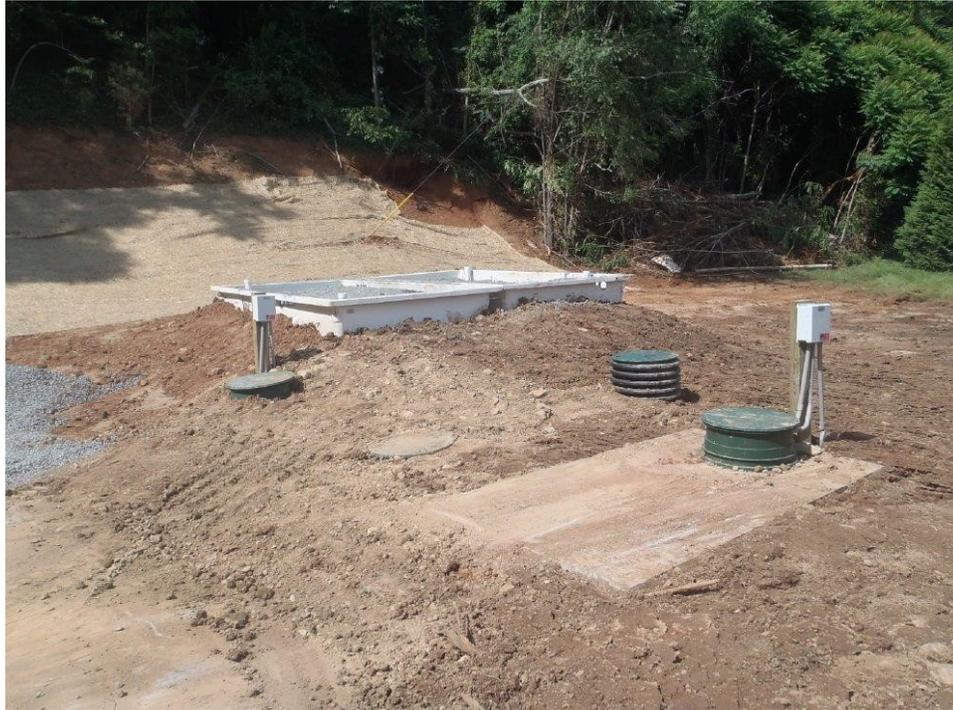
Photos: (Above) Alternative septic system installation; (Below) before (left) and after (right) views of a livestock exclusion practice in the Rockfish River watershed.
