**Project Location and Background**

**Implementation Highlights**

The Stroubles Creek TMDL Implementation Project is administered by the Virginia Tech Biological Systems Engineering (BSE) Department, Blacksburg, Virginia. The Department was contracted to manage the 319(h) grant and provide technical assistance and educational outreach to watershed residents, landowners, and other stakeholders for agricultural, stormwater, and stream channel BMP implementation. The table on the right shows BMP implementation since the implementation plan was completed in 2006 and overall implementation goals for the project area. (continued on page 2)

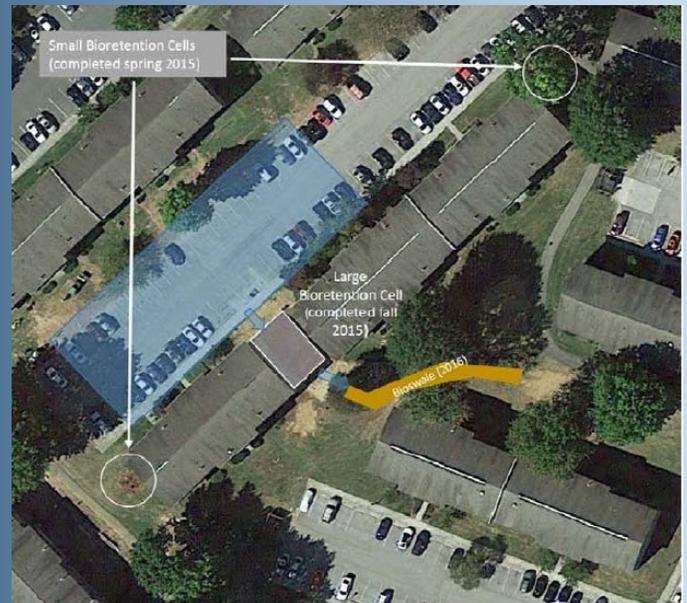
Photos: (Top) location of stormwater bioretention cells; (Middle) large bioretention cell; (Bottom) small bioretention cell.

Between May 2014 and June 2016, several stormwater management and agricultural BMPs were completed as part of this 319(h)-funded project. Three bioretention cells installed at an apartment complex to treat runoff from roofs and parking lots. One livestock exclusion practice was completed totaling 1,300 linear feet of fencing, as was a pipeline to connect a frost-proof trough servicing the livestock exclusion area. A riparian buffer was installed inside the livestock exclusion area, and other riparian buffer plantings were completed along Stroubles Creek between StREAM Lab and Merrimac Road. Additionally, monthly water quality sampling and monitoring of precipitation and stream flow were conducted and a data transmission system was completed to route data automatically through the existing StREAM Lab wireless system.

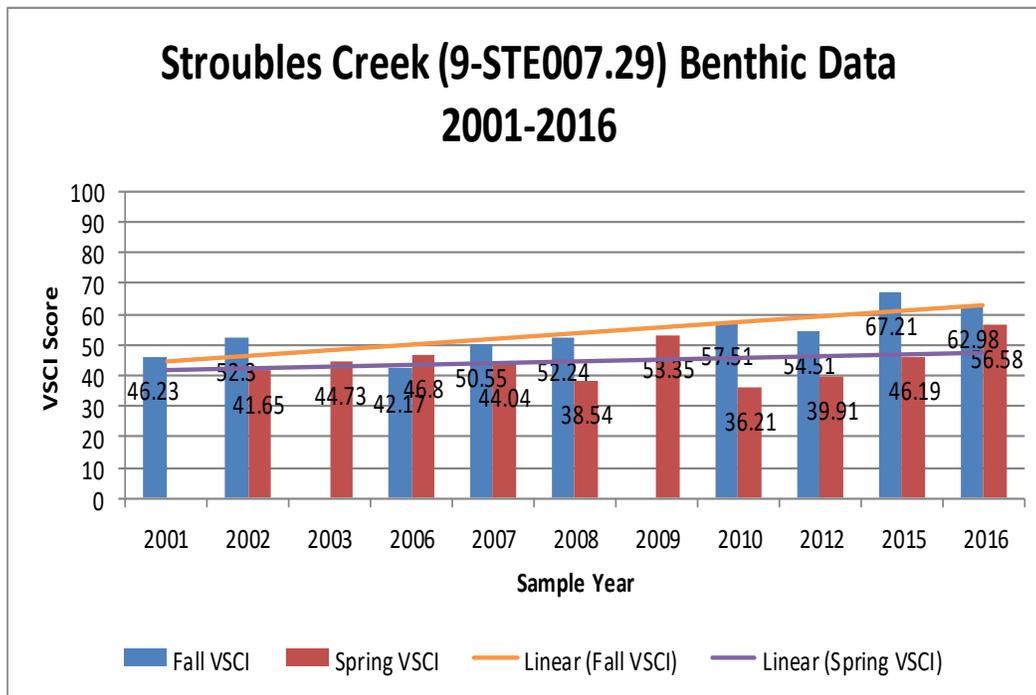
**Graph 1: Biological monitoring data for Stroubles Creek (Station 9-STE007.29), 2001-2016**

DEQ monitors water quality at several stations throughout the Stroubles Creek watershed. Water quality data collected were analyzed to determine the impact of BMPs implemented in the project area on the biological conditions and associated long-term trends, if any, in water quality conditions. The Virginia Stream Condition Index (VSCI) is used to designate biological impairment of a stream. Streams with VSCI scores greater than 60 are considered non-impaired, whereas streams scoring less than 60 are considered impaired. The biological water quality samples collected at monitoring station 9-STE007.29 in spring and fall seasons between 2001 and 2016 were analyzed for VSCI scores, and the results are shown in Graph 1 below. The number above each bar shows the VSCI score. Long-term VSCI scores are trending positively for both spring and fall with higher scores typically achieved in the fall season.

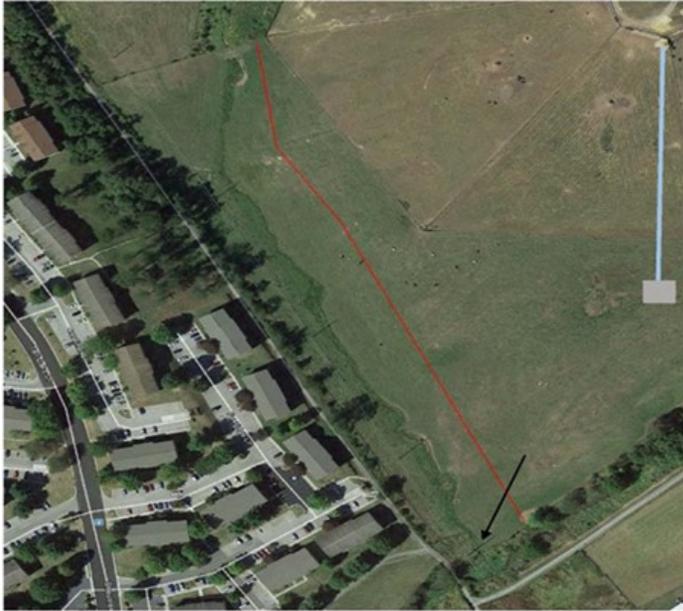
**Photos :** (above) *location of livestock exclusion practice;*  
(below top) *livestock exclusion fencing;* (below bottom) *tree planting*
