FIELD INSPECTION

Project Name:	Mountain Valley Pipeline	Inspector:	Matthew Grant
Inspection Date:	Wednesday, May 22, 2019	Project Contact:	Brian Clauto
Spread: Giles County AR GI-234 Montgomery County MP221-222 St11669-11766	Spread G	Weather (Wet/Dry/Rain):	Dry

FIELD INSPECTION PHOTO LOG

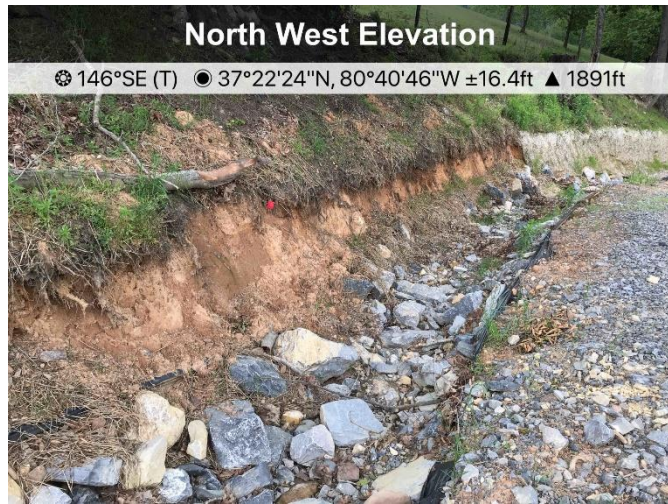
- Streams inspected included: MN-21, MN-22, EF65, EF-62. ECD's were in place at all streams inspected and no impacts were observed.
- AR GI-234 ditch slope requires stabilization.
- St#11704+14 Sump and waterbar requires maintenance.

- Fig. 1 AR GI-234 ditch slope requires stabilization.

Recommended Corrective Action: Maintain all controls per the approved plan and specs.

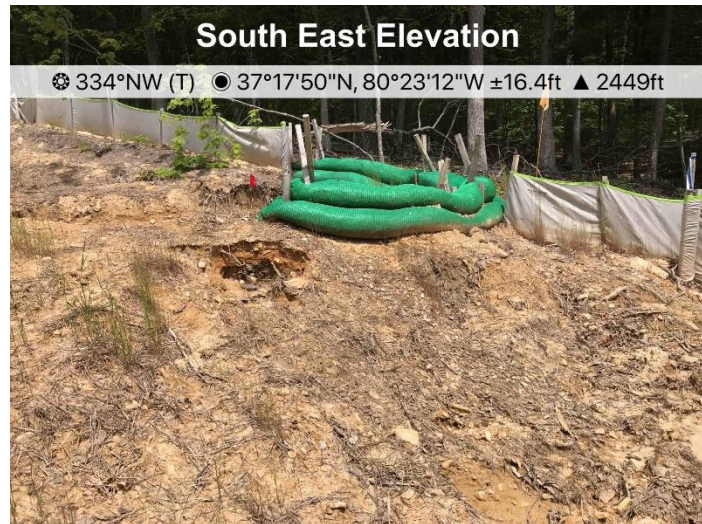
- Fig. 2 St11704+14 sump and waterbar requires maintenance.
