## FIELD INSPECTION

<b>Project Name:</b>	Mountain Valley Pipeline	<b>Inspector:</b>	Matthew Grant
<b>Inspection Date:</b>	Tuesday, December 10, 2019	<b>Project Contact:</b>	Brian Clauto
<b>Spread: Roanoke Co.</b> MP 245.9-245.3 AR RO-288 ATWS1307 & 1308 <b>Montgomery Co.</b> MP 230.6-230.7 AR MN 274 ATWS 704A, 1446,1062, 1375	Spread H	<b>Weather (Wet/Dry/Rain):</b>	Dry

## FIELD INSPECTION PHOTO LOG

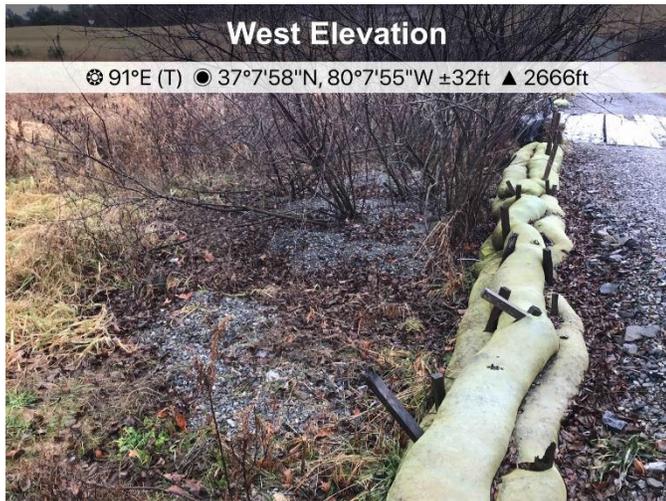
- Inspected designated streams and wetlands included: W-KL 1, W-Q11, W-IJ 10, S-Q20, S-C21, S-0011
- As previously documented road gravel remains in W-Q11, no landowner approval for removal has been granted.
- All controls were in place and functioning at designated stream crossings and wetlands.

- Fig. 1. Designated wetland W-Q11, road gravel has washed into wetlands.

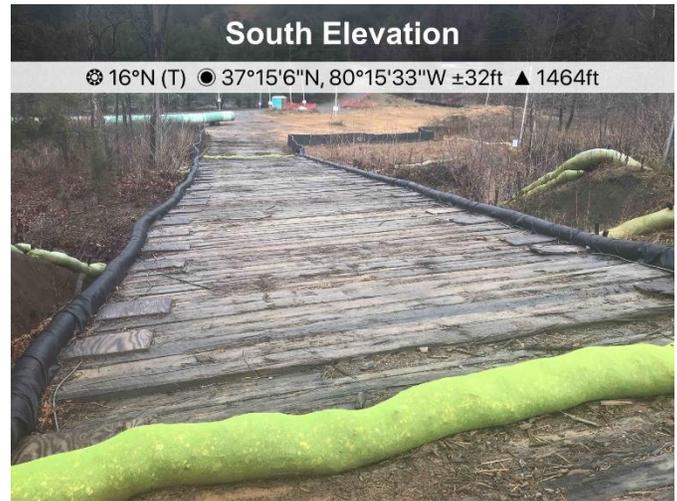
- Fig. 2. Designated stream crossing S-C21, ECD's are in place and functioning.

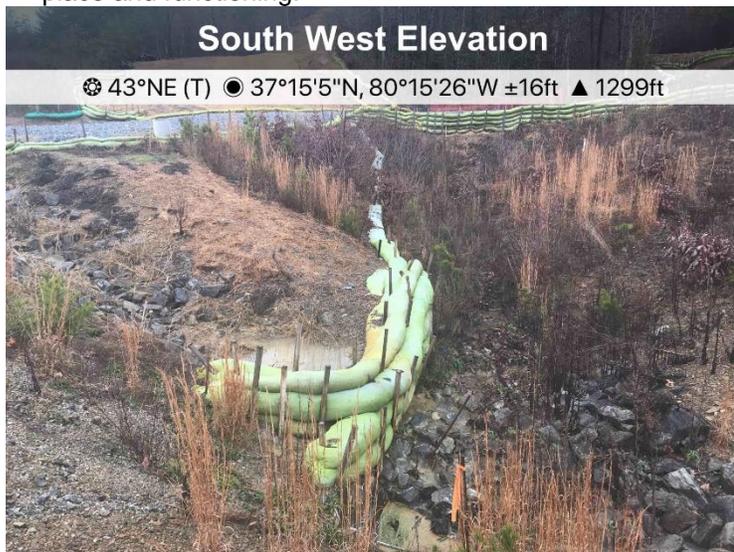
- Fig. 3. Near designated stream S-0011 and intersection of railroad ditch line. ECD's and stabilization of ROW are in place and functioning.

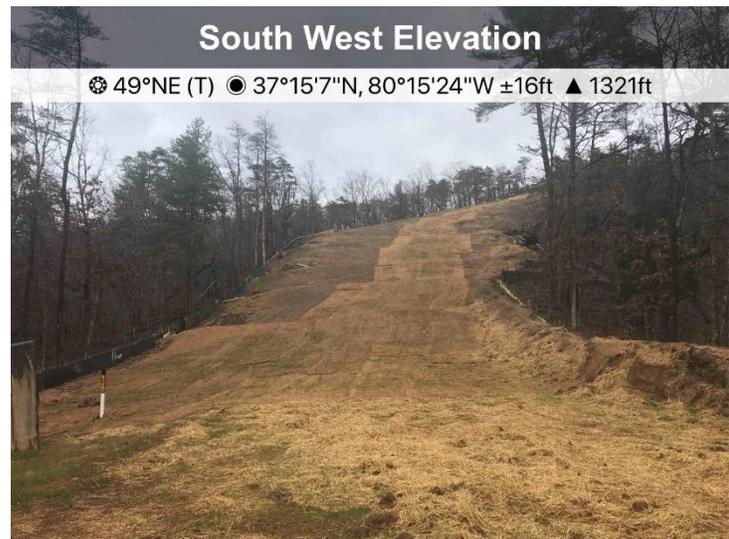
- Fig. 4. Near St122200+22 above designated stream S-0011, stabilization and ECD's are functioning.
