FIELD INSPECTION

Project Name:	Mountain Valley Pipeline	Inspector:	Marshall Willis
Inspection Date:	Friday, July 19, 2019	Project Contact:	Brian Clauto
Spread H: Montgomery County	STA 12420+00 – 12443+00 MVP-MN-279/279.02 ATWS 1506 + 1507 ATWS 725 + 726 + 727	Weather (Wet/Dry/Rain):	Dry

FIELD INSPECTION PHOTO LOG

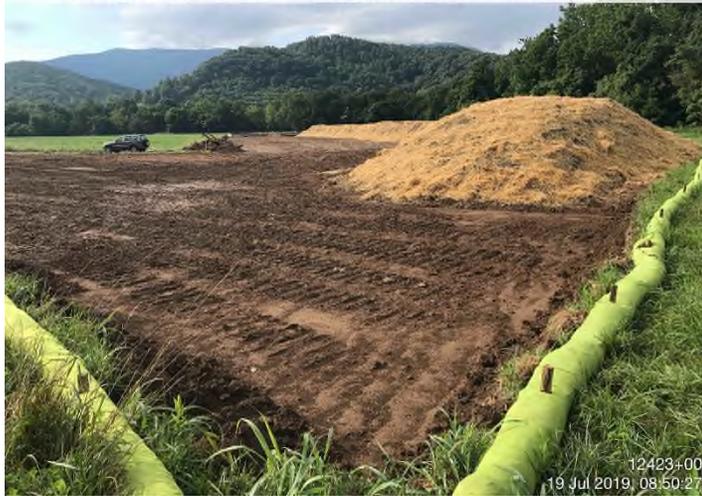
12423+00
19 Jul 2019, 08:50:27

Fig. 1: STA 12423+00 – Controls in place and functioning properly. Stockpiles stabilized with seed and straw.

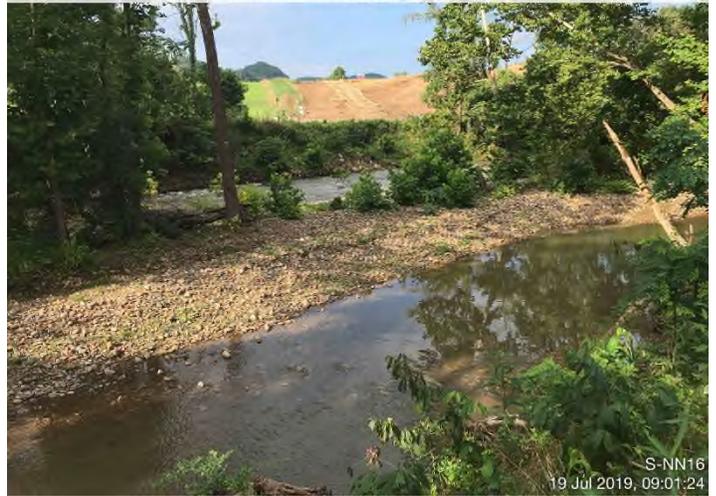
S-NN16
19 Jul 2019, 09:01:24

Fig. 2: Stream S-NN16 – Roanoke River crossing at STA 12435+16. No observed impacts from the MVP ROW.

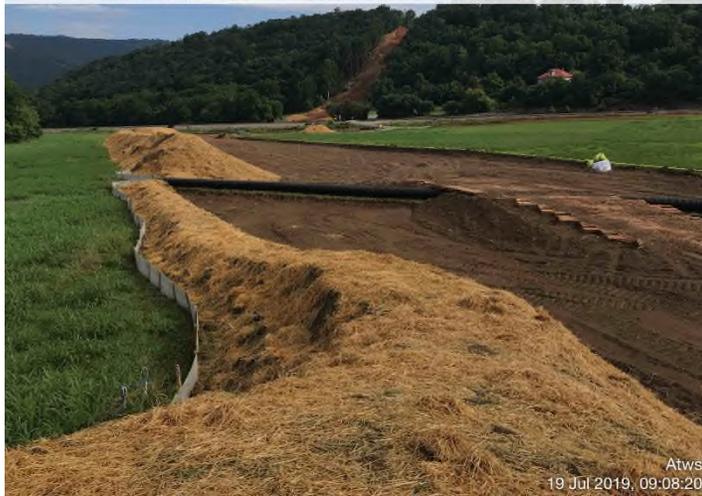
Atws
19 Jul 2019, 09:08:20

Fig. 3: ATWS 726 – Controls in place and functioning properly. Stockpiles and diversions stabilized with seed and straw.

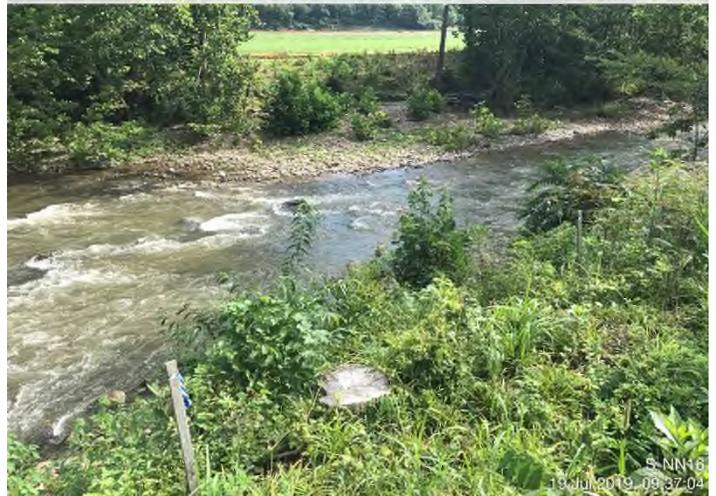
S-NN16
19 Jul 2019, 09:37:04

Fig. 4: Stream S-NN16 – Roanoke River crossing at STA 12435+96. No observed impacts from the MVP ROW.
